ENVIRONMENT, SAFETY AND HEALTH BULLETIN

DOE/EH-0697 Issue No. 2005-10 August 2005

Vertical-Rail Fall Protection

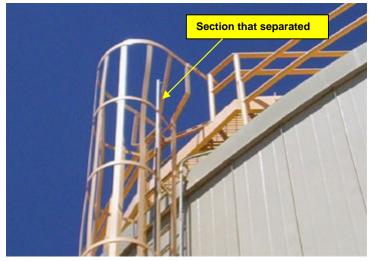
Figure 1. Rail Installation at RTC

A pipefitter was near the top of a 40-foot fixed ladder attached to the side of a million-gallon water storage tank at the Reactor Technology Complex (RTC) when the 4-foot top rail section of the vertical-rail fall protection tubing separated from the main vertical rail (Figure 1). He was holding the top rail section at the moment the rail separated, and was able to reattach the top rail. The pipefitter descended the ladder and reported the incident to management. (ORPS Report ID-BEA-ATR-2005-0007)

A design weakness in the rail system contributed to the incident. The connection for the upper section uses a twist-lock design that incorporates a metal pin (main section) and "L" groove. The locking mechanism between the pin and the L-groove was defeated when the alignment slot and the retaining pin became aligned (Figure 2). Only one of eleven systems at RTC is of this design. The manufacturer of the failed system, Antenna Products

(http://www.antennaproducts.com), helped to develop a repair for the rail that entails installing a set screw to secure the top portion of the tubing.
