**RESPONSE TO  
THE DEFENSE NUCLEAR FACILITIES SAFETY BOARD (DNFSB)  
RECOMMENDATION 94-4**

**INTERIM REPORT  
January 18, 1995**

ROOT CAUSE ANALYSIS AND GENERIC IMPLICATIONS  
OF THE UNAUTHORIZED DRAINING OF A PROCESS LINE  
IN BUILDING 771

# EVENT & CAUSAL FACTOR CHART BUILDING 771 TANK DRAINING EVENT OF 09/29/94

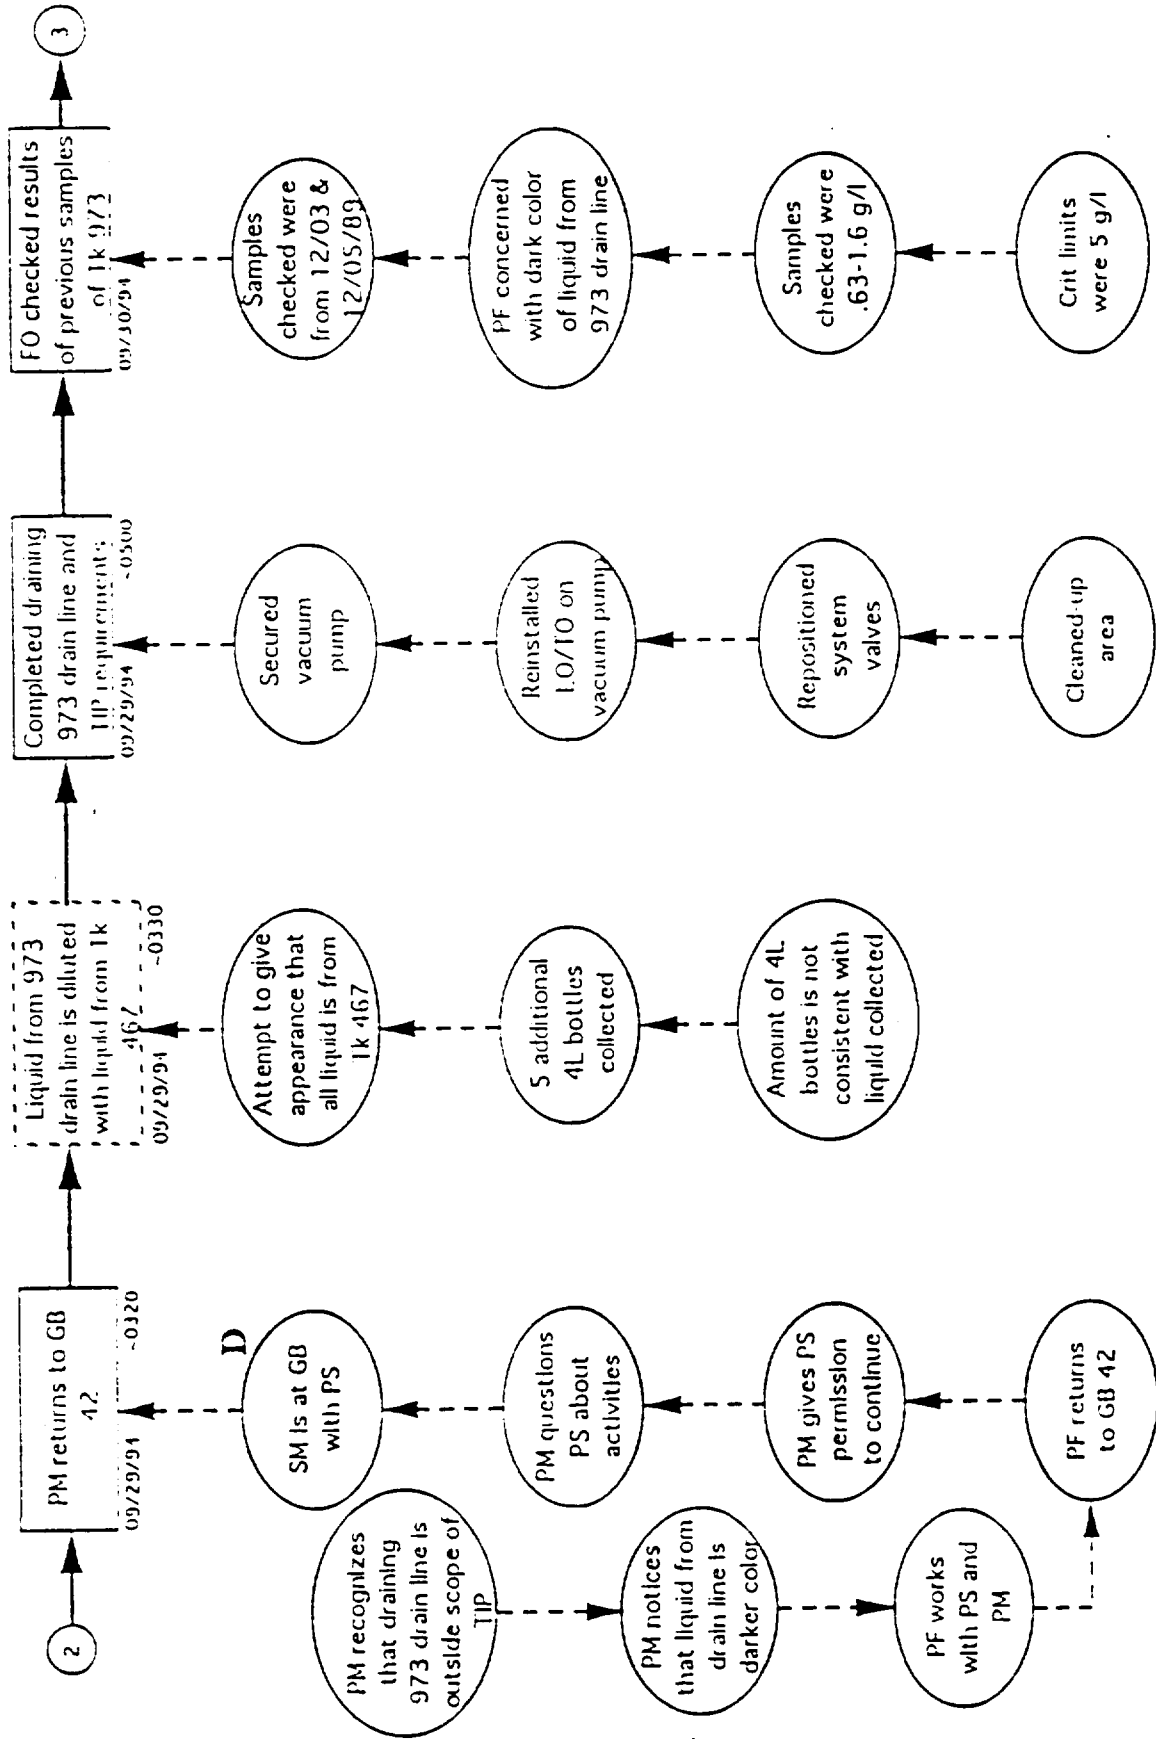
BUILDING 771 TANK DRAINING. EVENT OF 09/29/94

• Additional liquid assumed to be from 973 Tk drain line

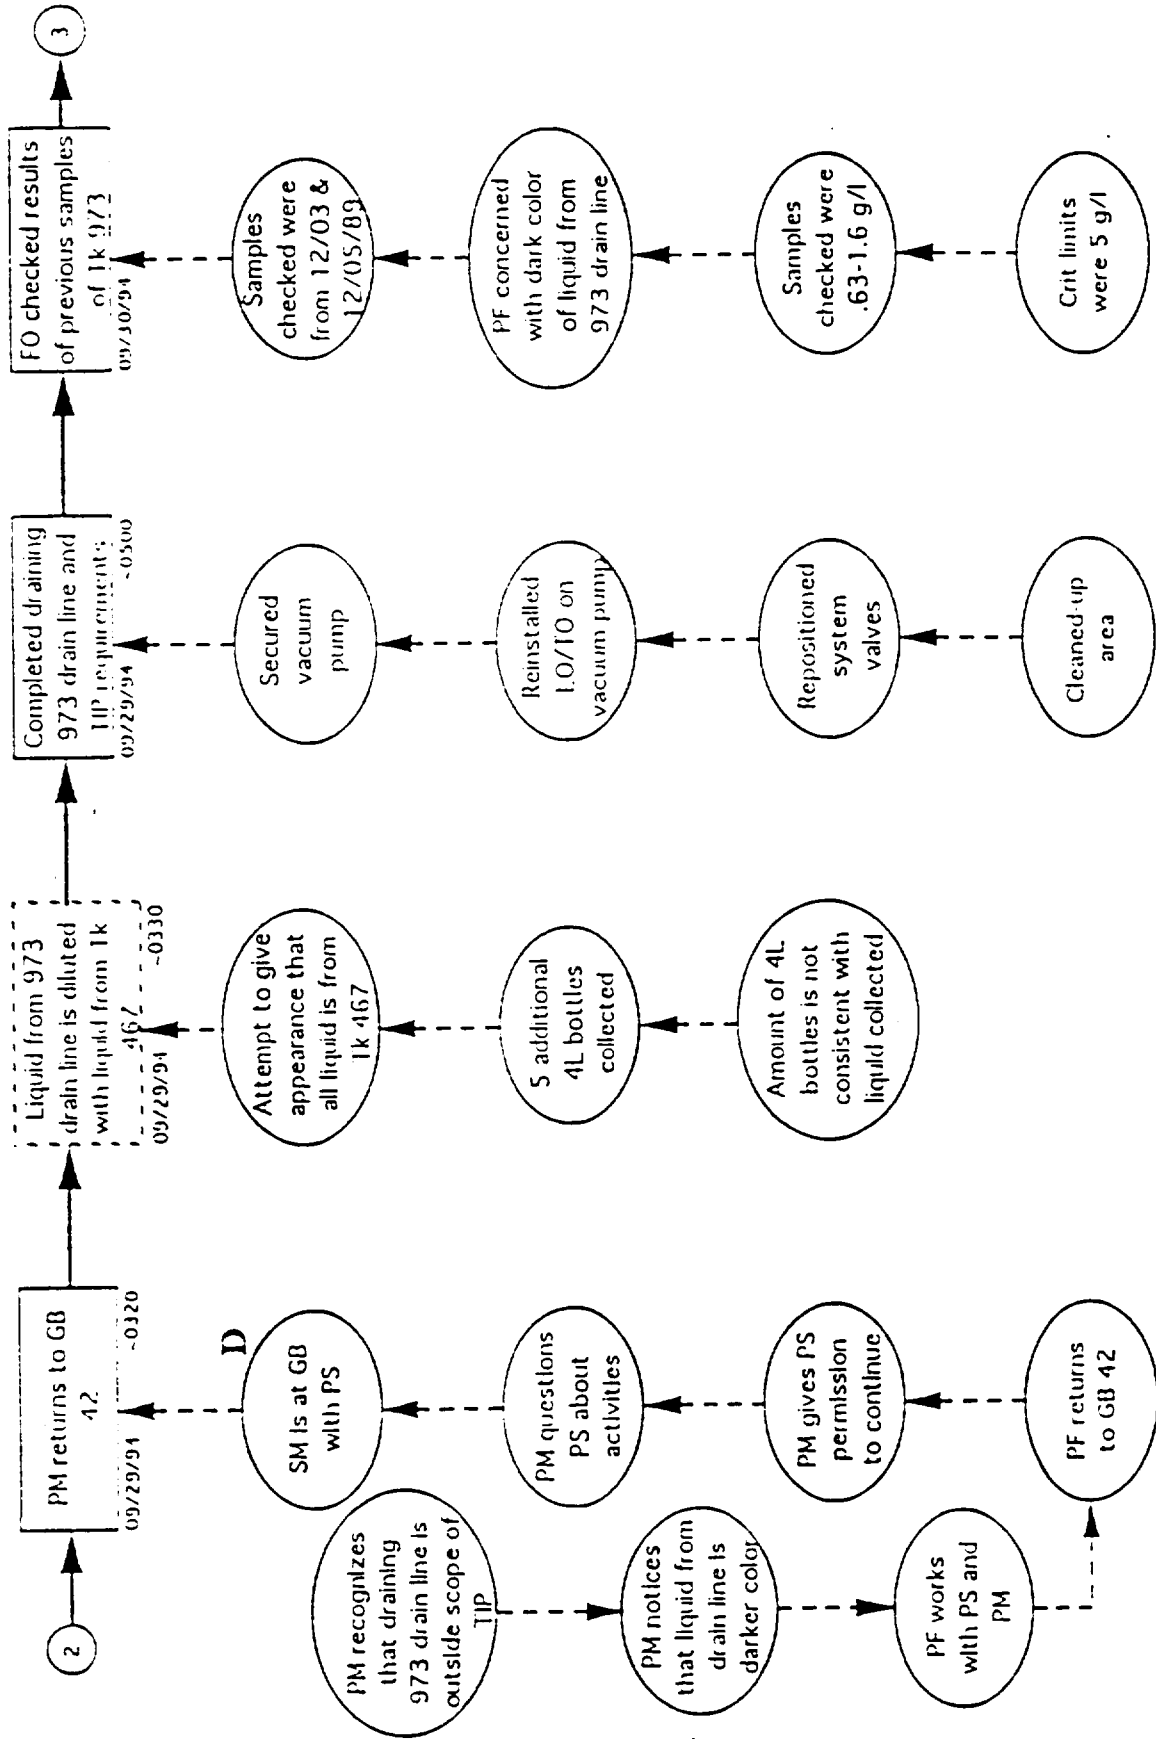
# BUILDING 771 TANK DRAINING EVENT OF 09/29/94

• Additional liquid assumed to be from 973 Tk drain line
