URANIUM-233 STORAGE SAFETY
AT
DEPARTMENT OF ENERGY FACILITIES

Defense Nuclear Facilities Safety Board

Technical Report

February 1997

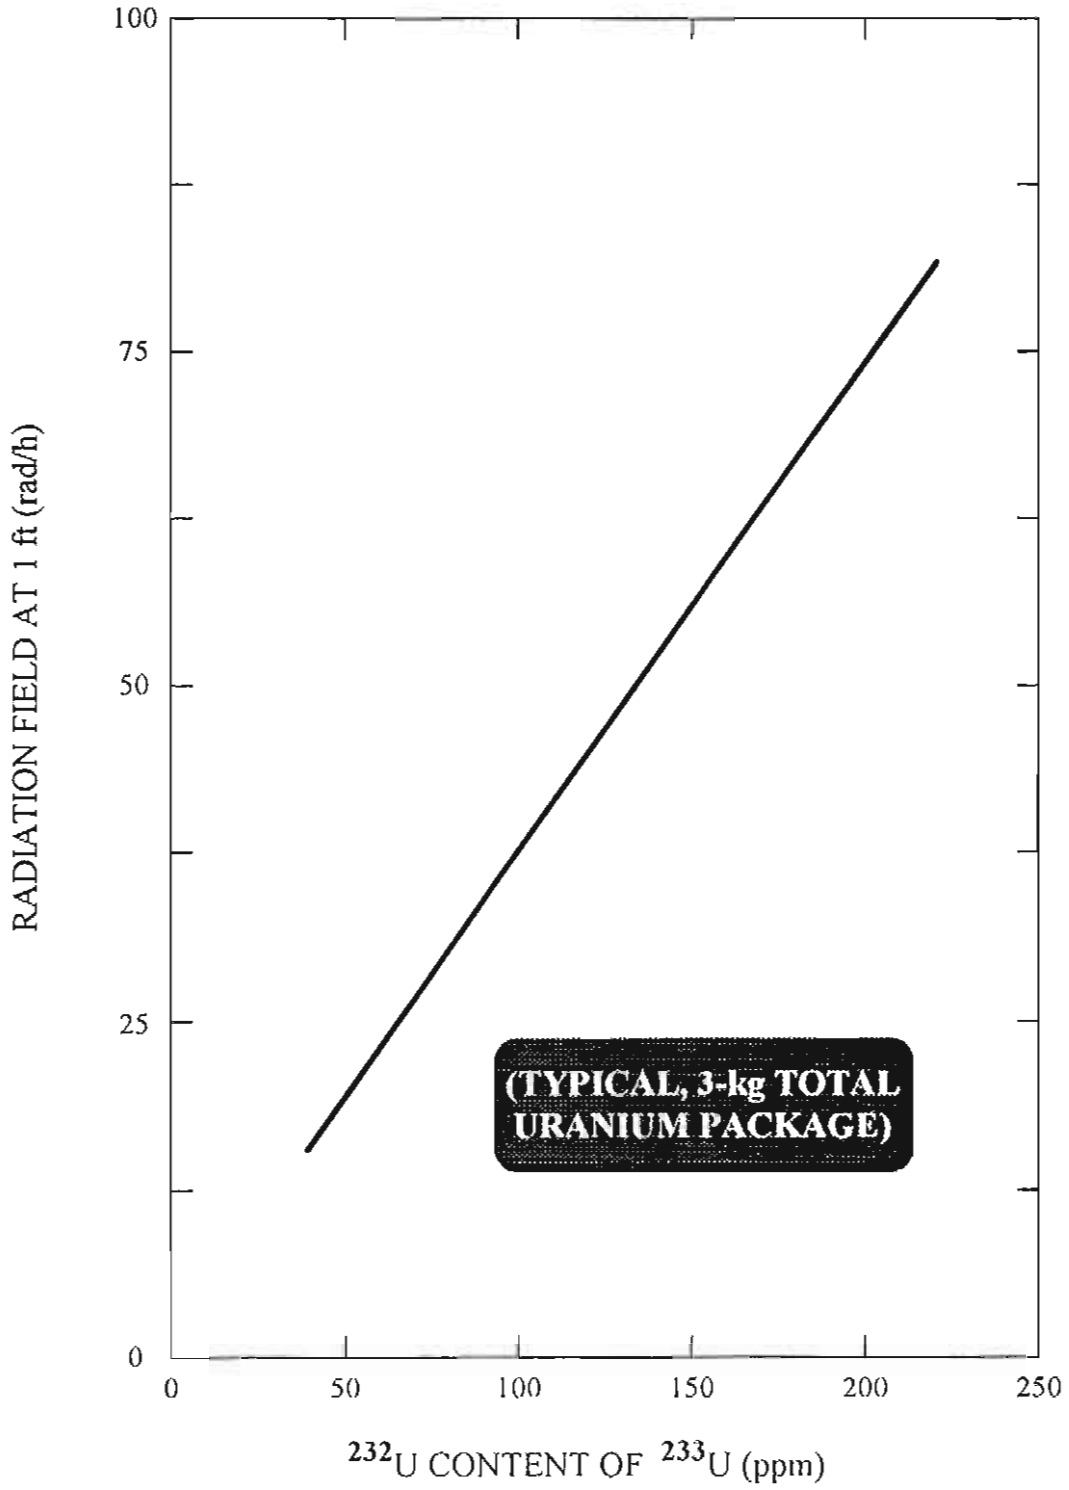
ORNL DWG 91A-414

APPENDIX C. RADIATION FIELDS ASSOCIATED WITH URANIUM-232 CONTENT
