## DEFENSE NUCLEAR FACILITIES SAFETY BOARD

## **Staff Issue Report**

<b>MEMORANDUM FOR:</b>	J. K. Fortenberry, Technical Director
COPIES:	Board Members
FROM:	H. W. Massie
SUBJECT:	Safe Storage of Sodium Fluoride Traps, Oak Ridge National Laboratory

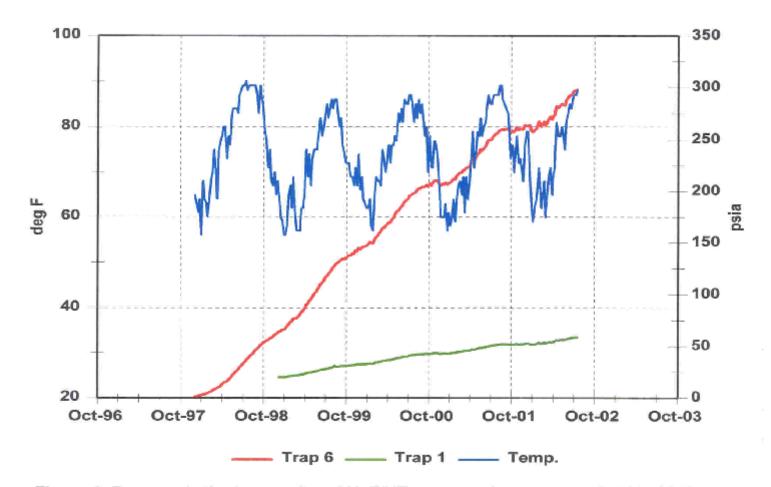
**Radiolysis in NaF Traps and Pressure Monitoring.** The internal pressure of the traps is increasing because of radiolysis of the NaF–UF<sub>6</sub> compound, which evolves fluorine gas. ORNL monitors the pressure in two traps (traps #1 and #6) stored in Cell 1 of Building 3019A. Figure 1 (attached) presents pressure data provided to the Board's staff by ORNL. The figure shows that the pressure in trap #6 is approaching 300 psig and is continuing to increase. Trap #1 contains considerably less material and has generated less pressure.

The pressure instrument is calibrated for pressures up to 250 psig. Therefore, ORNL is now estimating the pressure for trap #6 based on extrapolation of the calibration data, contrary to industry standards for calibration. Hence, uncertainty exists in the pressure measurements, and this uncertainty will increase as the pressure continues to rise above the calibrated range of the instrument. Furthermore, trap #6 is not believed to be the worst-case trap; thus higher pressures are expected to exist eventually in nine traps stored in the Building 3019A tube vaults. At this time, only one other trap is calculated to have a higher pressure than trap #6.

Figure 1: Pressure in the two monitored NaF/UF6 traps, and temperature in Bldg 3019.
