TA55-PES-11-001, Rev. 0

TA-55 Project Execution Strategy

August 2011

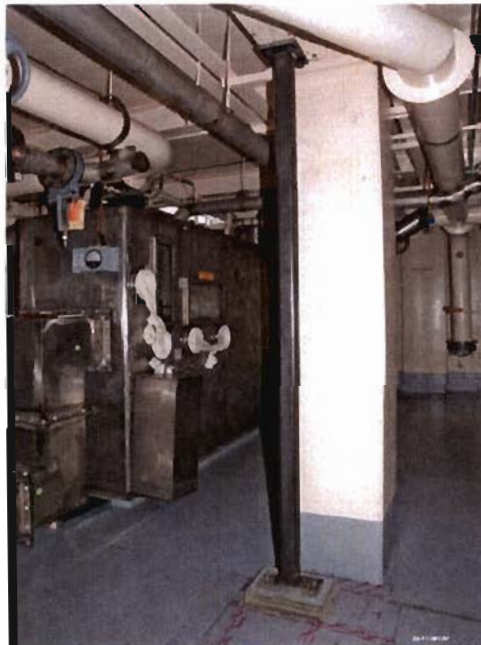
The Zone-1 filter plenum rooms have beam/column connections that are likely to fail in a seismic event because the anchorage of the beams to the columns is outside the column rebar cage. Correction includes installation of a steel column that transfers loads to the floor. The activity started in mid-April 2011 and was completed in July 2011 (see Figure 1).

Figure 1. New Steel Column Supporting Steel Beam

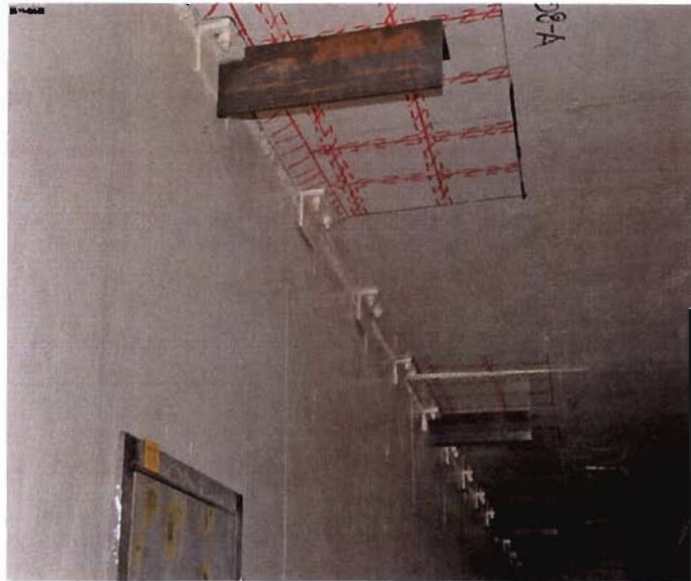
The concrete shield walls in the 200 Area (9-in.-thick reinforced concrete between ^{238}Pu operations areas) have insufficient anchorage to the roof and are of concern for falling over onto ^{238}Pu gloveboxes. The walls are connected with angle-iron clips to the ceiling. Additional perpendicular angle-iron supports are being installed to prevent shearing of angle-iron bolts with wall movement. These upgrades were completed in July 2011 for seven of the eight sides of the walls (see Figure 2). A separate design effort is in development to correct the last side of one wall because it requires an alternative fix due to limited accessibility.

Figure 2. New Anchor for Shield Wall

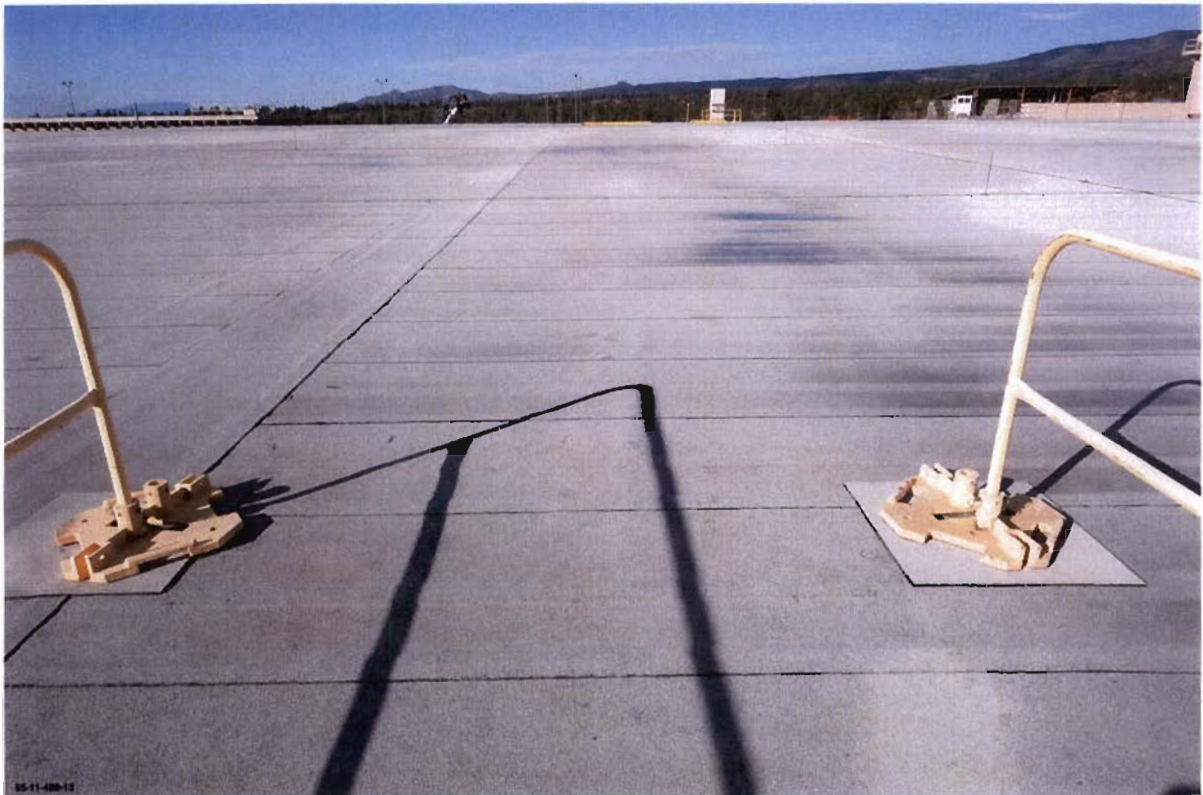
There is no shear wall on the laboratory level of the south side of PF-4 (column line 8). This results in overstress of roof girders, which could result in roof collapse. The current plan is to access the roof from the outside, remove 20 ft (width) of the roof, and to use concrete and rebar to correct the issue (see Figure 3). This action would require reinforced concrete added to the top of the roof about 236 ft in length, 8 ft in width, and 1 ft in depth. The drag strut would be tied into the roof via dowels into the roof concrete. The same contractor who improved the roof will perform this work, which will maintain the roof warranty. Construction started in August 2011.

Figure 3. Location for Drag Strut (Looking South Across PF-4 Roof)

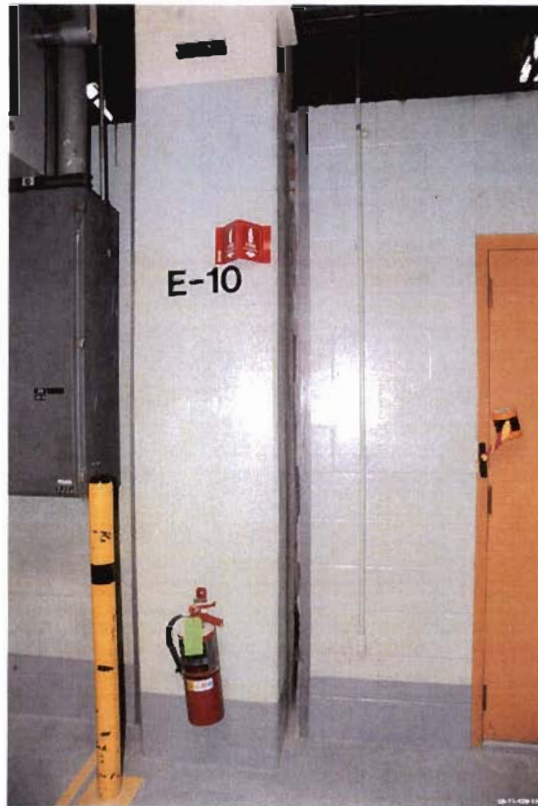
In the basement there are columns that support the main floor. Some columns have structures built next to them, and, with motion, the column is constrained from moving, which can ultimately cause a shear failure (thus they are referred to as “captured” columns). The correction is to cut a gap between the adjacent structure and the column to decouple the structural motion (see Figure 4).

Figure 4. Captured Column in Zone 1 Plenum Room (Wall Cut Back 1.5 in.)

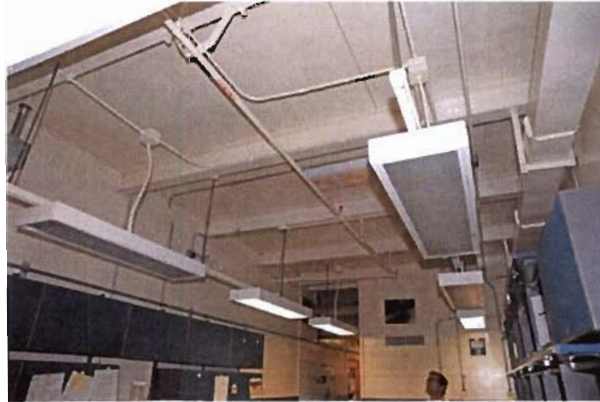
There are nine mezzanines in PF-4, five of which have issues related to lateral and longitudinal capacity and associated collapse. Mezzanine 6 has a higher failure probability, so it is being corrected first. The issue is the connections of the horizontal wall to the laboratory floor and the stiffness of the mezzanine floor near openings for stairways and ductwork such that the mezzanine could fall. The upgrade includes additional anchorage to the laboratory floor and the addition of beams under the mezzanine floor (see Figure 5).

Figure 5. View of Bottom of Mezzanine (Beams to be installed for additional support)

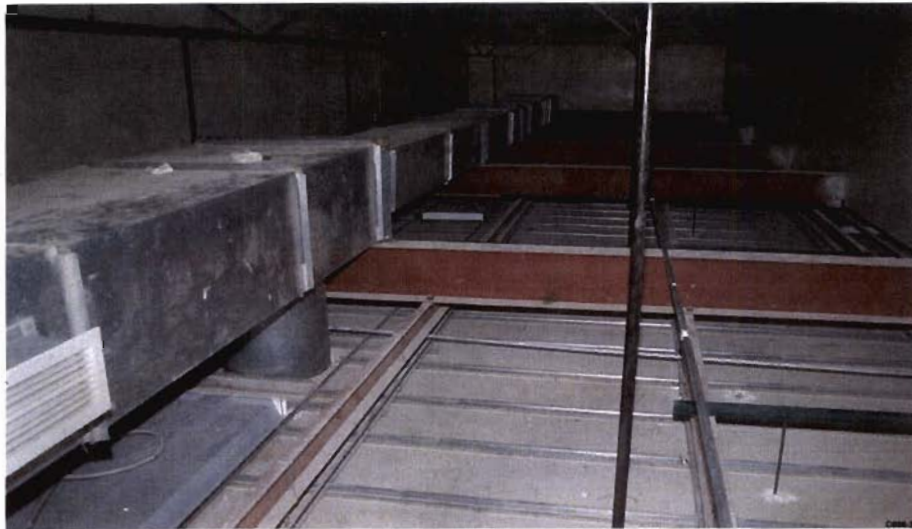
Ceiling beams have an issue in nine bays, each of which has five beams. The failure mechanism is torsional buckling. The corrective action is to connect the tops of the I-beams to the C-channel beams to provide additional stiffness. In addition, the C-channel beams need to be stiffened. Finally, the twisted-wire connection of the laboratory ceiling to the beams supports need to be strengthened (see Figure 6).

Figure 6. Ceiling Beams (I Beam, top right of photo; C Channel, right center of photo)

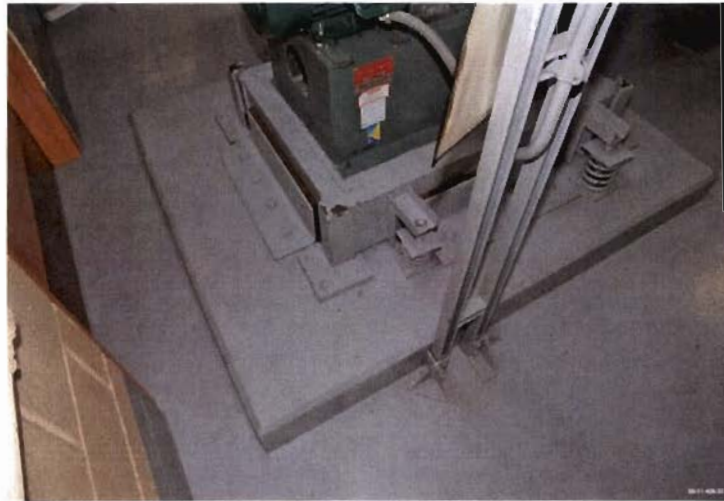
The glovebox exhaust fans are anchored to a 6-in. thick concrete pad. This pad is not adequately anchored to the basement floor, resulting in the potential for ductwork connections to the fan to breach in a seismic event. There are eight of these concrete pads. The fix involves anchoring angle iron around the perimeter of the pads (see Figure 7).

Figure 7. Glovebox Exhaust Fan and Concrete Base Pad

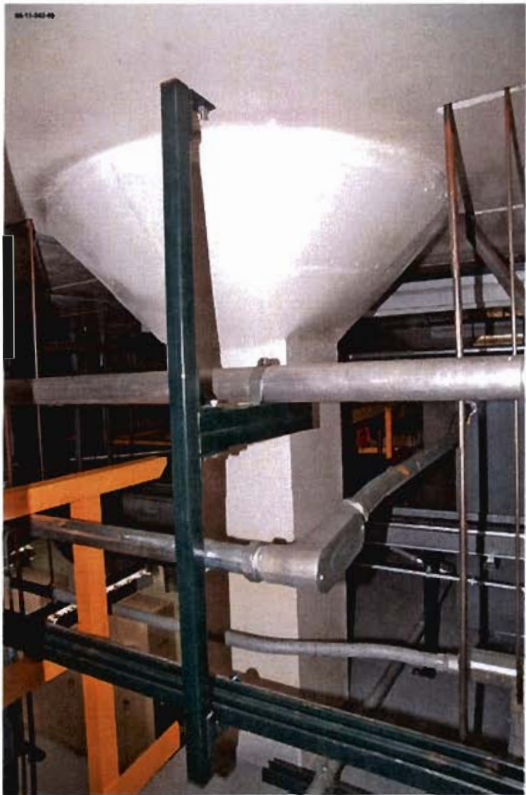
There are also captured columns in the vault and the corridors. Some columns (10 in the vault) are connected to adjacent structures with reinforced concrete, which is not amenable to cutting (see Figure 8). There are 52 columns in the corridors connected to laboratory walls. There is significant equipment connected to the columns or adjacent to the columns, which makes accessibility for upgrades costly (see Figure 9). The actual number of these columns that require upgrade will be determined through facility modeling with the drag strut correction in place. If some or all of the vault columns require upgrade, the expected solution is to reinforce the columns above the vault with fiberglass and resin coating to prevent failure and subsequent failure of the main floor.

Figure 8. Vault Captured Column

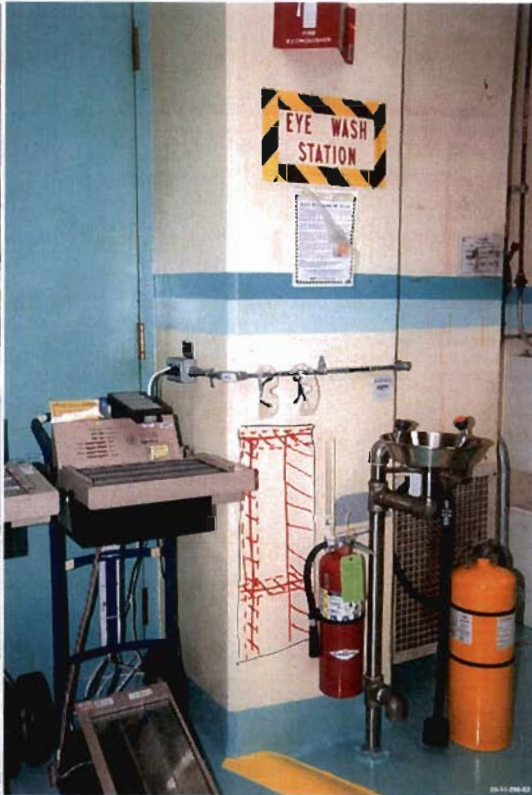
Figure 9. Corridor Captured Column

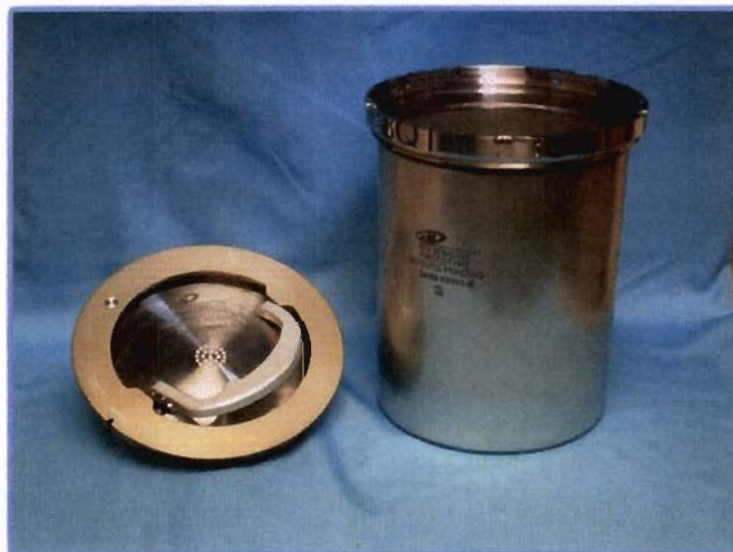
A standard test has been developed to establish a basis for crediting containers with a Damage Ratio of less than 1.0 in Safety Basis documents (see Figure 10). For each type of container, the test requires 20 test specimens filled with cerium oxide as a surrogate for plutonium oxide. The test containers are subjected to one of two pre-defined fires and then drop tested. The material remaining in the containers after the drop test is then measured and compared to the inventory before the test. The difference is used to establish the credited Damage Ratio using a statistical method. Two containers have been tested thus far, and additional containers will continue to be tested. Testing will be paid for by the upgrade projects; however, procurement of containers for use in the facility will be paid for by programs.

Figure 10. New Vault Storage Container

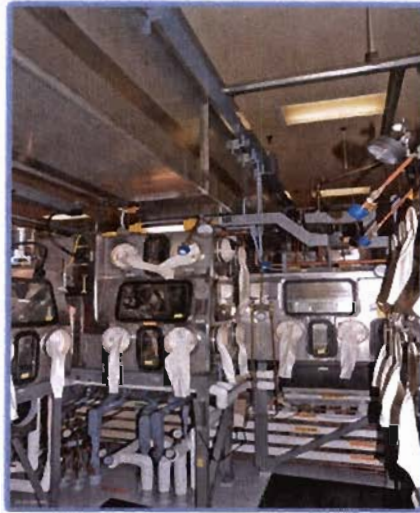
This work involves seismic upgrades to eight glovebox stands that support gloveboxes housing operations that involve molten plutonium. The work requires replacement of the existing stand with more robust structural members and stronger anchorage. To gain access to these components, all services below the glovebox must be removed (see Figure 11). The glovebox will be temporarily supported and the existing stand removed. The new stand members will then be installed with increased anchorage to the floor and diagonal members for support. All services will then be rerouted to the glovebox.

Figure 11. Glovebox Support Stand (Gray) and Glovebox Services

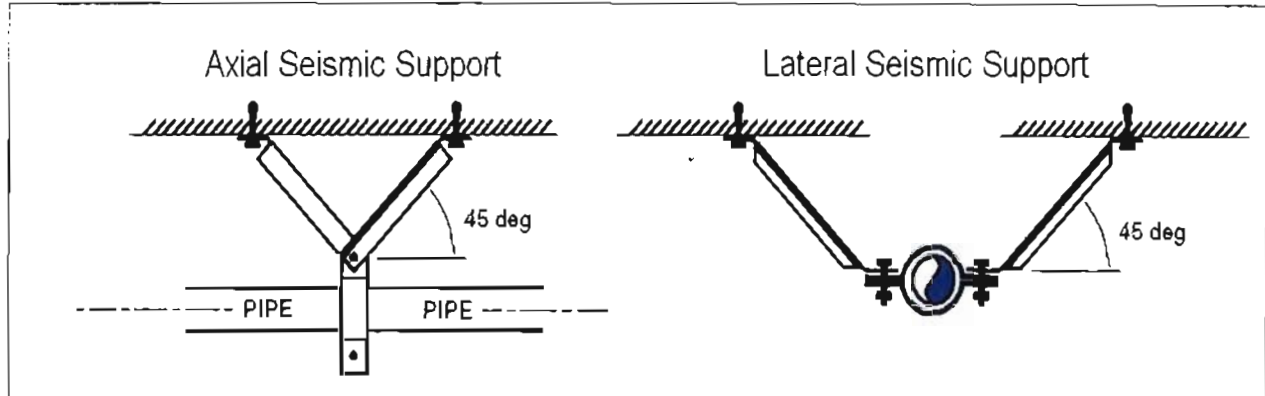
A conceptual design has been prepared based on SAFER structural reviews of the system. Additional pipe hangers are required on fire suppression branch lines supporting both the first floor and basement of PF-4, as well as additional hangers in the pump houses. The conceptual design defines the fix as requiring 236 additional pipe hangers (see Figure 12). The fire water tanks and underground fire water line do not require upgrades.

Figure 12. Typical Piping Support

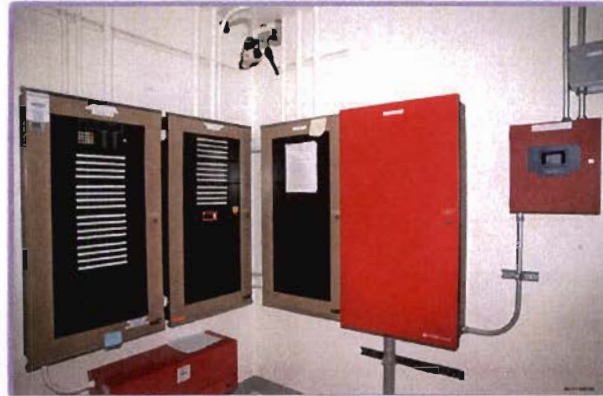
The purpose of the Fire Alarm System Replacement (FASR) Project is to replace the aging Fire Alarm Control Panel (FACP) 3225, which services Plutonium Facility (PF)-4 and 14 other structures at Technical Area (TA)-55. In addition to aging and maintenance issues, the existing detection, control, and evacuation devices are not NFPA or Americans with Disabilities Act (ADA) compliant, are not Underwriters Laboratory (UL) listed, and do not meet the current Los Alamos National Laboratory (LANL) standards (see Figure 13).

Figure 13. Fire Alarm Control Panels

The scope of this project is to replace Supervisory Panel (FACP) 3225 and all associated functions with new NFPA 72 compliant digital addressable fire alarm system(s) and to provide new fire alarm notification capability. This includes the following:

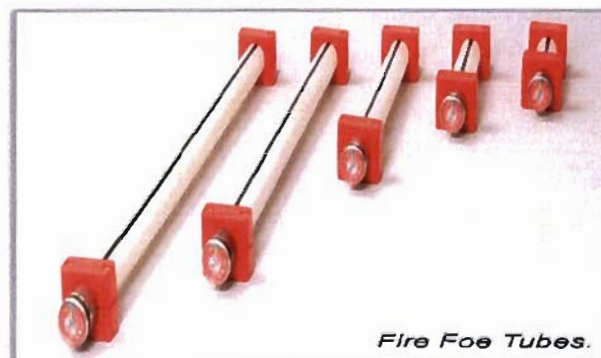
DOE Standards and NFPA 801 (Ref. 6) require gloveboxes that contain combustible material to be equipped with an inert atmosphere or fire suppression system. A promising fire suppression alternative is being developed that makes use of a passive, commercially-available product with a material cost of approximately \$1K per glovebox. This product is called the Fire Foe Tube®, which is a nylon tube that can be attached inside the glovebox. The tubes are filled with dry chemical and pressurized gaseous clean-agent fire suppressants that are released to the glovebox by weakening of the nylon during a fire (see Figure 14).

Figure 14. Fire Foe Tubes

The tubes have been tested at a nationally recognized test laboratory in a glovebox mock-up. The test report is now complete, which makes the tubes approved for use in PF-4 gloveboxes. Material compatibility studies are being conducted to fully understand the effect PF-4 glovebox environments have on the nylon tubes. Additional fire studies are also being conducted to gain a better understanding of reaction times for various sizes and type of fires. This work will be complete in FY12. Construction involves installation of the tubes on the ceiling of the gloveboxes and routing a wire from the tubes to the existing fire alarm system connection on the top of each glovebox for monitoring of the device.

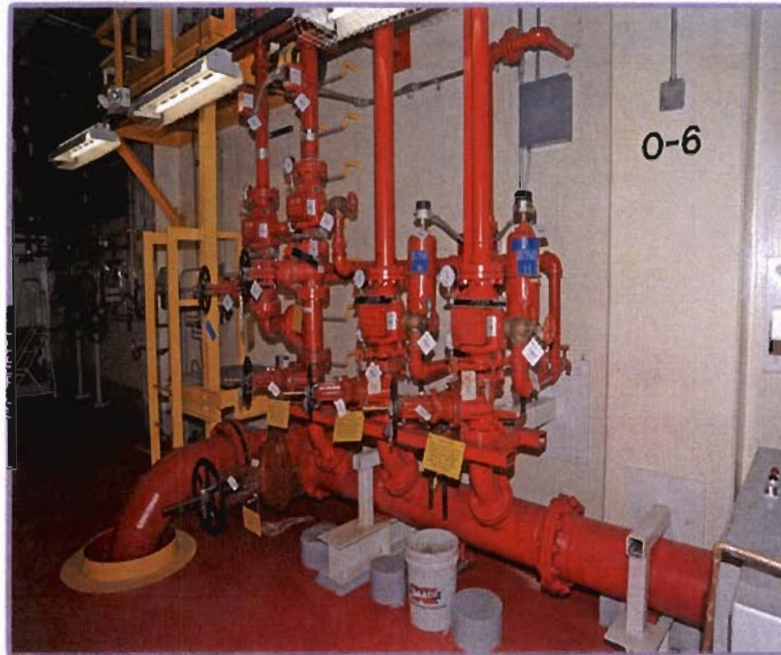
Figure 15. Fire-Suppression Risers

1. Install domestic water-booster pumping system with dual source capability; system shall be operable from electric and diesel sources. Provide pumping system with integral weather-resistant enclosure; the pumping system capacity shall be 1000 GPM at 110 PSI.
2. Install 10-in. domestic water line underground from building TA-55-6 to TA-55-2.
3. Install new laterals, one each from new 10-in. domestic water line to TA-55 buildings.
 - a. 10 in. lateral to PF-5
 - b. 8 in. lateral to PF-2, 3, 28, and 39
 - c. 6 in. lateral to PF-1, 6, and 114
4. The new domestic water line will not tie into PF-4, PF-8, or the new UPS building; the fire protection loop will service PF-4, PF-8, and the new UPS building.
5. Replace existing check valve in each of the two fire protection valve vaults with a solid-spool section of pipe (see Figure 15).
