This letter is in response to the Defense Nuclear Facilities Safety Board (DNFSB) letter dated December 17, 2014, requesting an updated plan and schedule for completing the alternate seismic analysis for the Los Alamos National Laboratory (LANL) Plutonium Facility (PF-4).

Description of the Los Alamos Plutonium Facility Upgrades

January 7, 2015

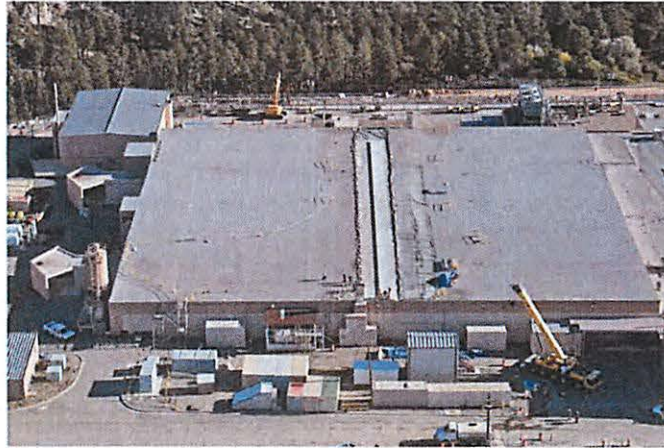
Figure 1. New Drag Strut Across PF-4 Roof

- A 140 ton concrete and steel reinforcement was installed on the existing roof to redistribute loads (Figure 1). This is referred to as the drag strut modification.

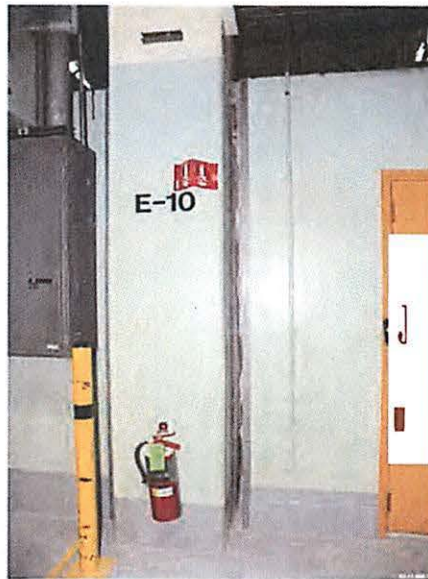
**Figure 2. Captured Column in Plenum Room
(Wall Cut Back 1.5 in.)**

- A gap was cut between the plenum room columns and adjacent structures to allow the columns to move (Figure 2).

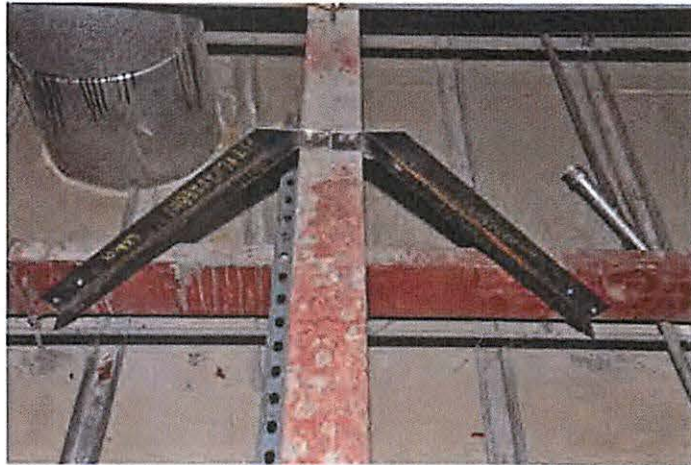
Figure 3. Ceiling Beam Brace from Top of I-beam to C-channel

- Five mezzanines above the main floor were reinforced.
- The top of ceiling beams were anchored to the C-channel beam to provide additional stiffness. In addition, the C-channel beams were stiffened (Figure 3).

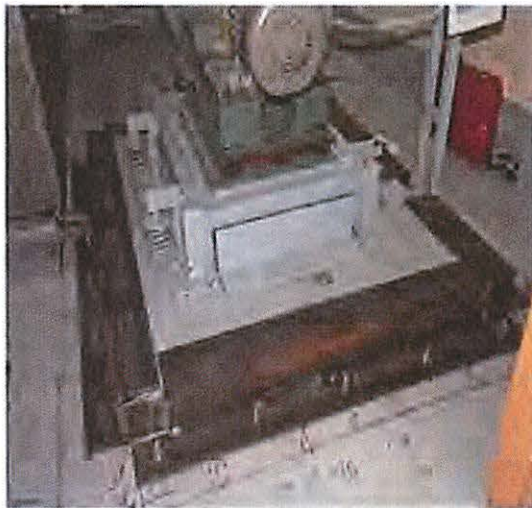
Figure 4. Glovebox Exhaust Fan and Concrete Base Pad with Bracing shown on the Perimeter of the Fan Pad

- Angle irons were installed around the perimeter of the glove-box exhaust fan concrete pads to anchor them to the floor (Figure 4).

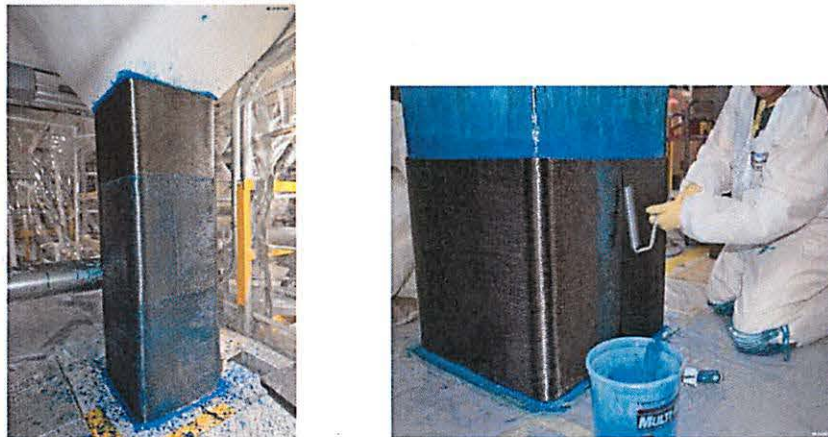
Figure 5. Basement Column reinforcement

- Eight basement columns were wrapped with carbon fiber reinforcement, thereby preventing loss of axial load capacity during and following an earthquake (Figure 5).

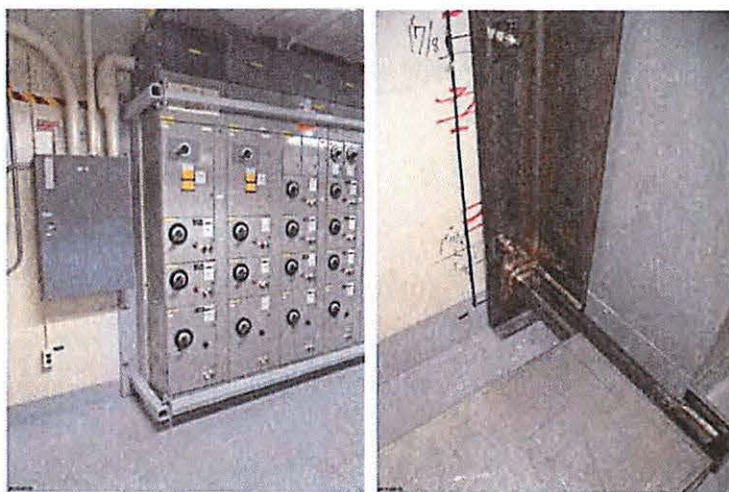
Figure 6. Motor Control System Anchorage

- The Fire Suppression System was upgraded to more effectively mitigate release from a postulated seismically-induced fire scenario.
- Anchorage of essential electrical distribution components has been improved (Figures 6 and 7).

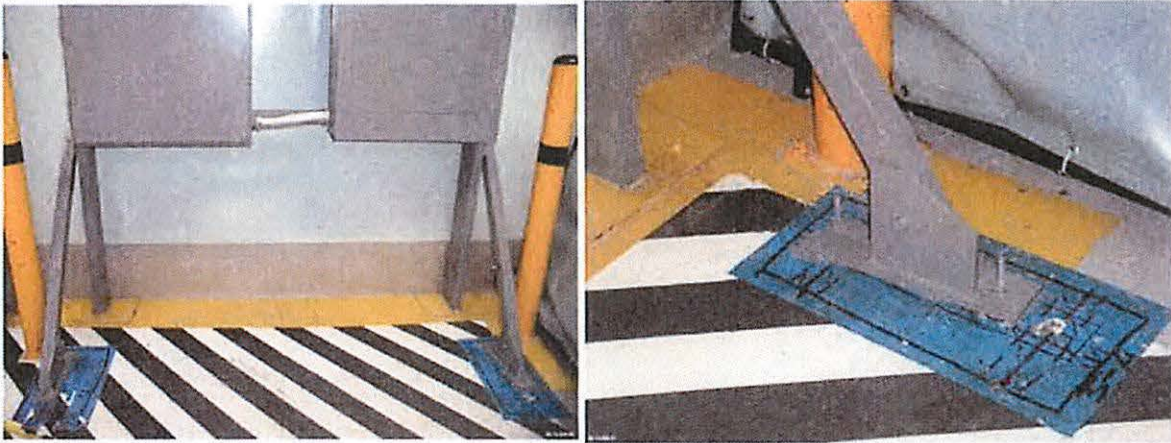
Figure 7. Anchorage of Uninterruptible Power Supply Auto Transfer Switch
