**DEFENSE NUCLEAR FACILITIES
SAFETY BOARD**

April 4, 2016

Staff Issue Report

SUBJECT: Waste Treatment and Immobilization Plant Quality Assurance Review

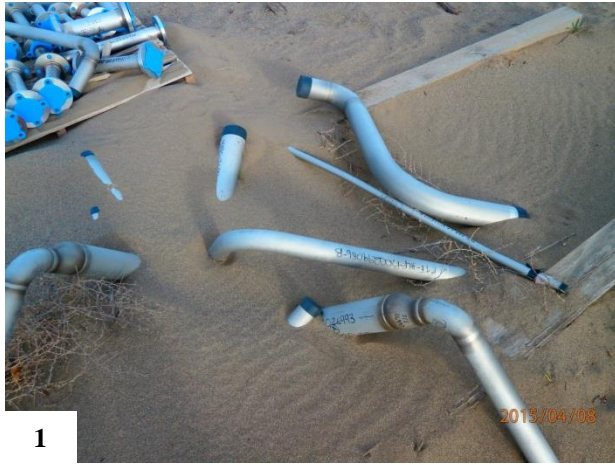
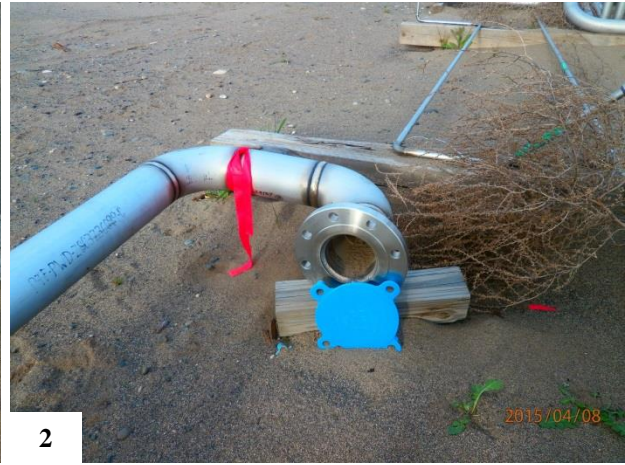
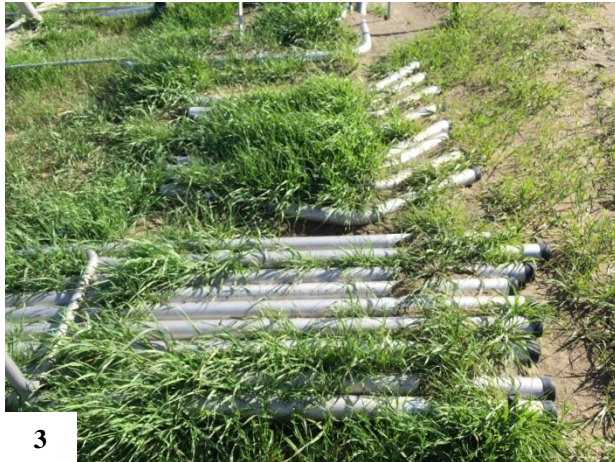
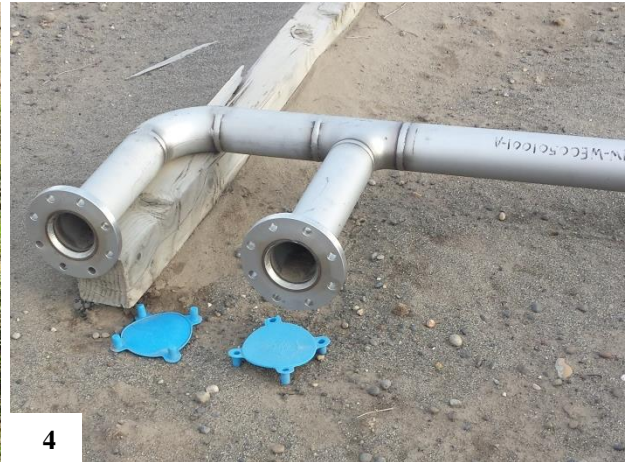
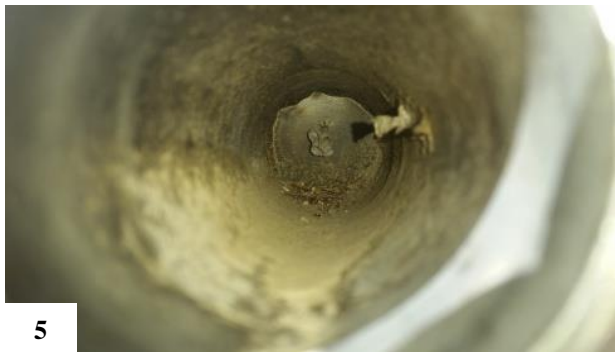
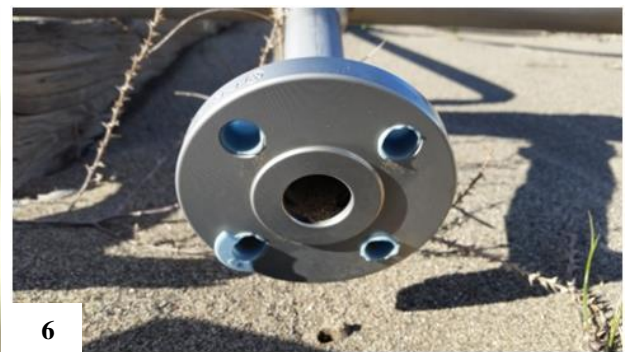
Deficiency 1, SSC Storage at the MHF Laydown Yard—In April 2015, at the MHF Laydown Yard, the staff photographed a substantial number of pipe spools and other SSCs buried in the sand and surrounded by excessive vegetation. Some SSCs were missing required protective coverings on their openings, and as a result, some SSCs showed signs of animal intrusion, contained standing water, or had a buildup of sand inside. See Appendix 1, Figures A-1 to A-8, for example photographs. These storage conditions are contrary to the following requirements:

Deficient storage conditions at the MHF Laydown Yard largely result from frequent high winds, blowing sand, and tumbleweeds, combined with inadequate corrective actions. BNI project procedure, *Field Material Inventory Management*, requires monthly surveillances of the MHF Laydown Yard. BNI assigned craft personnel to correct deficiencies identified during monthly surveillances; however, these efforts were not effective in maintaining compliant storage conditions. After receiving the staff review team’s agenda, BNI temporarily removed SSCs from rows 19 and 20, removed all sand, and leveled the ground. Appendix 1, Figures A-9 and A-10 illustrate BNI’s corrective actions. BNI also submitted a request for gravel to DOE-ORP. Pending approval, BNI expects the MHF Laydown Yard will be completely resurfaced with gravel within 2 years.

Figures A-1 to A-6. Staff review team photographs illustrating deficient storage conditions at the Material Handling Facility (MHF) Laydown Yard. Figure A-1 shows pipes buried in the sand. Figures A-2, A-4, and A-6 show missing pipe caps on pipe modules and a layer of sand built up inside. Figure A-3 shows excessive vegetation surrounding pipe modules. Figure A-5 appears to show part of an insect nest inside a structure, system, or component (SSC).

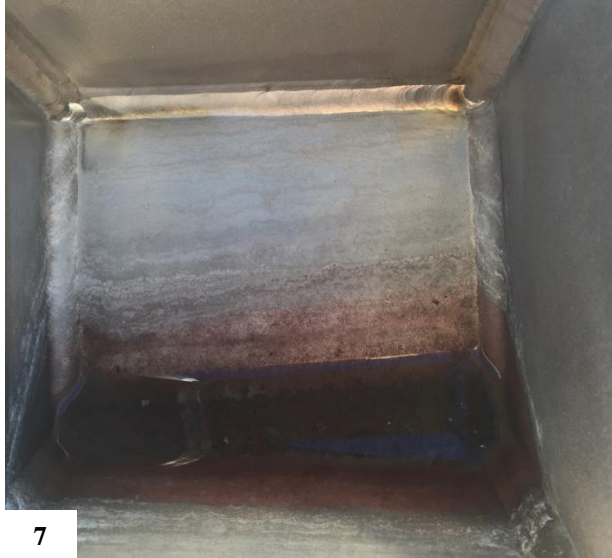
7

Figures A-7 to A-8. Staff review team photographs illustrating deficient storage conditions at the MHF Laydown Yard. Figure A-7 shows water accumulated inside a vessel. Figure A-8 shows additional pipe modules buried in the sand.

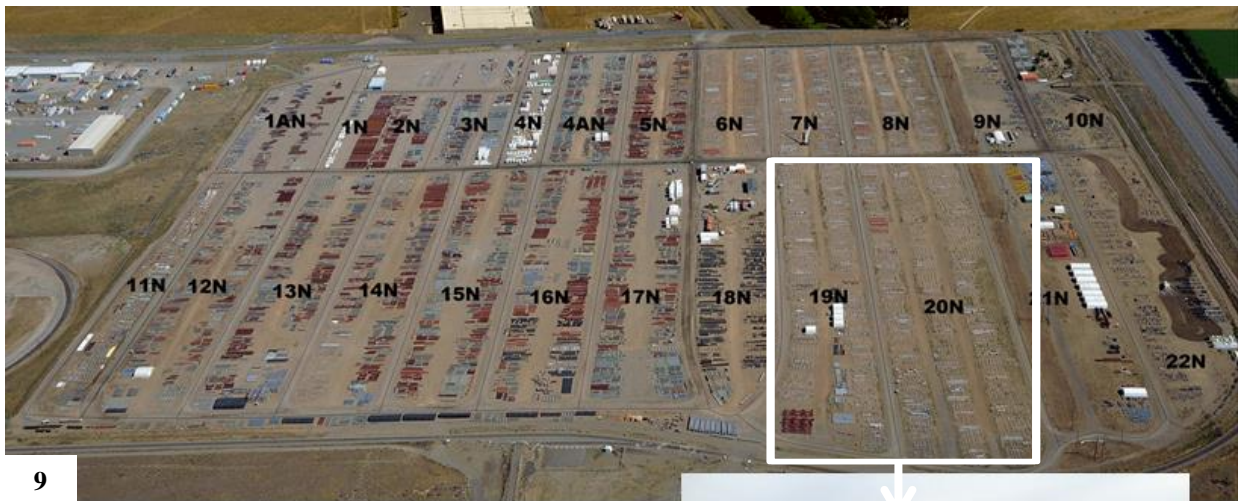
9

Figures A-9 and A-10. Photographs of the MHF Laydown Yard. Figure A-9 shows an aerial photograph of the 130 acre MHF Laydown Yard before Bechtel National, Incorporated (BNI) took corrective actions. Figure A-10 is a ground-level photograph of rows 19 and 20 following BNI corrective actions of temporarily removing all SSCs and removing the sand and leveling.

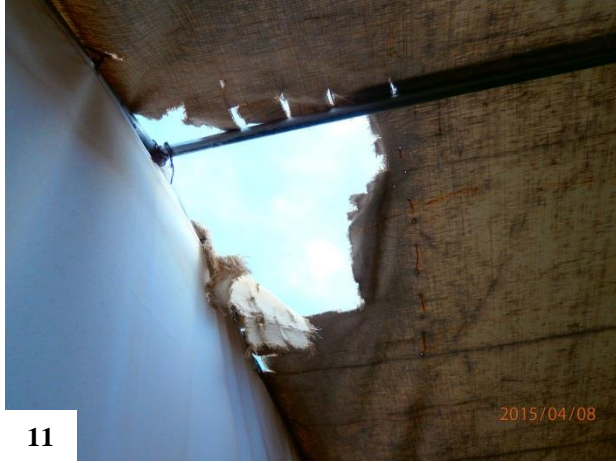
11

Deficiency 2, Storage Tents—In April 2015, , the staff photographed non-weathertight storage tents being used for “Level C Storage” at the MHF Laydown Yard and the WTP construction site. See Appendix 1, Figures A-11, A-12, and A-13, for example photographs. Some tents also showed evidence of animal intrusion. See Appendix 1, Figure A-14. These observed conditions are contrary to the following requirements:

Figures A-11 to A-14. Staff review team photographs illustrating deficient storage tents. Figure A-11 shows a ripped tent at the MHF Laydown Yard. Figures A-12 and A-13 show ripped tents at the Waste Treatment and Immobilization Plant (WTP) construction site. Figure A-14 shows evidence of animal intrusion in a tent at the WTP construction site.

Following receipt of the staff review team’s agenda, BNI performed an extent of condition for all Level C storage structures at the construction site. These structures included tents, small buildings, and trailers. BNI identified 10 structures requiring repairs and 8 structures that were less than adequate. BNI is relocating SSCs stored in deficient locations to warehouses. In addition, BNI will no longer designate storage tents located at the MHF Laydown Yard as Level C storage, unless they are repaired.

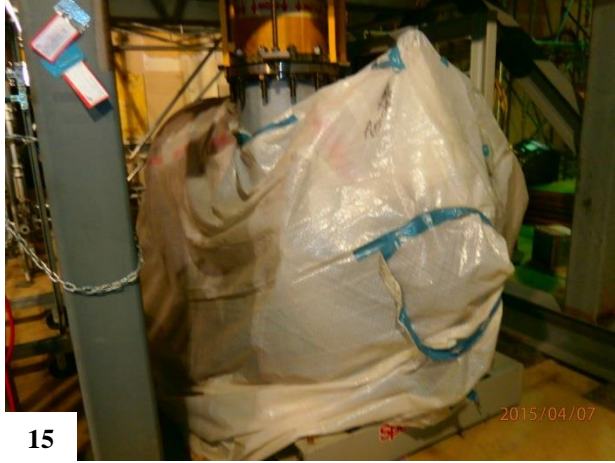
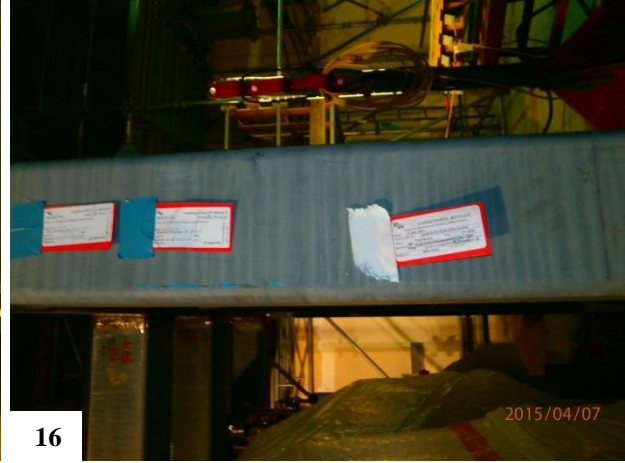
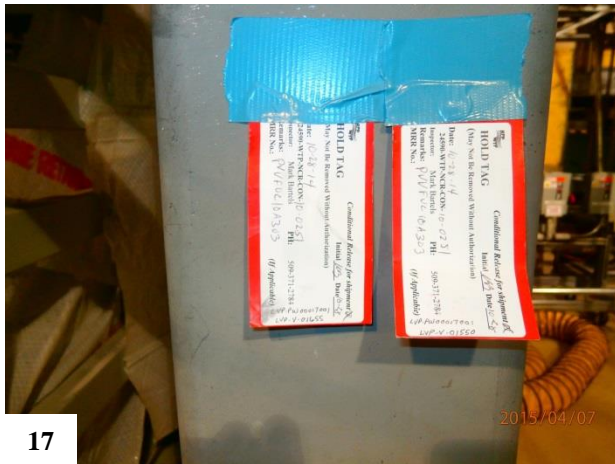
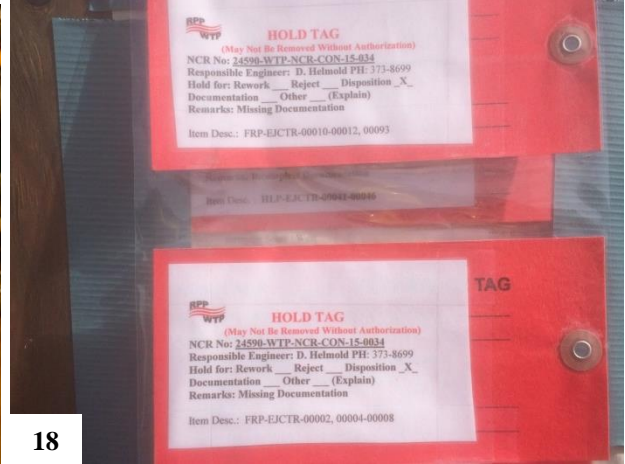
Deficiency 5, Identification of Nonconforming SSCs—BNI’s credited identification method for nonconforming SSCs in storage and the construction site is the use of electronic records in the Bechtel Procurement System (BPS) and Contractor Assurance Information System (CAIS) software. These electronic records identify the full list of active NCRs. In select storage areas, BNI uses electronic holds in the BPS software to identify nonconforming SSCs. When practical, BNI also hangs NCR hold tags on nonconforming SSCs. In April 2015 at the WTP construction site, the staff review team photographed NCR hold tags placed nearby when BNI judged it to be impractical to directly tag the SSC. See Appendix 1, Figures A-15 to A-18 for example photographs. These identification methods are defined in BNI project procedure, *Nonconformance Reporting and Control* [13]. This project procedure deviates from NQA-1 and the BNI project document, *Quality Assurance Manual*, without clear approval from DOE or the NQA-1 code committee. Additionally, since loss of either BPS or CAIS would result in the loss of these credited electronic records, BPS and CAIS should be evaluated against NQA-1, Requirement 17. These conditions are contrary to the requirements listed below:

Figures A-15 to A-18. Staff review team photographs illustrating alternate methods of identifying nonconforming items. Figures A-15 to A-17 depict Nonconformance report (NCR) hold tags on structural steel near the nonconforming item. Figure A-18 shows NCR hold tags on the outside of a storage tent near the Pretreatment Facility construction site.

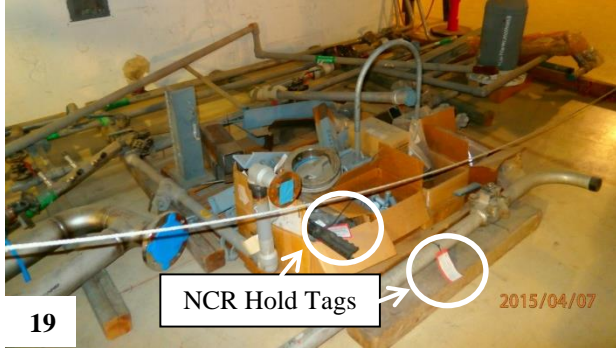
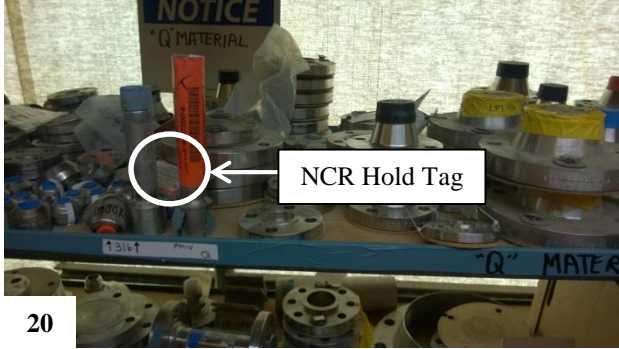
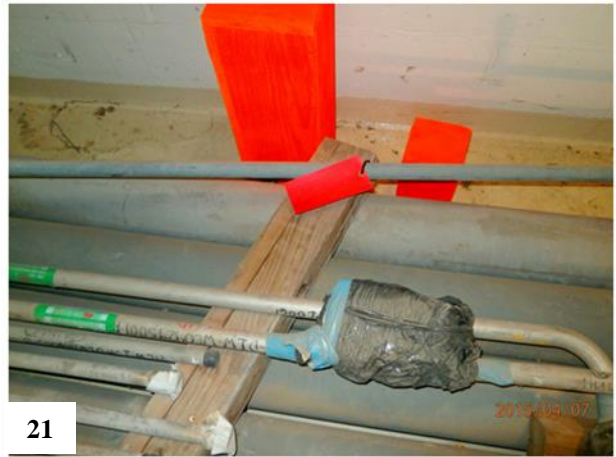
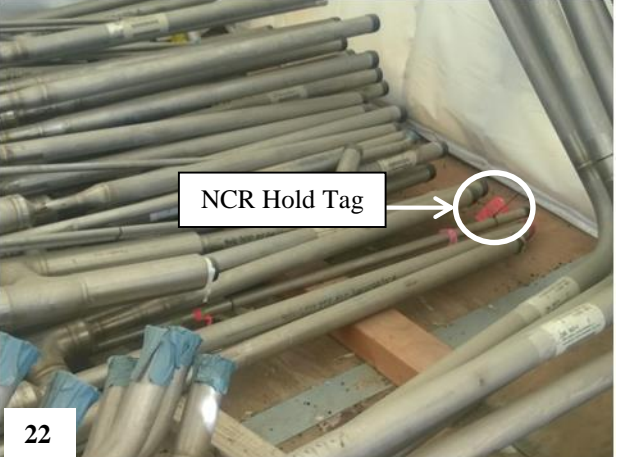
Deficiency 6, Segregation of Nonconforming SSCs—In April 2015 at the WTP construction site, the staff photographed some SSCs that were tagged with NCR hold tags but not segregated from other SSCs when it was practical to do so. See Appendix 1, Figures A-19 to A-22 for example photographs. These situations are contrary to NQA-1, Requirement 15, Paragraph 300, and the BNI project document, *Quality Assurance Manual*, Section 15.1.2.3.1, which require nonconforming items be segregated when practical.

Figures A-19 to A-22. Staff review team photographs illustrating nonconforming SSCs that were not properly segregated. Figures A-19 and A-21 are inside the High-Level Waste Facility. Figure A-20 was inside a storage area at the WTP construction site. Figure A-22 was inside a storage tent near the Pretreatment Facility.

BNI located the nonconforming SSCs and discovered that in most instances, the NCR or construction deficiency report (CDR) had been closed but the hold tag had not been removed. However, per the BNI project procedure, *Nonconformance Reporting and Control*, these SSCs should have been segregated until it was confirmed that the NCR or CDR was closed. Of note, one hold tag was for a CDR that had been closed nearly four years prior. BNI personnel said that they have now segregated the nonconforming SSCs identified by the staff review team. In addition, they said that they removed the closed NCR and CDR hold tags from the SSCs. BNI did not disagree with this issue, but it has not discussed other corrective actions besides segregating the items and removing the tags identified by the staff review team.

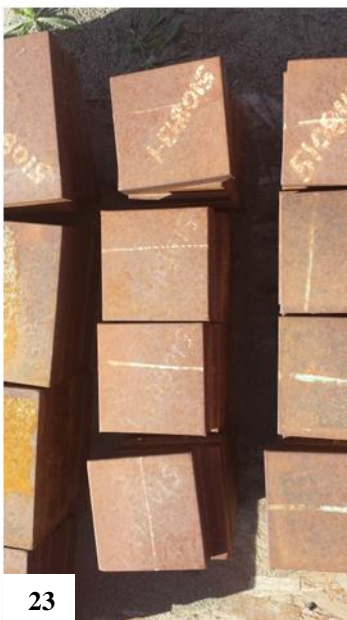
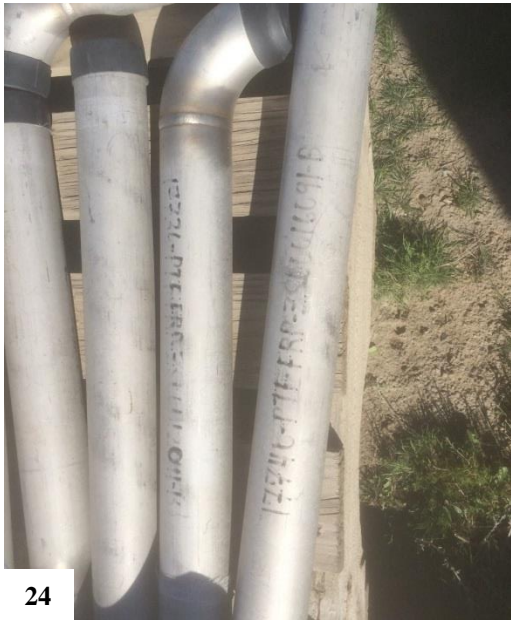
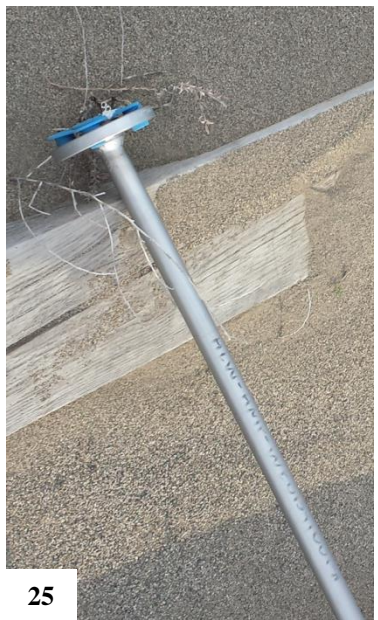
Deficiency 8, SSC Identification Markings—In April 2015, the staff review team photographed several SSCs in the MHF Laydown Yard with illegible identification markings. See Appendix 1, Figures A-23 to A-25 for example photographs. This condition is contrary to NQA-1, Requirement 8, and the BNI project document, *Quality Assurance Manual*, Section 8.1.2.3, which require legible identification. In April 2015, the staff review team conducted a sample inventory audit of SSCs at the MHF Laydown Yard. The staff review team experienced difficulty reading the correct labeling on several pipe spools with faded hand-written labeling. However, BNI and the staff review team were eventually able to use the BPS software and photographs to correctly interpret the labeling on each pipe spool. BNI is in the process of replacing hand-written identification labels with a more durable barcode labeling system.

Figures A-23 to A-25. Staff review team photographs illustrating illegible physical markings of SSCs at the MHF Laydown Yard.

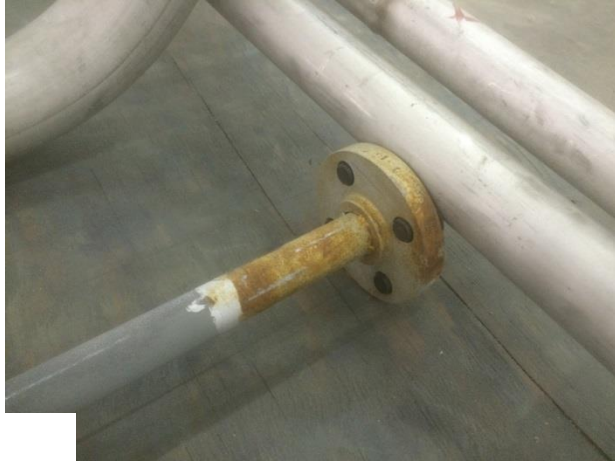
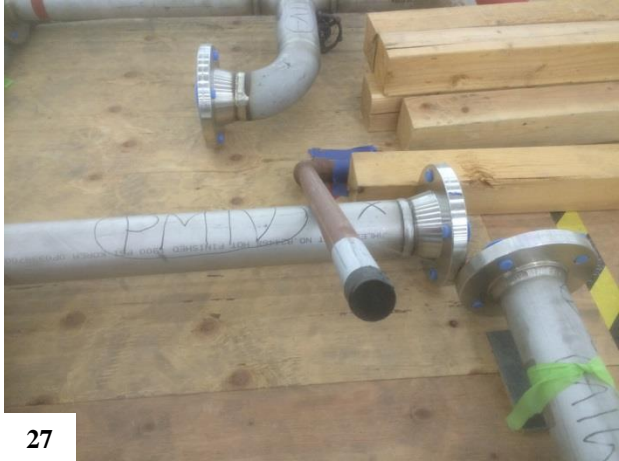
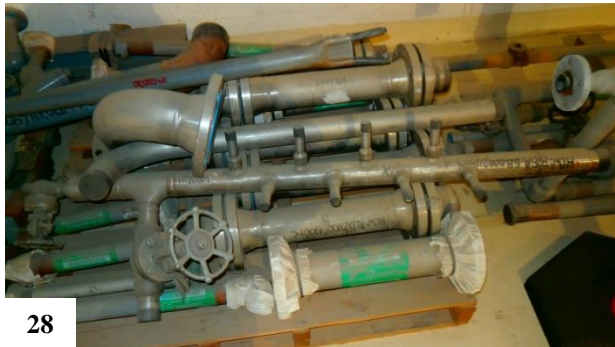
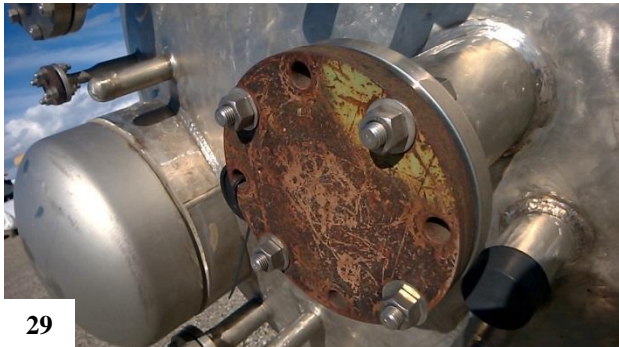
Deficiency 9, Segregation of Dissimilar Metals—In April 2015, the staff review team photographed carbon and stainless steel piping in contact at the Yakima Warehouse and High-Level Waste Facility. The staff also photographed a carbon steel flange cover used on a stainless steel vessel in the 4.5-Acre Laydown Yard. See Appendix 1, Figures A-26 to A-29, for example photographs. Carbon and stainless steel piping in contact is contrary to a BNI engineering specification, *Field Fabrication and Installation of Piping* [14], Section 3.1.5.1 and the BNI project procedure, *RPP/WTP Storage Plan*, Section 3.1. An additional BNI engineering specification, *Packaging, Handling, and Storage Requirements* [15], Section 5.7.1, prohibits carbon steel flange covers on stainless steel vessels by stating, “Metallic plugs and caps contacting metal surfaces shall not cause galvanic corrosion at the contact areas.” DOE Order

Figures A-26 to A-29. Staff review team photographs illustrating improper segregation of dissimilar metals. Figures A-26 and A-27 show carbon and stainless steel in contact at the Yakima Warehouse. Figure A-28 shows carbon and stainless steel in contact at the High-Level Waste Facility. Figure A-29 shows a carbon steel flange cover on a stainless steel vessel at the WTP construction site

Following receipt of the staff review team's agenda on June 29, 2015, BNI conducted an extent of condition review. BNI personnel said they had corrected all instances of carbon and stainless steel piping in contact. They also said they had identified several other instances where carbon steel flange covers were being used on stainless steel equipment, which were also corrected.
