**DEFENSE NUCLEAR FACILITIES  
SAFETY BOARD**

## Staff Report

September 1, 2022

### Reactive Materials Hazard Review at the Y-12 National Security Complex

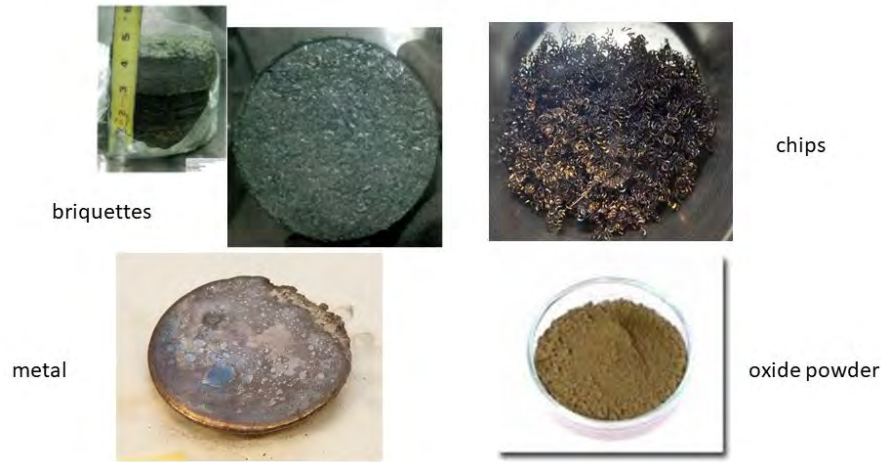
**Figure 1.** *Uranium Material Forms at Y-12.*

*Enriched Uranium Thermal Runaway Reaction Hazards*—In general, uranium is very reactive in air, particularly moist air. Enriched uranium process operations generate various uranium products that are very reactive. Figure 1 shows examples of uranium forms generated at Y-12.

These forms include chips, briquettes, metal buttons, and uranium oxide powder, whose reactivity is dependent on parameters such as: specific surface area; morphology; and oxidation kinetics. The DOE-HDBK-1081-2014, *Primer on Spontaneous Heating and Pyrophoricity*, defines a pyrophoric material as one that “even in small quantities and without an external ignition source can ignite at or below 130°F in contact with air” [7]. The handbook further states that uranium in a finely divided form (e.g., chips and powders) is pyrophoric in air. Y-12 has experienced 15 pyrophoric events in production and development facilities between 2016 and 2021 [8 – 18] due to the physical forms of uranium (Figure 1) generated during processing. Seven of those events are described in Table 1. The full list of all 15 events is provided in Appendix A.

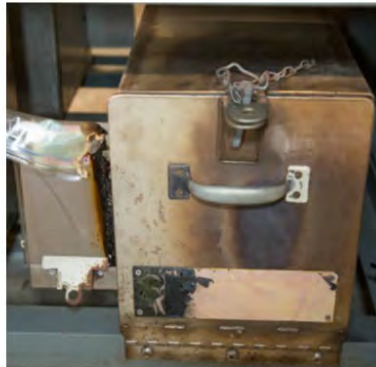
**Figure 2.** *Briquette Thermal Runaway Reaction Event in Storage at Y-12*

The seven events in Table 1 demonstrates that different uranium physical forms (chips, briquettes, or buttons) generated at Y-12 can undergo a thermal runaway reaction. The event in the DNFSB resident inspector activity report for the week ending on June 30, 2017 [16], shown in Figure 2 is an example of a severe thermal runaway reaction that could have caused significant injury to a facility worker if one had been present.

<b>June 30, 2017</b>	Exothermic reactions of multiple cans containing briquettes.	Fire department used thermal imaging to verify storage box was at ambient temperature before opening. Operators opened storage box and observed containers were burned and the tape seal melted.

Inner container with briquette

Outer lock box

Y-12 should improve its control strategies to prevent and mitigate uranium pyrophoric hazards and identify thermal runaway uranium reactions with sudden energy release as an initiating event for fire in its safety bases. An improved hazard analysis and control strategy could be used to reduce the likelihood of (i.e., prevent) and ensure appropriate response to (i.e., mitigate) pyrophoric events. This should include improved procedures and training to ensure responses to pyrophoric events are consistent with the guidance in DOE-HDBK-1081-2014 [7] throughout the enriched uranium processes.
