### DEFENSE NUCLEAR FACILITIES SAFETY BOARD

# **Staff Report**

March 3, 2024

### Pantex Plant 12-44 False Ceiling Replacement Review

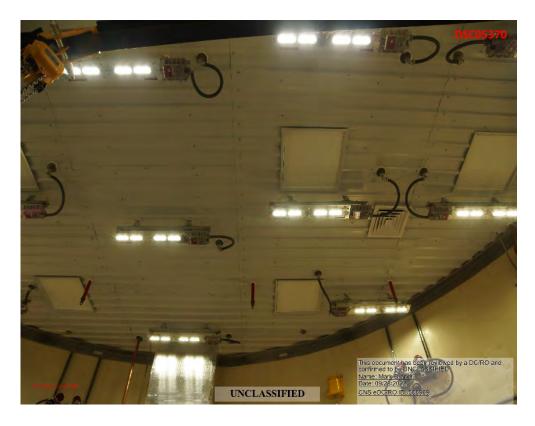
Figure 1. Upgraded False Ceiling within a 12-44 Nuclear Explosive Cell

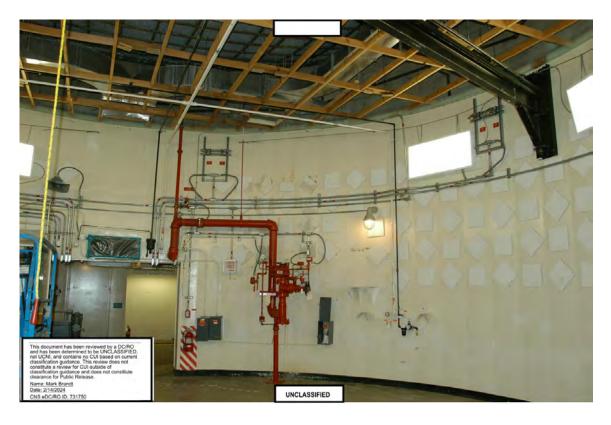
**Figure 2.** Wood Framing of a False Ceiling Prior to Demolition

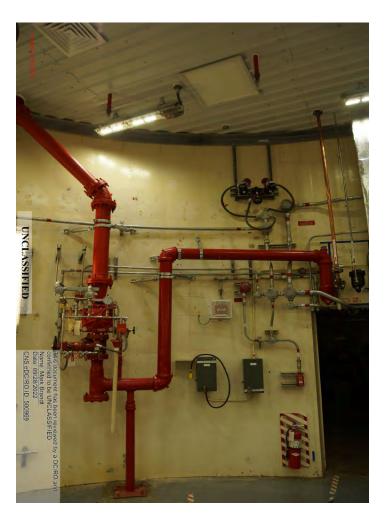
Cast Iron Fittings—During the review, the staff team questioned why the construction subcontractor used cast iron fittings in the new deluge fire suppression systems, contrary to the requirements and guidance in DOE directives. DOE Standard 1066-2023, Fire Protection [18], states, "[t]he following sprinkler components should not be used:...Cast iron pipe fittings," and DOE/EH-0545, Seismic Evaluation Procedure for Equipment in U.S. Department of Energy Facilities [19], considers cast iron as an outlier material and discourages its use. However, DOE/EH-0545 states that cast iron fittings may be considered acceptable if they can be shown to be subject to low seismic and impact loads.

CNS further investigated the concern and determined that the presence of cast iron fittings in cell fire risers could pose an impact hazard to nuclear explosive operations in the 12-44 Cell 5 and 6 round rooms (main operations areas) during a seismic event. Unlike other nuclear explosive cells at Pantex where fire risers are in support areas outside the round room, the 12-44 cells' deluge riser assemblies are located within the round rooms. In January 2024, CNS determined a potential inadequacy of the safety analysis existed [22], held an investigation and critique, and filed an occurrence report [23], categorizing the event as 3A2(L)—i.e., a "violation or noncompliance of a credited hazard control."

CNS has since determined cast iron fittings were also installed in new risers in four nuclear explosive bays in Building 12-104 and a corridor through which nuclear explosives pass. Although the risers for nuclear explosive bays are in the equipment interlock where nuclear explosives pass for a short period of time in an approved transportation configuration, the Pantex safety basis identifies seismic qualification of appurtenances in both interlocks and main operating bays as a planned improvement. CNS determined that changes made to site-wide and project-specific specifications allowed cast iron fittings to be installed on new construction projects [25]. CNS believes this allowance was introduced into specifications in 2017; however, CNS is still evaluating the timeline. CNS is currently investigating why these changes were made and what process was followed to approve them.

**Figure 3.** 12-44 Cell Fire Suppression Deluge Riser

CNS subsequently determined the concern represented an unreviewed safety question [24] and conducted a causal analysis. CNS implemented operational restrictions that require nuclear explosives, nuclear materials, and explosives within the falling distance of the deluge riser to be in a transportable configuration (e.g., within an enhanced transportation cart). In addition, CNS is prohibiting the use of cast iron fittings on upcoming construction projects. Figure 3 shows a cell deluge riser from a 12-44 cell.
