# OPERATING EXPERIENCE SUMMARY

Summary 2002-01  
January 14, 2002

# Operating Experience Summary 2002-01

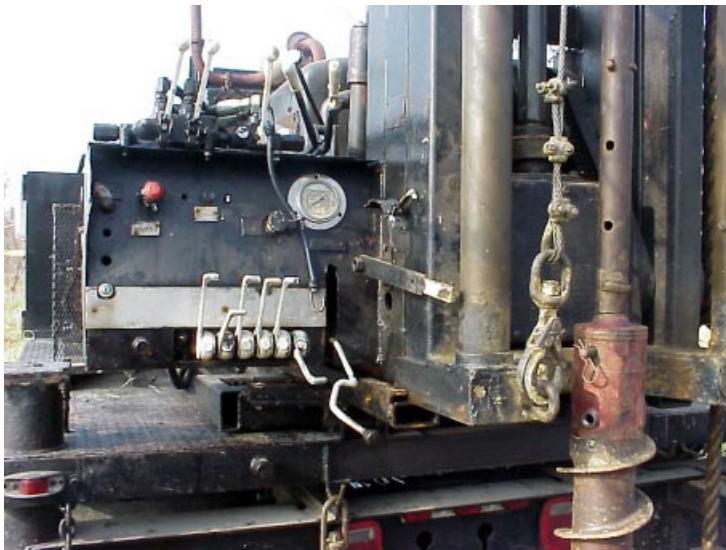
**Figure 1. The drilling equipment**

Figure 1 shows the drilling equipment that was being used. At the time of the event, the driller was aligning an extension rod to the threaded rod cap that is nested inside the auger assembly (See Figure 2). The driller used his left hand to actuate the feed valve lever to lower the auger head. The assembly dropped faster than he expected, trapping his right hand in the drive assembly and auger.

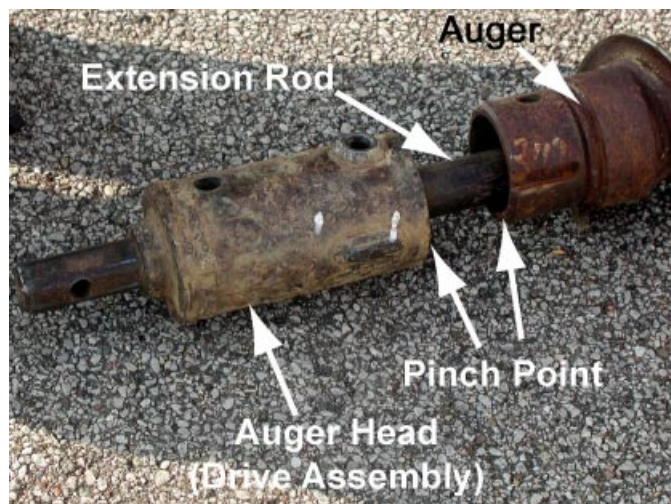
**Figure 2. The auger assembly and pinch point**

Manually aligning the extension rod to the threaded rod cap, which introduces a driller's hand into the pinch point, has been an accepted practice among many drillers and considered in the purview of skill-of-the-craft. The driller was employed by an experienced subcontractor, and oversight by the site contractor, Bechtel Jacobs Company, LLC (BJC), had not included the involvement of a subject matter expert in drilling safety.

The activity hazards analysis (AHA) for the work activity addressed pinch points in a general manner; i.e., it identified a pinch point as a hazard and directed, "Do not place parts of the body between objects," without giving any detail regarding the drilling train assembly or disassembly. Operations were performed without written procedures, and the drill rig operating manual was not kept with the equipment. A slip wrench that is designed for extension rod handling, and which, if employed, would have prevented the injury.

Corrective actions recommended by the on-site investigative team are good examples of the items all sites involved in drilling activities should consider. These include:

- BJC will assess all ongoing drilling activities to determine what exposures operators/crew have to pinch points and rotating hazards and verify that adequate mitigation and barriers are in place.
- BJC will revise its subcontracting process to require that contractors submit a comparison of equipment proposed for use against current manufacturer and industry standards to identify non-conformances and compensatory measures. All heavy equipment should contain operating manuals, and daily equipment checks should meet or exceed the requirements in the operating manual. The site should adopt the use of the drill receipt inspection checklist found in the BJC document, *Safety Guidance for Lifting Operations Associated with Drilling, Subsurface Sampling, and Monitoring Well Installation*, December 1994.

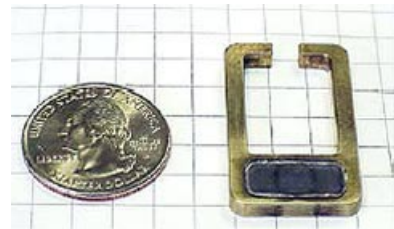
**Figure 1. The shutter**

This shutter consists of a brass slide with a lead insert to stop x-rays when the shutter covers the hole in the tube housing where x-rays escape from (Figure 1). The shutter is held closed by a spring and can only be retracted when a solenoid withdraws the shutter by overcoming spring tension. The spring returns the shutter to the closed position when the solenoid is de-energized by the control panel or when a door interlock is activated.

The lead shutter insert protruded above the sliding surface of the shutter. It is believed to have deformed and loosened, causing uneven wear and binding. Another deficiency associated with lead is the formation of lead oxide, and this oxidation is believed to have caused a stuck shutter in a similar device in April and July of 1993 at Oak Ridge (OE Weekly Summary 93-28, *Personnel Radiation Exposure Caused By X-ray Diffraction Machine Component Failures* (ORPS Report ORO--MMES-X10METCER-1993-0008). Corrosion, however, is not believed to have been a significant factor in the 2001 event.

ORNL corrective actions include replacing the lead-containing shutter with one made of tungsten, adding a set of enclosure door switches to interrupt x-ray generator power, and adding a more visible set of shutter-position indicator lamps.

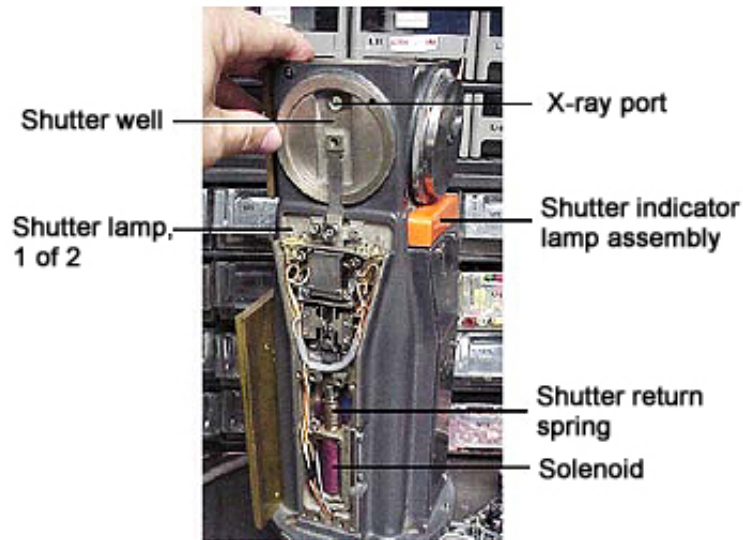
**Figure 2. The x-ray tube housing**

The interlock system was designed to function via switches in the enclosure frame that will close the shutter if the enclosure doors are opened. An electric solenoid, when energized, holds the shutter open against pressure from a spring, and when the interlocks are activated, the solenoid is de-energized and

the spring returns the shutter to the closed position, blocking x-rays escaping from the port in the tube housing (Figure 2).

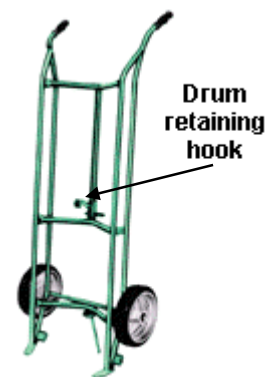
**Figure 1. A Harper Model 9468 dolly**

The dolly involved in this incident is as a Harper, Model 9468 (Figure 1), which is rated for 1,000 pounds. The 55-gallon drum being moved weighed approximately 385 pounds. During a quality insurance inspection, inspectors found 27 dollies with defective welds on the retaining hooks in addition to the one that had too large of an opening. A Safety Flash (site-wide notification of a safety-related event) was immediately issued to all Rocky Flats facilities. The deficient dollies were removed from service, and maintenance will re-weld them in accordance with the manufacturer's weld criteria.

The direct and root causes of this event were identified as inadequate welds that attach the retaining hook to the frame of the dolly. When this event was discovered, management directed the inspection of all Harper Model 9468 dollies that were used in the facility. Corrective actions included (1) verifying that welds on the dollies comply with the manufacturer's weld criteria, (2) repairing those that do not comply, and (3) issuing a site-wide notification of the drum dolly problems.
