OPERATING EXPERIENCE SUMMARY

Office of Environment, Safety and Health

Summary 2002-02
January 28, 2002

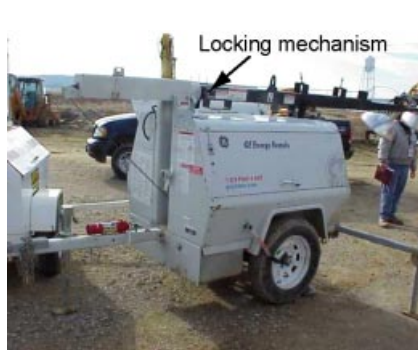
Figure 1. The light tower in the lowered position

The equipment operators were positioning a TEREX[®] Amida 3-section, telescoping light tower to provide additional lighting for a parking area. This particular model (TX3000) uses a single-winch system to raise and lower the mast vertically and horizontally. A spring-loaded locking device, consisting of a sliding bar that is tapered on one side, can be locked in the engaged position by a locking pin. This allows a single winch to perform two operations: (1) telescoping the mast sections vertically, and (2) raising and lowering the mast sections (in the retracted position) from the horizontal transport position to the vertical position. Figure 1 shows the light tower in the lowered horizontal position, and Figure 2 shows a typical light tower in the fully raised position.

After raising the mast, the equipment operators noticed that one lamp was aimed skyward and required adjustment. One of the operators turned the crank to lower the mast vertically until the sections of the mast were seated. He then inserted the spring-loaded lock pin to secure the mast sections in place and released the vertical lock pin to allow the mast to be lowered horizontally. When the mast was at approximately a 15-degree angle above horizontal, it suddenly fell to the horizontal position and extended approximately 42 inches. The other operator, who was standing outside the expected fall area of the mast, was struck on the top right side of his head and was knocked to the ground. The operator who lowered the mast immediately began to administer first aid to his co-worker, who suffered a scalp laceration approximately three inches in length.

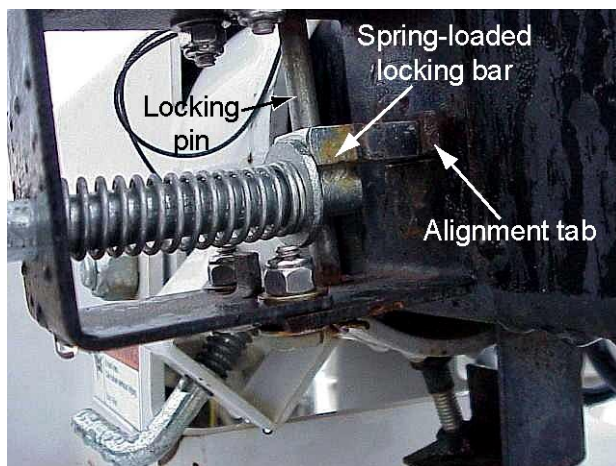
Figure 3. The locking mechanism

A contributing cause of this occurrence was "inattention to detail" because investigators determined that the sliding bar was not fully engaged and was not locked into the inner sections when the mast was lowered. It was noted that the manufacturer's diagram on the mast does not clearly depict the fully locked bar configuration for the safe lowering of the mast. Also, this was the first time the equipment operator had operated this type (single-winch) of light tower, and he did not consider it necessary to refer to the operator's manual. Figure 3 illustrates the locking mechanism.

Investigators determined the root cause of this occurrence was "inadequate or defective design." A manufacturer's design engineer met with subcontractor and Fluor Fernald personnel to evaluate the incident. A replication of the sequence of events, as described by both equipment operators, resulted in a duplication of the occurrence. The design engineer could not confirm the designed configuration of an alignment tab, but did acknowledge that the tab appeared to have been bent and that the function of the safety pin and retaining washer could easily be defeated. He added that he believed that the mast spring-loaded locking device design was not intended to allow as much freedom of movement as could be seen with this sliding bar. The light tower involved in this incident, as well as five other light towers by the same manufacturer that were on site, allowed the spring-loaded locking bar to be disengaged and turned 90 degrees, even with the locking pin inserted behind the retaining washer on the spring-loaded locking bar.

As a result of the investigation, all single-winch light towers were removed from service at FEMP, and will be replaced with double-winch units from a different manufacturer. The two-winch units are considered to be safer than single-winch light towers. Safety precautions were also developed for all Fernald personnel involved in using light towers. Additionally, hardhat requirement labels will be affixed to all light towers site-wide. It is suggested that personnel at DOE facilities review the use of single-winch light towers in service at their sites to ensure that similar accidents do not occur.
