OPERATING EXPERIENCE SUMMARY

Office of Environment, Safety and Health

**Summary 2002-03
February 11, 2002**

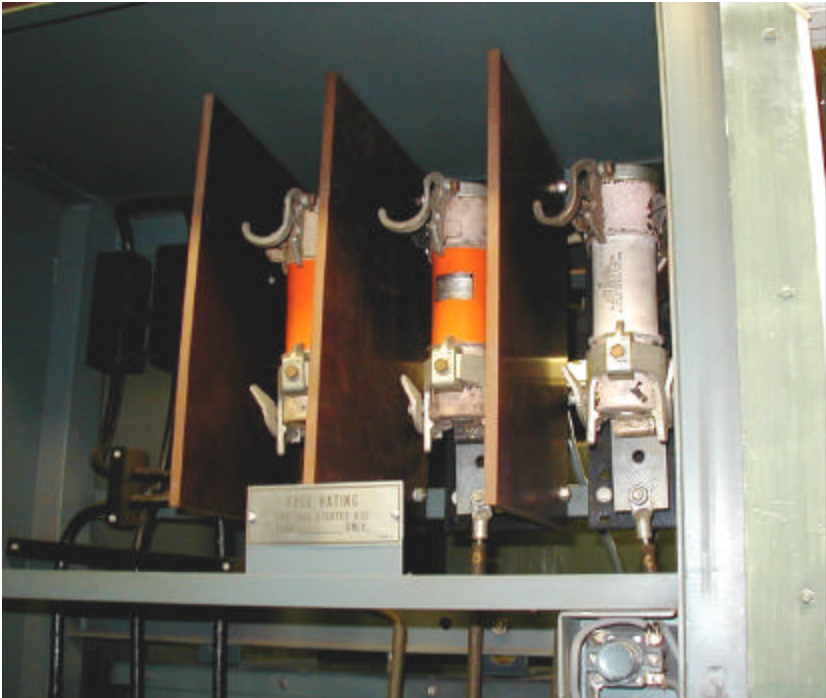
In preparation for the induction regulator replacement, towerline workers were sent to inspect the Westinghouse switchgear cabinet (Figure 1). During this inspection a Chemistry Department worker, who was not part of the inspection team, opened the fused cutouts on his own initiative to facilitate the inspection. This individual followed verbal procedures he had been given earlier by a now-retired cyclotron operator, who had informed him that opening contacts in the power circuit de-energized the fuses. Believing the circuit was de-energized, the worker did not check for voltage and was not wearing appropriate PPE.

Figure 1. Westinghouse switchgear cabinet showing fuses and their recommended rating

In the course of the inspection, the towerline workers addressed additional equipment issues related to the transformer room. These issues involved a missing view port in a switchgear cabinet, out-of-date labels, and inadequate space for the switchgear cabinets. As a result of this inspection, the Laboratory Electrical Safety Officer locked out the 2,300-volt Westinghouse switchgear cabinet equipment.

The direct cause of the incident was that the worker performed hazardous work without adequate work planning and control. The worker failed to recognize that the activity required a pre-job hazard review and formal authorization, and opened the fused cutouts on his own initiative.

- Facility management reviewed this incident with personnel in the departments and groups involved with cyclotron operations to emphasize the necessity of proceduralized work planning before carrying out any verbal procedures, as well as the need to review procedures associated with legacy facilities.
- Chemistry Department personnel received a memo emphasizing the necessity of reviewing work practices associated with legacy equipment to ensure worker safety, and that work cannot be carried out without proper work planning.
- Maintenance personnel replaced the glass that was missing from the view port on the rectifier cabinet before the circuit was re-energized.

Management needs to emphasize to workers that work cannot be carried out without formal authorization, appropriate procedures, and task-specific controls in place. In addition, management needs to ensure that legacy equipment is inspected before it is used, and, wherever appropriate, brought up to current codes.

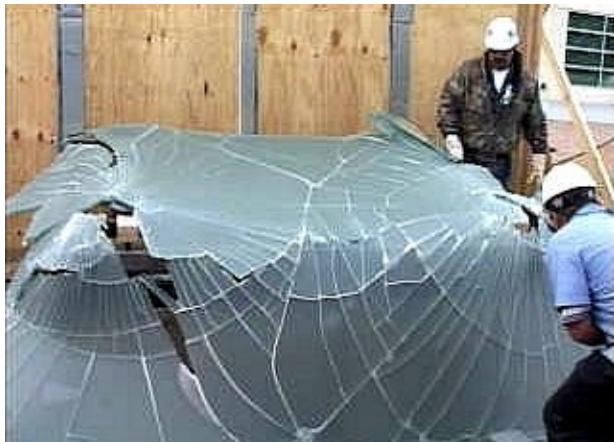
Figure 1: *Shattered glass projection screen lying on top of cart*

of the glass projection screen remained almost entirely contained within the projection film membrane that encased it (Figure 1). A subcontractor worker received a minor wrist injury while attempting to stabilize the falling screen with his hand. Laboratory management reported this as a near-miss occurrence. (ORPS Report ALO-LA-LANL-CMPTRDIV-2002-0001).

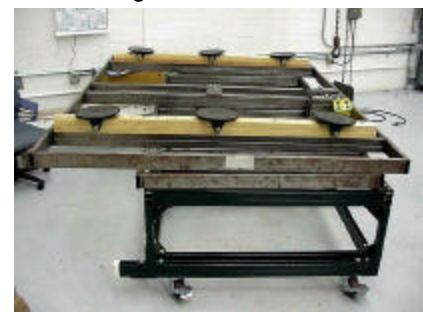
The glass projection screen, which measured 9 feet high by 16 feet long by about three-quarters of an inch thick, was positioned on a wheeled cart frame constructed from bolted Unistrut[®] metal framing (Figure 2). Suction cups were mounted on a platform to secure the glass. A motor-driven Dayton actuator tube assembly (screw jack) provided the means to raise or lower one side of the support platform from a horizontal position to an upright position. With the projection screen loaded on the cart outdoors in a vertical orientation, subcontractor workers moved it to the building entryway where it was to be tilted to fit through a doorway. As they re-oriented the projection screen to an angle of 45 degrees to fit through the doorway, a plastic bushing that moved along a threaded bolt within the actuator assembly failed (Figure 3). The entire glass projection screen quickly fell to a horizontal orientation on the cart

Figure 2. *The Unistrut[®] cart*

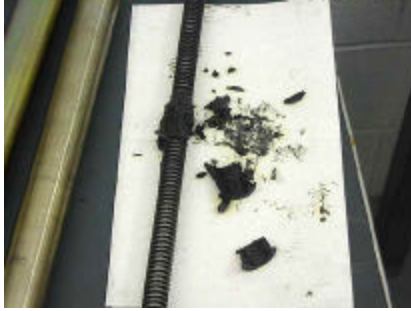
Figure 3. The failed bushing

The facility representative stated that the projection screen transport subcontractors had not developed a hazard analysis for the screen installation work. Furthermore, the LANL Health and Safety team contacted the manufacturer of the actuator tube assembly and learned that it was rated for only 600 pounds. The cart did not have a rating posted on it because it was a “homemade” cart by a different glass subcontractor from a previous job that had not been consulted regarding this installation. Had the glass projection screen fallen into the hallway rather than outside the entryway, the potential for injuring more workers was high because there were more workers in the hallway waiting to help guide it. The narrow doorway forced the workers to stand at both sides of the projection screen and out of the path of the falling glass.

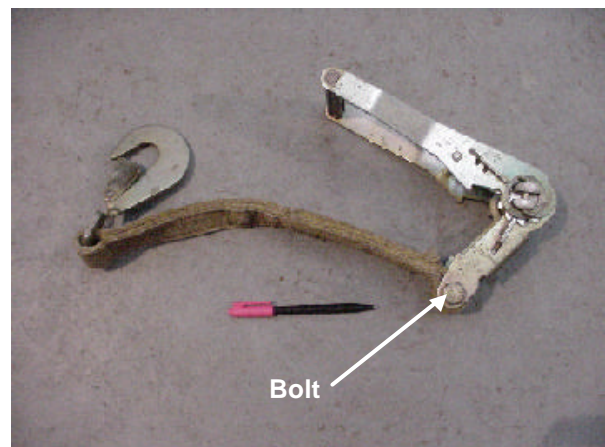
On January 24, 2002, at Argonne National Laboratory – West (ANL-W), a Quality Assurance (QA) representative conducted an inspection of ratchet-type tie-down straps and identified some with suspect/counterfeit bolts in Building 783. ANL-W initiated this inspection of their rigging gear as a result of information in a Brookhaven National Laboratory (BNL) ORPS report. There were no personnel injuries or equipment damage as a result of this condition. However, failure of suspect/counterfeit fasteners installed on tie-down devices could result in shifted or dropped loads, endangering personnel and DOE property. (ORPS Report CH-AA-ANLW-ANLW-2002-0001)

Figure 1: Ratchet tie-down strap with suspect/counterfeit bolt

suspect/counterfeit bolts were segregated and removed from service. Actions are being taken to determine whether there are more of these tie-down straps on site.

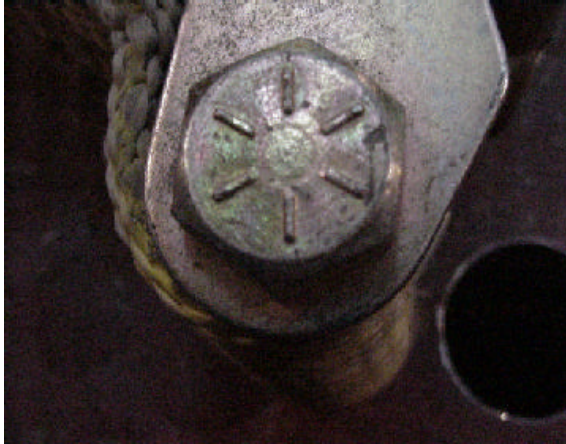
None of the suspect/counterfeit bolts (Figure 2) were attached to a load or in use at the time of this inspection, and none showed any sign of failure or deformation. Thirty tie-down straps containing

Figure 2: Close-up of suspect/counterfeit bolt

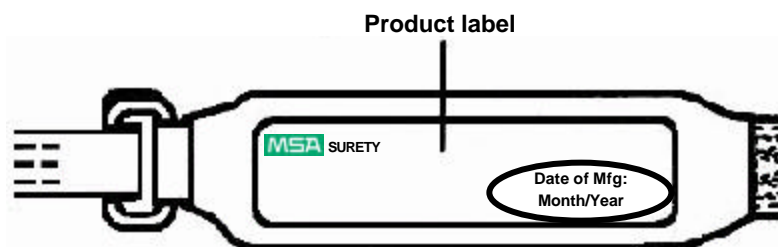
MSA recommends locating all fall protection components that use a Sure-Stop shock absorber and inspecting them to determine the date of manufacture. The date of manufacture is located on the label affixed to the shock absorber sleeve (Figure 1). If this date is within the affected range or if the date cannot be determined, the shock absorber is subject to this notice and must be removed from service.

Figure 1: Label Location on Shock Absorber Sleeve

If you have any of the recalled products, contact MSA Customer Service to make arrangements for the return and inspection of all affected products at 1-800-MSA-2222. MSA says that the equipment used to
