# OPERATING EXPERIENCE SUMMARY

**Summary 2002-04  
February 25, 2002**

# Operating Experience Summary 2002-04

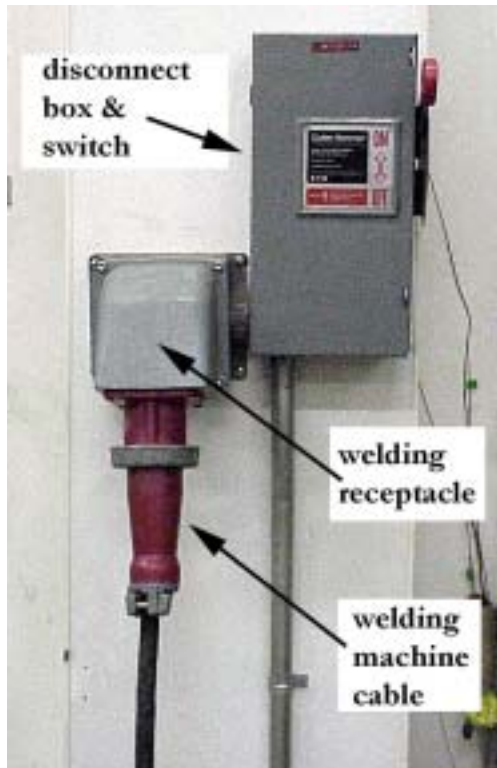
**Figure 1: 480-volt disconnect box and welding receptacle**

During the morning of December 10, 2001, a loud bang was heard from a 480-volt disconnect box in Building 98 (see Figure 1). At the same time, a feeder panel breaker tripped, causing a loss of electrical power. A journeyman electrician locked out the box and checked the circuit. He found that a wire in the welding receptacle attached to the disconnect box had chafed and shorted out. The electrician replaced this single wire, along with a fuse in the disconnect box. A laboratory electrical coordinator reset the feeder panel supplying power to the building, and two other electricians checked the building's 480-volt circuit. They found no problems.

When the welding activity resumed an hour and a half later, the disconnect box produced another loud bang, and power was lost. The electrician again locked out and checked the box and welding receptacle. This time, he found that the ground wire in the receptacle had melted and damaged

The next day, the plant engineering staff and electricians checked the 480-volt distribution system for grounding and other problems, but could not immediately find any. Finally, the plant engineering staff found that the welding receptacle's green ground wire was not in the green-ringed ground pin as would be appropriate (see Figure 2 for correct wiring configuration). The staff concluded that the electrician must have switched the ground wire with a hot phase wire during his second repair of the receptacle. Although he made some voltage verification checks, he obviously failed to make all the required checks.

- performing testing and certification of all welding receptacles
- conducting briefings for welders and electrical safety personnel
- performing annual inspections of welding machines
- adopting new procedure requirements for grounding in welding areas
- partnering the journeyman electrician with senior electricians while performing electrical activities

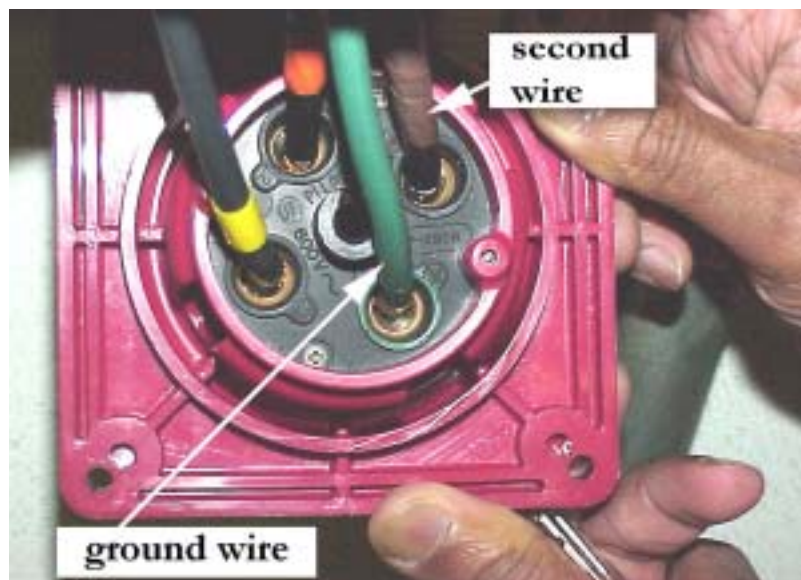
another wire it touched. He replaced the two wires (see Figure 2). When his supervisor questioned him about his first repair, the electrician stated that he may have overlooked other wires in the receptacle that may also have been chafed. Suspecting that the first welding machine might be faulty, the supervisor replaced it with a second machine of different manufacture, which seemed to operate correctly.

**Figure 2: Welding receptacle wires correctly connected**

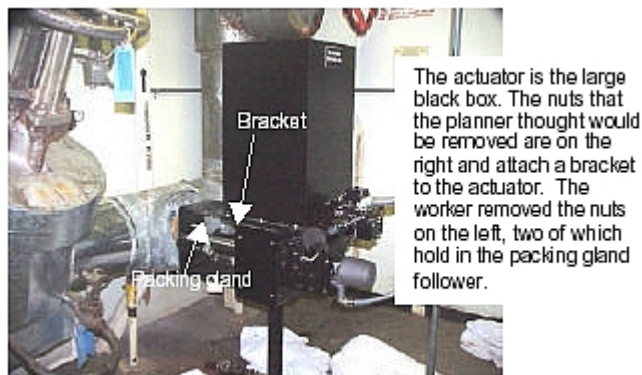
On December 12, 2001, at the Rocky Flats Environmental Technology Site, steam and valve packing were expelled from a steam control valve in the 374 Operations facility when a mechanic accidentally removed the packing gland and follower. The mechanic should have removed the valve actuator, but removed the wrong fasteners because of inadequate instructions in the repair work package. The valve, which is exposed to steam at 100 pounds per square inch, had been isolated, but the pressure between the isolation points was not released, thereby keeping the valve internals pressurized. The job was stopped, and personnel left the area until the valve was locked and tagged out. There were no personnel injuries or equipment damage as a result of this event. (ORPS Report RFO--KHL-374OPS-2001-0004; Final Report filed January 28, 2002)

A troubleshooting and repair standard work package was being used to remove a valve actuator (illustrated in Figure 1). The planning team walked the job down several times, but did not discuss the specific work steps to be performed. The resulting work package failed to include adequate direction to perform the planned work. In addition, a subsequent review of the technical documentation on the valve found that the work package did not direct the correct sequence of troubleshooting steps. Also, the technical manual for the valve was not available on site. Because of the deficiencies in the work package, the work instructions did not provide specifics of the steam valve assembly or detailed instructions to remove the actuator from the valve.

**Figure 1. The valve actuator**

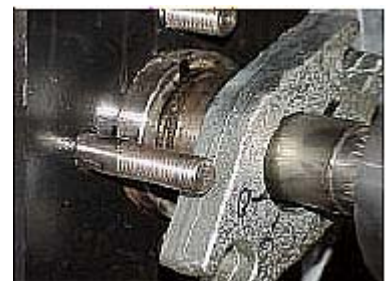
The supervisor had asked if the system was to be breached during the work and was told by engineering that it was not, but the supervisor was not familiar with the proper way to remove the actuator and not knowledgeable with the planned work to determine if it could be performed safely. Although the inlet valve and outlet valve for the steam control valve were closed and the drain valve was open, no one identified the potential for trapped residual steam pressure and the need for venting. The residual steam in the system caused the packing gland components to be unexpectedly expelled.

**Figure 2. The packing gland**

The direct cause of this occurrence was inattention to detail. The mechanic was unable to determine which nuts needed to be removed in order to de-couple the actuator because the description and instructions in the work package were inadequate for the work to be performed. The root cause was inadequate work planning, which resulted in a loss of work control. The work instructions did not contain sufficient detail about the steam valve assembly to remove the valve actuator. In addition, a lockout/tagout should have been applied to the valve in any event.
