OPERATING EXPERIENCE SUMMARY

Office of Environment, Safety and Health

**Summary 2002-05
March 11, 2002**

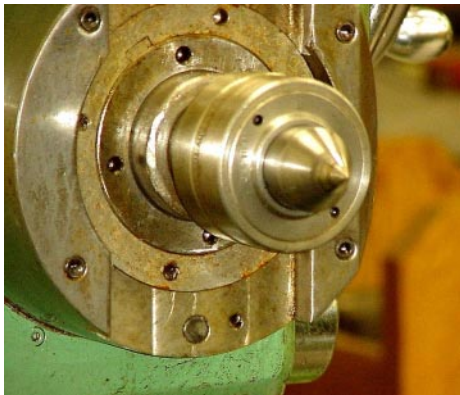
On January 11, 2002, at the Kansas City Plant, an associate, who was standing on top of a lathe, was knocked backwards onto the lathe bed when he was struck by a large metal part that was suspended from an overhead hoist. The associate was standing on the smooth, oily metal rails of the lathe while attempting to remove a 100-pound end cap from the suspended part. While holding the end cap in his hands, the part came free and swung into him, causing him to fall with the heavy end cap on his legs. The associate was not injured, but the facility representative indicated that had the associate not fallen just perfectly he could have been sliced by the cutting tool, broken a leg or ankle if he fell into the cavities cast into the lathe housing, or punctured by the sharply pointed lathe spindle (see Figure 1).

Figure 1. Lathe spindle

The causal analysis cited personnel error (inattention to detail) as the root cause for this occurrence because the associate focused on completion of the work to meet production schedules rather than working safely. The lesson learned from the occurrence report is that employees must place safety first above completion of work processes. An essential step is to identify hazards before attempting tasks. In this case, there were two hazards to address. The first hazard involved human lifting. Because the end cap weighed approximately 100 pounds, no one should have tried to remove it by hand without external support.

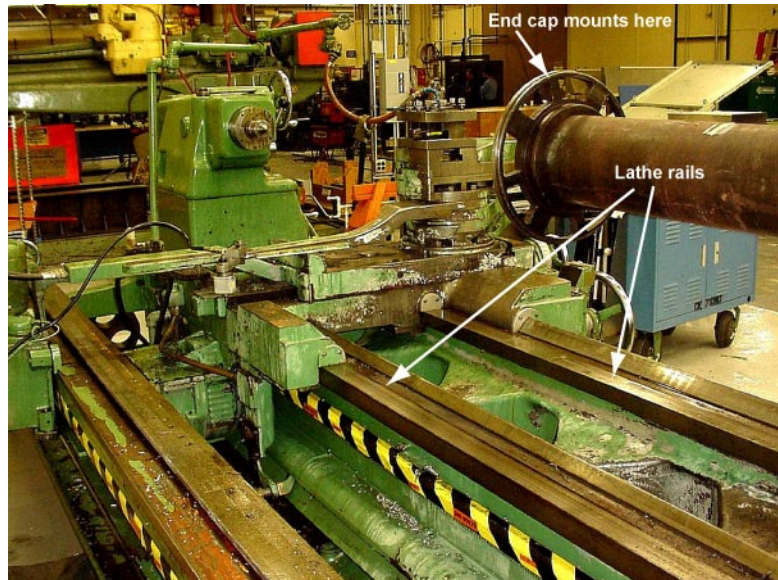
At this time, the contractor has yet to develop formal lessons learned and corrective actions. However, two immediate lessons can be learned involves human lifting and the other pertains to traction control. Because the end cap weighed approximately 100 pounds, no one should have tried to remove it by hand without external support. This weight alone exceeds Honeywell's allowable human lift load of 40 pounds. In addition, the operator was standing on the oily rails of the lathe. These rails have a pointed ridge,

which gives the operator very little standing surface. The operator had almost no means of shoe traction control even if the part had not moved.

Figure 2. Close-up of lathe rails and mounting fixture

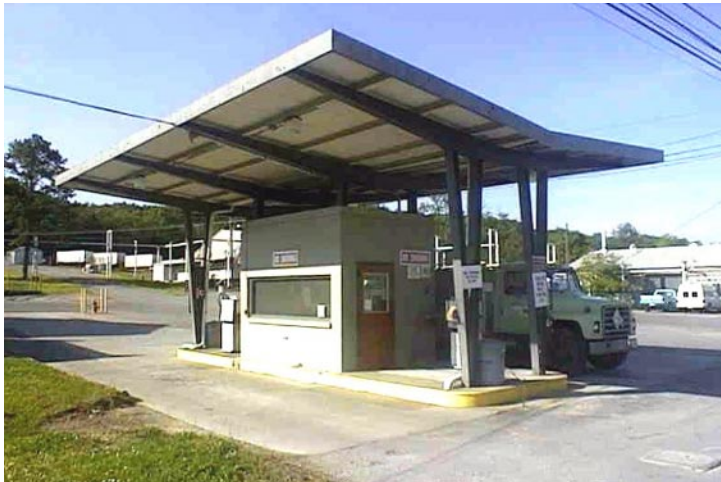
Figure 1: ORNL fuel distribution center, Building 7069

A pipefitter and electrician were assigned the task of changing the filters on three fuel dispensers at ORNL Building 7069, a fuel distribution center (Figure 1). The task was considered skill-of-the-craft routine work. The workers were unaware that the two dispensers for unleaded gasoline shared a common pump, and that turning on one of these dispensers would pressurize the gasoline supplies to both. They did not lock and tag out the dispensers before working on them. The regular fuel center attendant, who was familiar with the pumping system alignment, was out sick that day.

While the pipefitter was changing one of the filters on an unleaded gasoline dispenser, an ORNL employee drove into the fuel center and began refueling his vehicle from the other unleaded gasoline dispenser. This pressurized supplies to both dispensers, causing gasoline to spray from the loosened filter and onto the pipefitter. He attempted to re-tighten the filter, but the filter gasket was ruptured. After one or two minutes, the electrician shut off gasoline flow to the two dispensers by entering a cancellation command into the fuel center computer. The workers called for assistance, which led to the arrival of the fire department and a spill response team. The emergency crews cordoned off the area, established a fire watch, monitored gasoline fume concentrations, and cleaned up the spill.

The contractor's preliminary causal analysis identified the lack of a procedure for fuel filter replacement as the direct cause of the occurrence. The root cause was a work planning deficiency in treating this as a skill-of-the-craft job. That was an incorrect task level assignment, particularly because the pipefitter had only performed one fuel filter change before and was unfamiliar with the system alignment for the gasoline pumps and dispensers. The contractor has developed instructions for fuel filter changes and will issue a memorandum stressing the importance of task-level assignment and its relationship with the determination of hazards and controls.

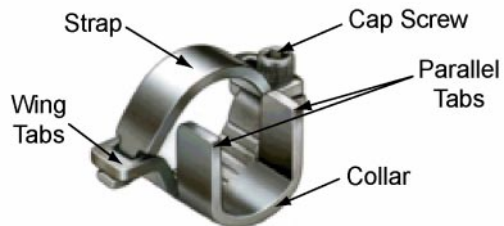
separate leak in the process piping inside the glovebox resulted in the higher than normal tritium concentration inside the glovebox. Both leaks were caused by loose Swagelok® connections (see Figure 1). The cause of the loose monitor connection has not been determined at this time; however, facility personnel believe the loose connection inside the glovebox is attributable to vibration from a nearby pump. Facility personnel are considering a locking device that will prevent the loosening of these types of fittings in critical applications. One such device is shown in Figure 2. It is positioned such that the male nut of the connection fits within the parallel tabs of the collar and the female nut fits inside the wing tabs.

Figure 2. A Swagelok® locking device

This event serves as a reminder that even small leaks in fittings and valves in tritium applications are readily detected. Precautionary testing measures and mechanical devices may lessen the probability of an undesirable event scenario developing. Recommended practices to reduce the probability of these events can be found in DOE-HDBK-1129-99, *Tritium Handling and Safe Storage* (<http://tis.eh.doe.gov/techstds/standard/hdbk1129/hdbk1129.pdf>). Additional information on recommended practices on tritium valves and fittings can be found in Technical Notice 94-01, *Guidelines for Valves in Tritium Service*, published by the Office of Nuclear Safety in September 1994 (<http://tis.eh.doe.gov/docs/tn/eh-0417.pdf>).
