OPERATING EXPERIENCE SUMMARY

Office of Environment, Safety and Health

**Summary 2002-06
March 25, 2002**

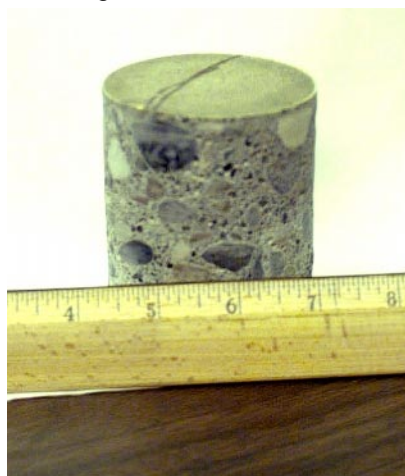
Construction workers were drilling a 2¾-inch-diameter hole through the concrete floor in preparation for installing a communication circuit. The floor area being cut was above the false ceiling and slightly north of a wall between two office areas when the concrete plug dropped. The concrete plug was 2¾ inches in diameter by 3 inches in length and weighed about 1½ pounds (Figure 1). The concrete plug broke through the ceiling tile and came to rest on a filing cabinet (Figure 2).

Figure 1. The 2¾ x 3-inch concrete plug

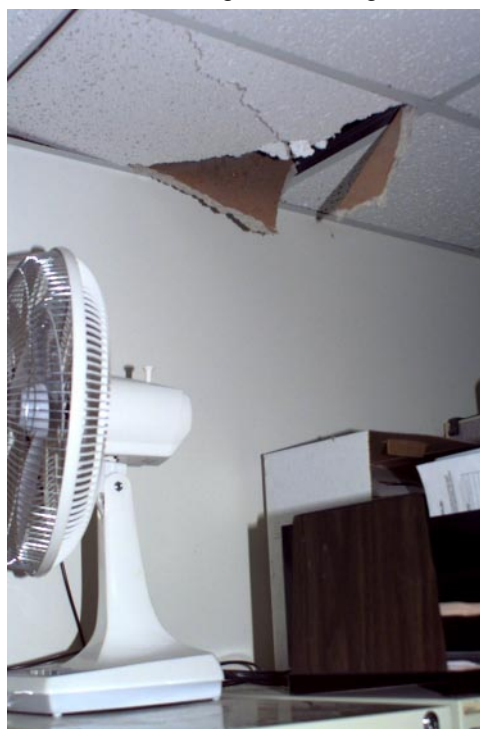
Figure 2. Damaged ceiling tile and filing cabinet where plug came to rest

This event illustrates the importance of identifying all possible hazards associated with a job. The safety analysis for the core-drilling activity did not address the potential hazard from a falling object, such as the concrete plug. Effective methods for protecting workers from falling objects include installing physical barriers, using anchors or bracing, and maintaining distance by establishing an exclusion area. When work is being performed overhead, it is important that the exclusion area be posted as to the hazard and that the area is sufficiently adequate to ensure the safety of personnel who are not directly involved in the work activity.

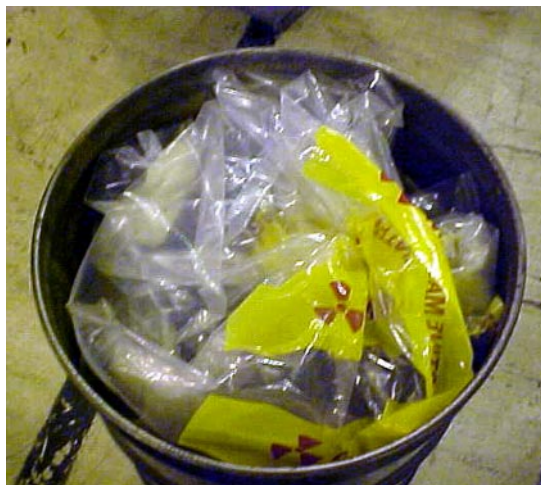
Figure 1. Waste drum at ETTP

A 55-gallon waste drum (see Figure 1) was involved in the ETTP incident. A worker was moving the drum by tipping and rolling it, and was not trying to open it. While the worker was handling the drum by the retaining ring, the lid released and struck him in the chest and helmeted-respirator. A subsequent examination of the lid and ring found that both were dented on their edges. However, the examination could not determine whether the lid and ring were deformed before the incident, or if the top of the drum striking the floor caused the denting. If the former is true, then the ring could have been improperly seated, and the force applied by the worker grappling the ring could have pulled it off the drum. Whether the drum was over-pressurized and what contribution that would have made are not fully known.

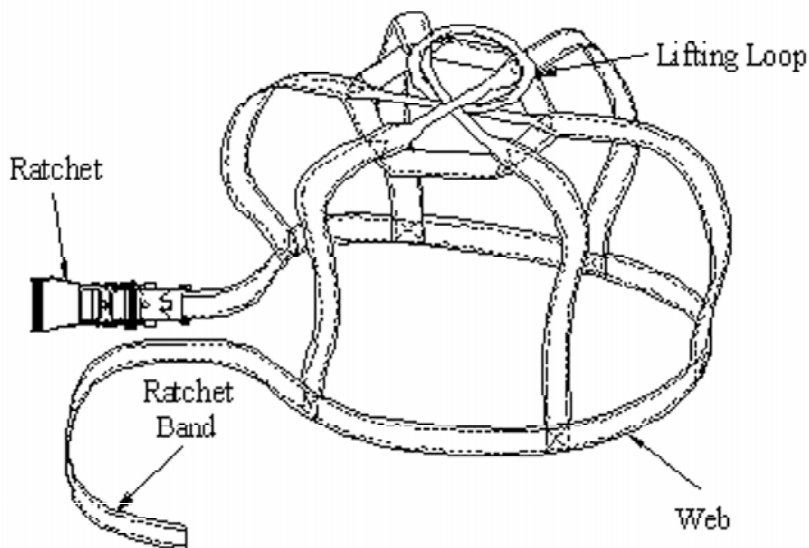
Figure 2. A drum web

The contractor has since abandoned the hand-flex test for detecting pressurization, and now requires installation of a drum web (shown in Figure 2) before opening any open-top waste drums with the potential for pressurization. The web fits over the lid and top of the drum, and its ratchet band is tightened around the middle of the drum. This safely constrains the lid and retaining ring from being propelled by potential pressurization while the drum is being opened. Other lid-restraining devices have been successfully used at other DOE sites (for example, see Figure 2-1 in Operating Experience Weekly Summary 98-21).
