OPERATING EXPERIENCE SUMMARY

Office of Environment, Safety and Health

**Summary 2002-07
April 8, 2002**

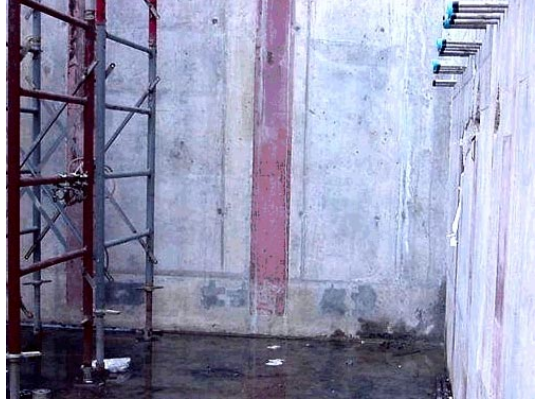
On April 3, 2002, at the Savannah River Site, a subcontractor carpenter was ascending a shoring frame scaffold when he slipped and fell backward, striking his head on an adjacent concrete wall. The fallen worker was stabilized and transported to the Medical College of Georgia. The injured worker suffered head trauma and is listed in serious condition following surgery. At the time of the fall, the worker was standing on a frame rung approximately 3 feet above the floor. The accident scene was secured. The subcontractor has ceased using the shoring scaffolds. A formal investigation is being conducted, and updates will be detailed in a future issue of the Operating Experience Summary. (ORPS Report SR--WSRC-CMD-2002-0002)

The worker slipped from the scaffold and struck his head on the wall on the right.

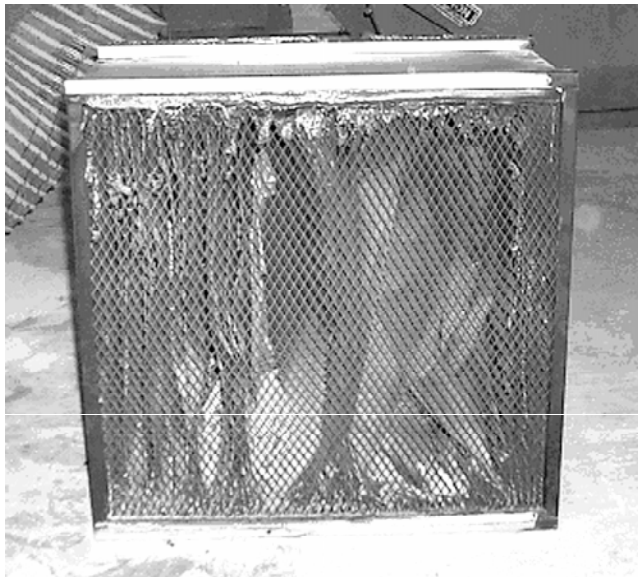
On February 13, 2002, at Building K-33 of the East Tennessee Technology Park (ETTP), filters in a High-Efficiency Particulate Air (HEPA) filter system caught fire. Hot kerf (debris) from plasma arc torch cutting in the Decontamination and Decommissioning (D&D) Workshop probably ignited combustible material that passed through ventilation ducting and into a bank of polyester/paper cartridge filters. The cartridge filters ignited and burned, and the ventilation airflow spread the fire into a separate HEPA filter unit downstream. Both the pre-filters and HEPA filters (Figure 1) in that unit burned. Workshop workers shut off the ventilation fans and partially extinguished the fire using portable fire extinguishers. The fire department arrived and completed extinguishing the smoldering filters after removing them from their casings. Because of a rubber-like smell in the building, the contractor directed that all workers evacuate Building K-33 during the event. Samples taken from a continuous air monitor at the work area and from

Figure 1. Burned fiberglass/cellulose HEPA filter

The investigation also found that tape used to connect and repair the flexible hose had burned. A burning tape fragment could have been the ignition source for the polyester/paper cartridge filter fire. As a result of this fire, the contractor has developed corrective actions that include the following.

- Establish procedures to inspect spark arrestors and HEPA hoses before hot cutting begins.
- Issue a procedure requiring debris screens for all HEPA hoses placed on the floor.
- Procure spark arrestor casings that can be easily accessed for inspection.
- Issue Toolbox Topics on HEPA hose inspections, combustibles in hot work areas, and the exclusive use of flame-retardant tape within 35 feet of hot work.

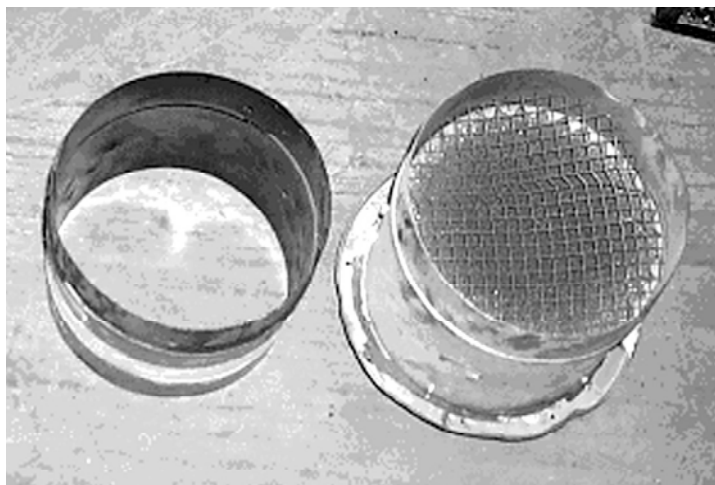
Workers in the K-33 D&D Workshop use either portable HEPA filter units or 10-inch flexible hoses connected to a central ventilation/HEPA filter system to vent fumes caused by hot-cutting uranium enrichment equipment. In this incident, workers were cutting a converter shell with a plasma arc torch and placed a flexible hose from the central system on the floor next to the shell. To prevent hot kerf and burning debris from contacting the filters, metal-mesh spark arrestors are installed upstream in the ventilation ducting. In this event, however, the spark arrestor was missing from the casing (Figure 2), located at the junction between the flexible hose and rigid ducting. An investigation also found that a spark arrestor was missing from one of the portable HEPA filter units. The spark arrestor casings

could not be opened easily for inspection, and there was no procedure to verify that the arrestors were in place before hot-cutting work commenced.

This event illustrates that the absence of a spark arrestor, lack of pre-job inspection requirements, and inaccessible spark arrestor casings led to the fire in this occurrence. One of the factors influencing the selection of safety equipment should be the ease with which it can be inspected.

Figure 2. The casing on the left was missing a spark arrestor

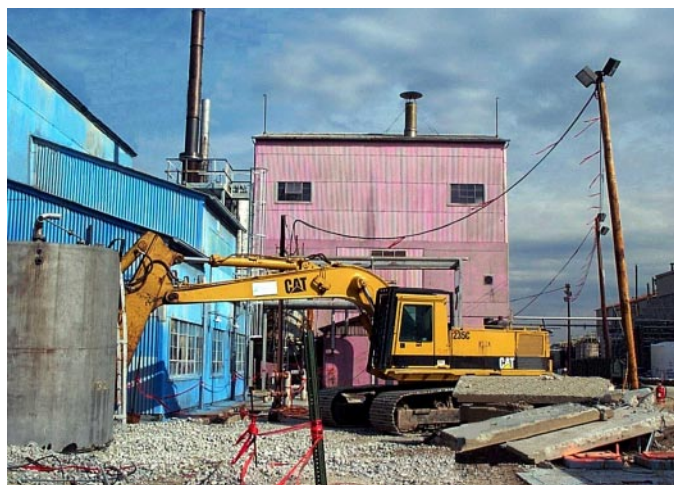
On February 25, 2002, at the Fernald Environmental Management Project (FEMP), the counterweight of an excavator performing a shearing operation snagged a guy wire of a utility pole, causing it and two other poles carrying energized 480-volt lines to list. A spotter and a foreman were on hand to assist the heavy equipment operator in performing the shearing operation. There were no injuries to any of the personnel involved in this incident. However, there was a significant potential for injury to personnel from physical as well as electrical hazards resulting from this incident. (ORPS Report OH-FN-FFI-FEMP-2002-0010)

Figure 1. The excavator at the scene of the incident

As the operator maneuvered a second tank around a building, the foreman, who was standing back near the pipe bridge, saw the overhead electrical lines moving. He looked at the excavator and saw that the right end of the counterweight on the rear of the excavator had snagged the guy wire of a utility pole, causing the pole to lean inward. The foreman directed the operator to immediately stop the excavator. The foreman and spotter proceeded to the rear of the excavator and found that a guy wire was caught on the counterweight of the excavator and that the pole to which the guy wire was attached was leaning. In addition, two other poles along the roadway were leaning and the energized 480-volt electrical lines running between them were stretched tight, leaving almost no sag. It was later found that the guy pole on one of the utility poles had broken as a result of this incident. The operator backed the excavator to release the guy wire from the counterweight and then moved the excavator forward to set down the tank that he had been moving. The electrical lines were de-energized and will remain isolated until repairs are completed.

This occurrence demonstrates that spotters should be required for all construction activities involving heavy equipment. Although a single spotter was used in this event, additional spotters would have ensured that all sides of the excavator remained at a safe distance from surrounding obstructions. In future operations involving this activity, Fluor Fernald will place an additional spotter at the rear of the excavator to monitor the rear area for potential obstacles.

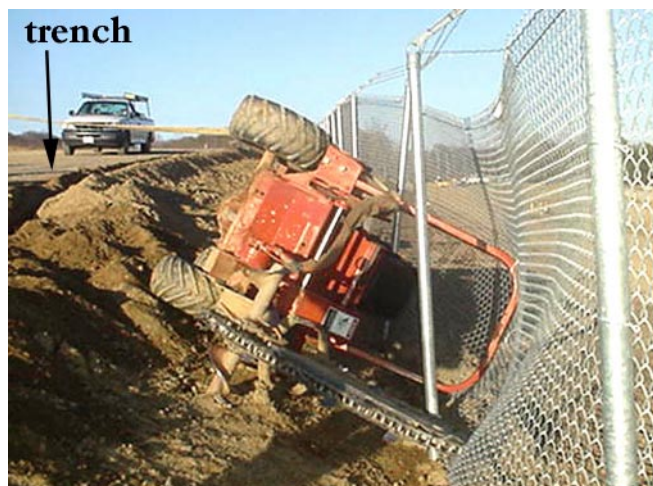
On March 4, 2002, at the Y-12 Site, a trencher machine operator was backfilling a trench when the trencher tipped over and slid down an earthen slope into a chain link security fence (Figure 1). The trencher's seatbelt constrained the operator, and its roll bar kept him from striking the fence. The

Figure 1. The trencher slid down the slope and was caught by the fence

The operator had cut a trench for electrical conduits along the side of a road, leaving a spoils pile of loose dirt along the road edge. After conduits and marking tape were laid into the trench, the operator started to backfill. He used the front blade of his Ditch Witch® 3500 trencher (Figure 2) to push loose dirt into the trench, placing the right wheels of his trencher on the spoils pile for support. As he began to backfill, the soft spoils pile gave way, and the trencher slid to the right, towards the downhill slope. The wheels next caught in firmer soil, and the trencher overturned and slid into the

At this time, the contractor has not finished developing corrective actions and lessons learned. However, preliminary causal analyses indicate that the job planners failed to address the hazards posed by the steep slope next to the road, and by the instability of the soft spoils pile.

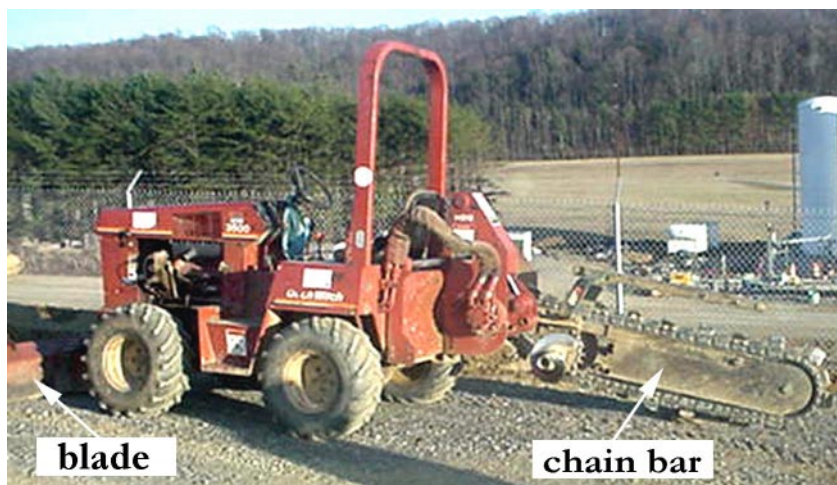
Figure 2. The trencher

equipment for backfilling the trench. The front blade did not extend far enough to the right, forcing the operator to place the right wheels on the unstable spoils pile. Also, raising the chain bar moved the center of gravity of the trencher high and to the right, towards the sloping side of the road.

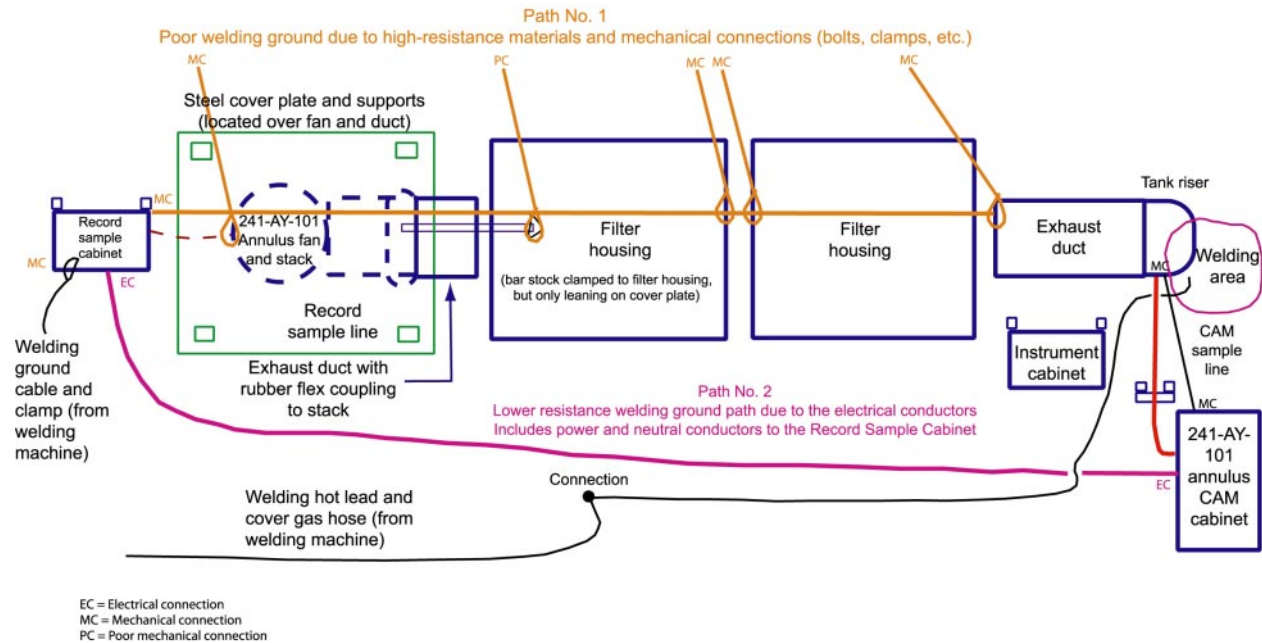
Figure 1 illustrates the physical layout of the area where the welding work was performed, as well as the electrical configuration.

Figure 1. Physical layout and electrical paths

An investigation found that the welding machine current had flowed in two paths. One path (high resistance) went through the equipment and associated mechanical connections. The second path (lower resistance) was mostly through the electrical equipment grounds and associated cabling where the majority of the welding machine current flowed. The grounding cable for the cabinet was rated for

electrical equipment grounding, but not for welding. The insulation on the grounding cable had melted, causing the insulation on an adjacent power cable into the cabinet to fail. When the power cable failed, it tripped a circuit breaker in the annulus CAM cabinet power distribution panel.

The apparent cause of this event was that the welding ground was placed too far from the actual welding operation. The distance between the ground attachment and the weld was approximately 10 to 15 feet. The welder used the closest metallic object (the Unistrut[®] frame) to establish and maintain an arc because the welding ground cable was too short and no other welding-rated cables were available. The high-resistive mechanical connections used to ground the welding machine forced the welding current to seek the less resistive grounding path provided by the electrical equipment. This overheated the wire insulation and ultimately led to the electrical equipment cable failure.

- clarify the grounding requirements (including connectors for cable/hose extensions) associated with welding at the Tank Farms,
- specify the field approach for welding and the use of welding experts at the Tank Farms, and
- provide information applicable to Tank Farm work activities (e.g., stray current corrosion, high-frequency impacts, and welding near sensitive equipment or instrumentation).

The contractor is also updating work control documents to require that work planners use welding subject matter experts to assist in identifying proper grounding.
