OPERATING EXPERIENCE SUMMARY

**Summary 2002-08
April 22, 2002**

1. GANTRY CRANE COLLAPSE DURING LIFT

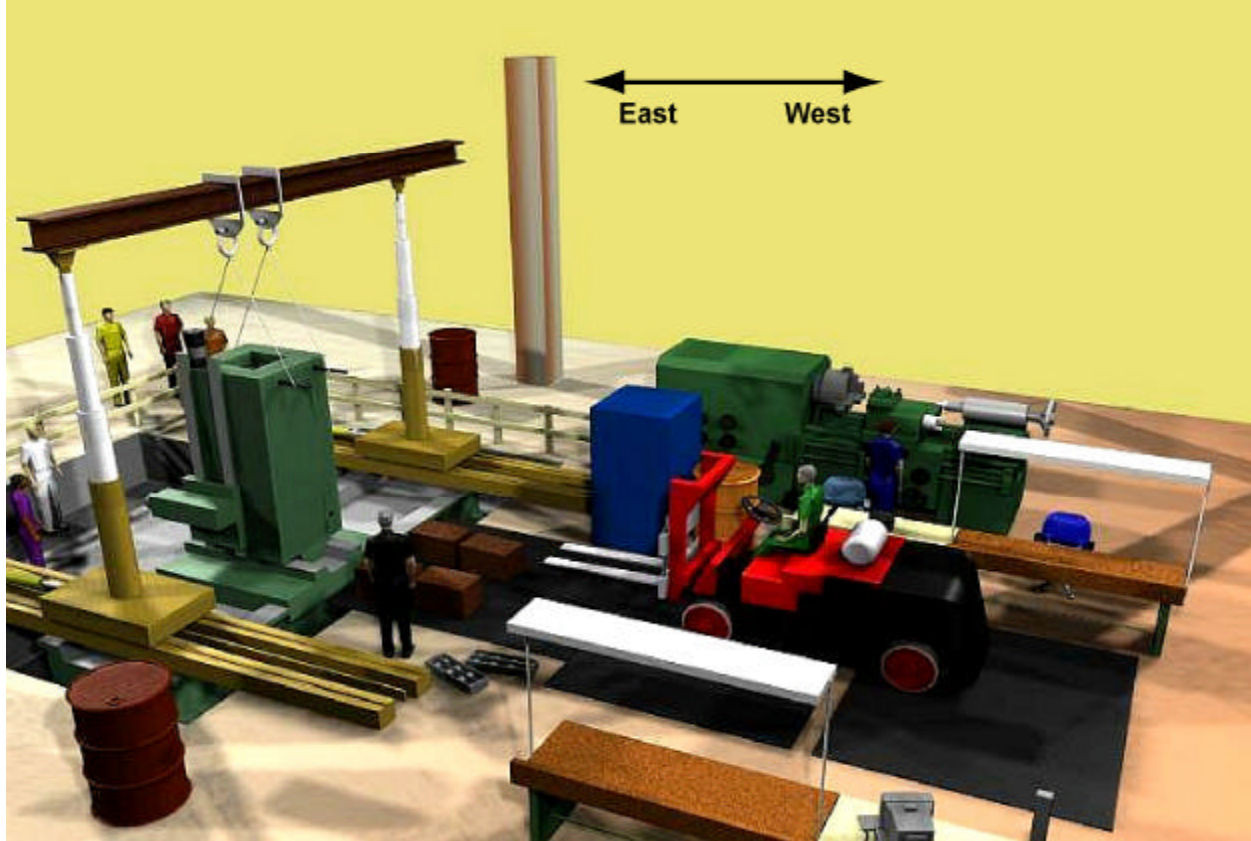
Figure 1. Initial configuration of gantry crane and spindle column

The spindle column was suspended from a gantry crane that consisted of an I-beam supported by two hydraulic cylinders located on two parallel rails. The spindle column required a vertical lift, transitioning to a horizontal position, and ultimately resting on a flat side. The subcontractor had taped off the work area with caution tape to prevent anyone from entering the work zone. The caution tape was removed on one side to allow access for a forklift being used in the operation.

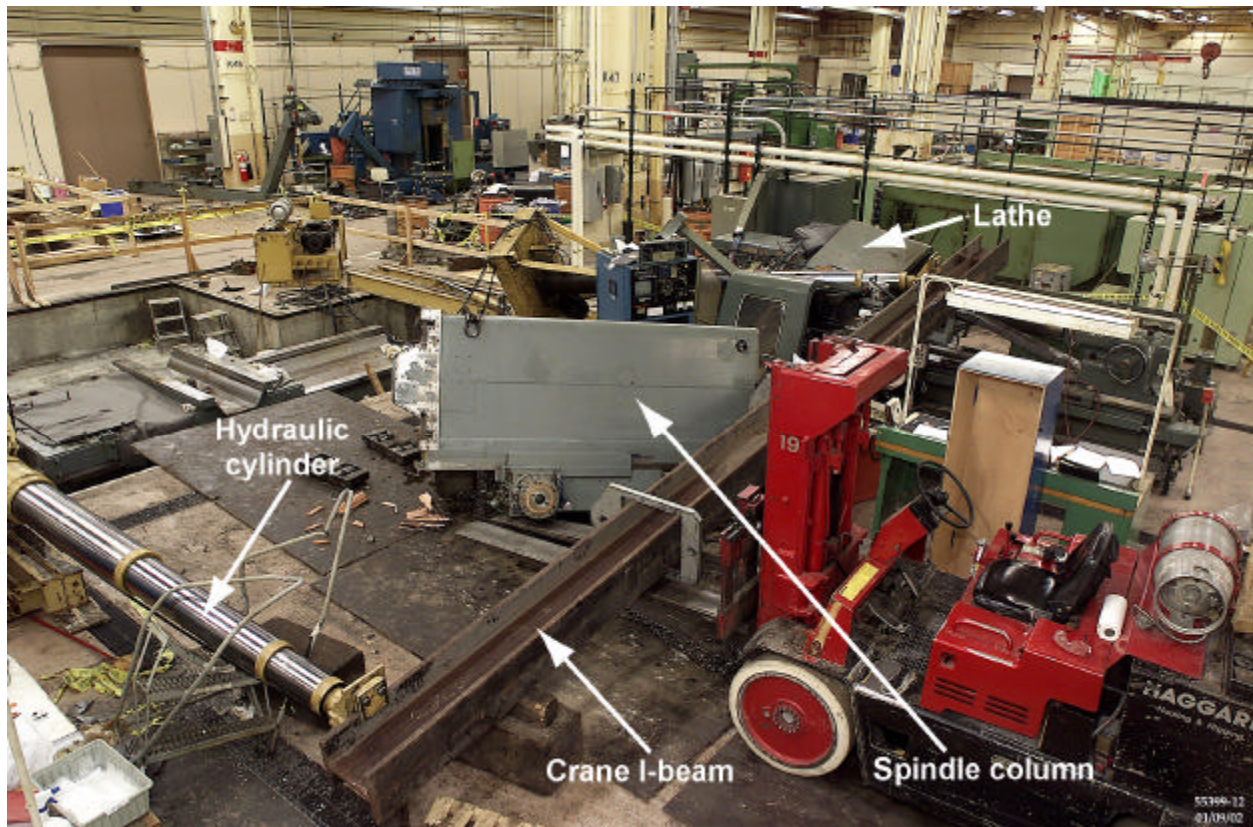
The forklift operator jumped off the vehicle to clear the falling gantry crane. Simultaneously, an associate working on the lathe heard the warning yell of a coworker, looked up, and saw the falling gantry crane. The associate immediately ran to the west to avoid the falling gantry crane and spindle column. The I-beam of the crane came to rest on the forks of the forklift and on the lathe (Figure 2).

Figure 2. The collapsed gantry crane

The causal analysis for the crane collapse cited a procedure problem as the root cause. Because the lift was complex and unusual in nature, the subcontractor failed to apply the correct safety rules and techniques. The direct cause was the horizontal force created when the center of gravity of the spindle column shifted. This force, acting on the top member of the two-point gantry crane, caused the crane and the attached load to topple. No one anticipated that pulling the base of the spindle column would shift the center of gravity. In addition, the subcontractor did not re-evaluate the work area after initial attempts at laying the spindle column on its side failed, to ensure that nearby workers were clear of the potential hazard.

- NNSA Hoisting and Rigging Guidelines should be used to apply correct rules and techniques for complex and unusual lifts.
- All potential hazards of the job should be identified before a lift is initiated.
- No lift should be considered routine.
- Lifting recommendations and techniques specified by the lifting equipment manufacturer should be reviewed prior to attempting lifts.
- Employee empowerment (stop-work authority), accountability, and the expectation of management intervention when unsafe actions or conditions exist should be clearly established, understood, and implemented.
- Any employee or subcontractor is expected to question the adequacy of identified work zones.
- Lifting processes should be stopped and re-evaluated whenever the load does not respond in the manner anticipated.

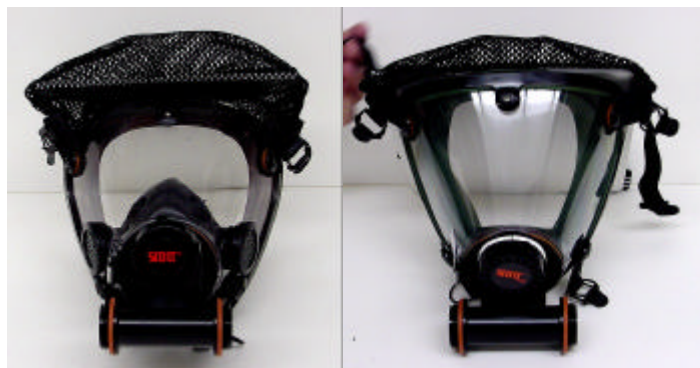
Figure 1. Scott AV-2000[®] (left) and Scott-O-Vista[®] respirators

The procedure governing this activity requires that the issuer provide the user with the respiratory protection for which the user has been fit-tested. In this instance, the issuer provided a respirator for which the user was not fit-tested. Following an investigation of the incident, it became clear that the issuer was unable to differentiate between the two types of respirators.

Corrective actions include awareness training for respirator users and issuers on the differences in respirator models, placing posters at issuing stations to illustrate these differences, evaluating other site projects for similar problems, and evaluating training and fit-test practices to ensure that these differences are appropriately communicated.

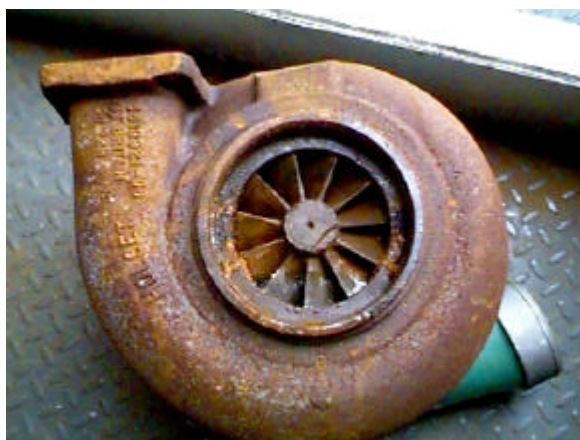
Figure 1. The rusted turbocharger

Investigators believe that without the horizontal muffler installed, a path was provided to allow rainwater to enter the exhaust system and ultimately the engine.

Figure 1 shows the rusted condition of the turbocharger, which is driven by diesel exhaust. This rust damage might have been prevented by placing a heater in the diesel enclosure during storage. Figure 2 shows the condition of the even-numbered bank of cylinders (2 through 12) with the heads removed. The

The contractor has not finished developing formal corrective actions, root cause analysis, or the lessons learned; however, this event illustrates the importance of performing periodic maintenance on equipment that has been placed in short- or long-term storage and ensuring that stored equipment is properly protected from the weather. It is a good practice to store and maintain newly procured equipment in accordance with any manufacturer's recommendations. It is also important that ownership of new equipment be clearly established and properly transferred, so that the owner can ensure the equipment is entered into a routine maintenance program, even if the equipment is to be placed in a temporary storage status. This will help ensure that the equipment will function properly when it is placed into operation.

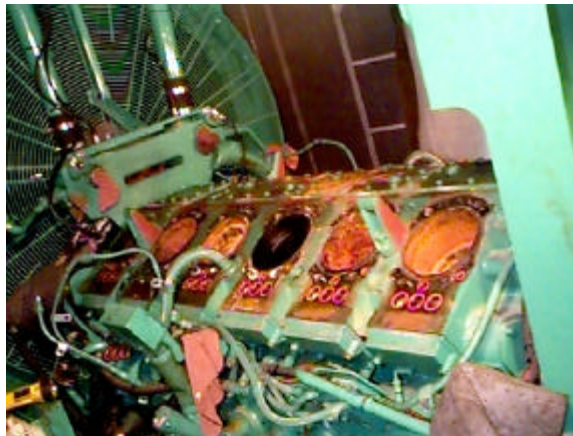
lack of rust damage to cylinder number 8 indicates that the exhaust valve was closed for that cylinder. There were only 17 hours of runtime on the diesel and that time was clocked during factory testing.

Figure 2. Damaged cylinder bank

- ? Failure to ensure that the necessary Level B storage was available onsite for equipment of this physical configuration
- ? Inadequate control and storage of project equipment
- ? Failure to perform in-storage maintenance (no request for maintenance was made to PMMD)
- ? Lack of ownership responsibility
