OPERATING EXPERIENCE SUMMARY

Office of Environment, Safety and Health

**Summary 2002-09
May 6, 2002**

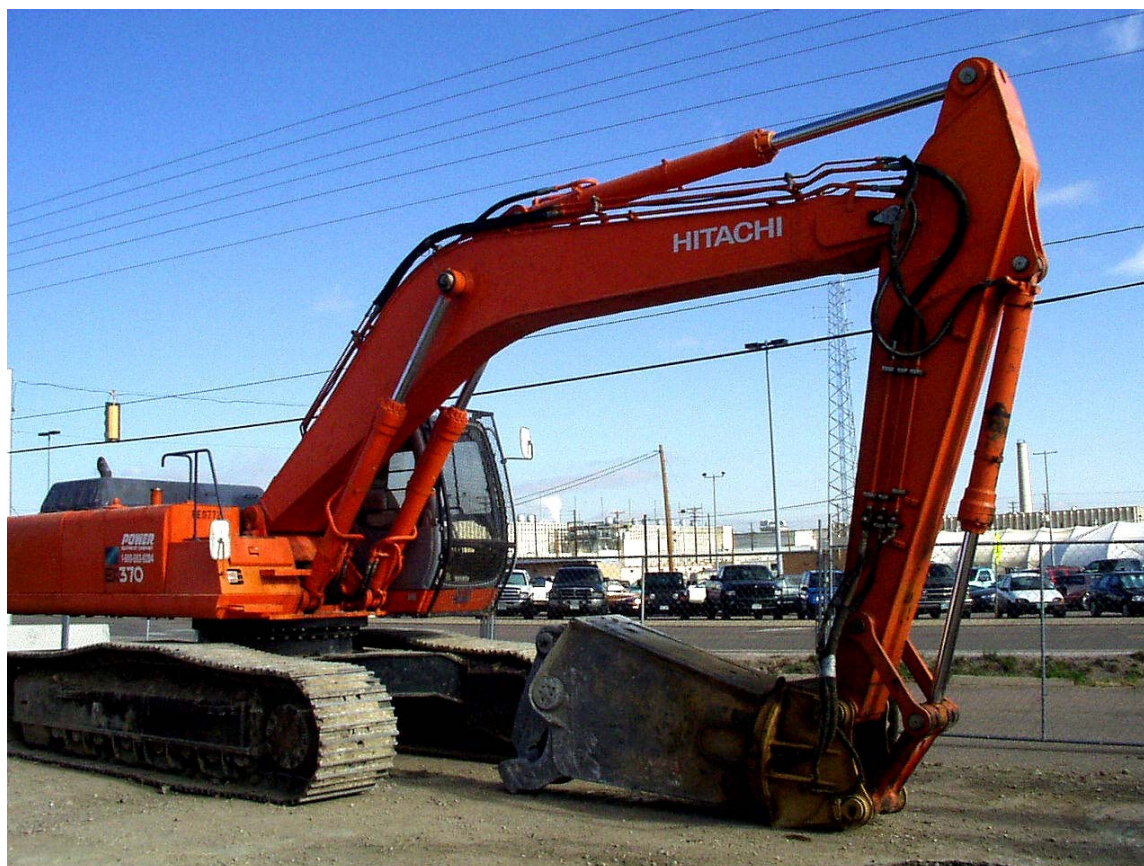
On April 22, 2002, at the Rocky Flats Environmental Technology Site, the boom of an excavator contacted an overhead 13.8 kilovolt high-voltage power line, causing a visible electrical arc and tripping a substation circuit breaker. The excavator was being used to dismantle a building using mechanical shears attached to the boom for breaking up concrete. The line was checked for damage and it was returned to service a short time later. There were no injuries to the operator or equipment damage. (ORPS Report RFO--KHLL-NONPUOPS3-2002-0002)

The equipment operator was moving the excavator to position it out of the work area by extending the boom to assist in turning (see Figure 1). During one of these maneuvers, the boom contacted the power line, which was approximately 23 feet above the ground. A spotter was not used because the excavator was not expected to operate near the overhead lines.

Figure 1. Excavator with boom positioned on the ground

This event demonstrates the importance of exercising extreme caution when operating excavators, cranes, front-end loaders, forklifts, and other vehicles in the vicinity of power lines. Pre-job briefings, facility procedures, and training programs should emphasize the dangers associated with these types of operations. Many events have occurred because equipment operators were not aware of potential hazards around and above them. The use of a spotter in this circumstance might have prevented this occurrence.

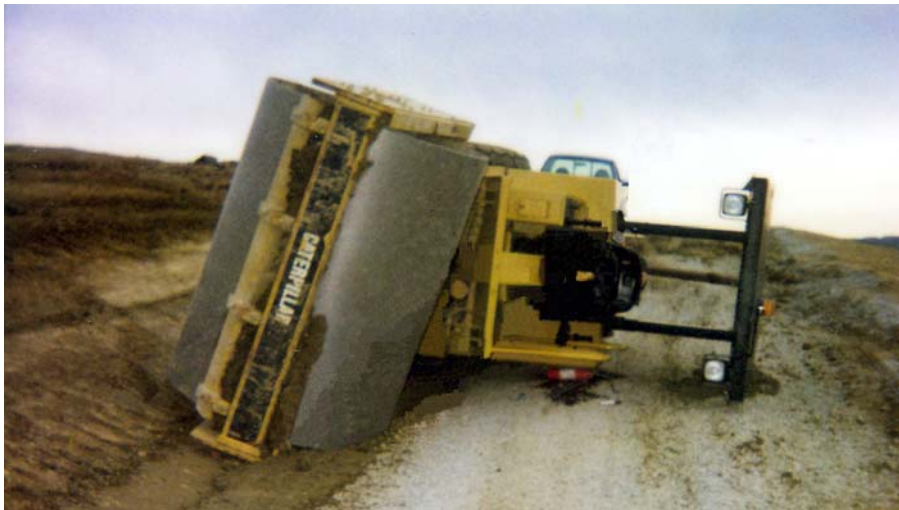
Although the operator had driven a roller before on flat terrain, he had not been on sloped terrain. The operator requested directions on rolling the slope from other personnel, via his two-way radio. Another operator responded with the instructions to roll "up and down, very carefully." A laborer who was standing nearby also gave the operator hand-signal direction showing that he should roll perpendicular to the face of the slope and not parallel with the slope. The supervisor who had assigned him to operate the roller did not hear the operator's call for direction over the radio, although several other supervisory and safety personnel did, and they listened to ensure that the directions were correct. The operator later stated that he had received directions from another operator and a laborer, but felt that with the end of the work shift near and bad weather approaching; he could complete the work sooner by going parallel to the slope. Operation of the roller had not been covered during the daily safety briefing because it was not anticipated that a roller would need to be used that day.

As the operator proceeded parallel across the slope, the roller overturned and landed with the left side on the access road (Figure 1). The operator was protected within the cab of the machine by the rollover protection system, and was restrained by his seat belt. When the roller came to rest, the operator shut off the machine, released the seat belt, and moved to a safe location. No other personnel observed the rollover, and were alerted to the accident only when the operator sounded the horn.

Figure 1. The overturned drum roller

- Management will ensure that supervisors properly place their highest priority on worker safety
- Supervisors will directly observe new-hire employees operating equipment to ensure that they operate the equipment safely. The Occupational Safety and Health Administration (OSHA) standard 29 CFR 1910.120(e)(3)(iii) states, in part, that new employees working at environmental restoration sites are required to receive a "minimum of one day actual field experience under the direct supervision of a trained, experienced supervisor."

- Supervisors will observe each operator as he operates equipment and document his proficiency level on a certification form. Each operator must demonstrate his proficiency on each piece of equipment before he can operate equipment alone.

- Review all applicable work packages to ensure that the hazards associated with operating heavy equipment are known and adequately addressed.
- Establish a standard for key project personnel who will be notified in the event of an emergency.

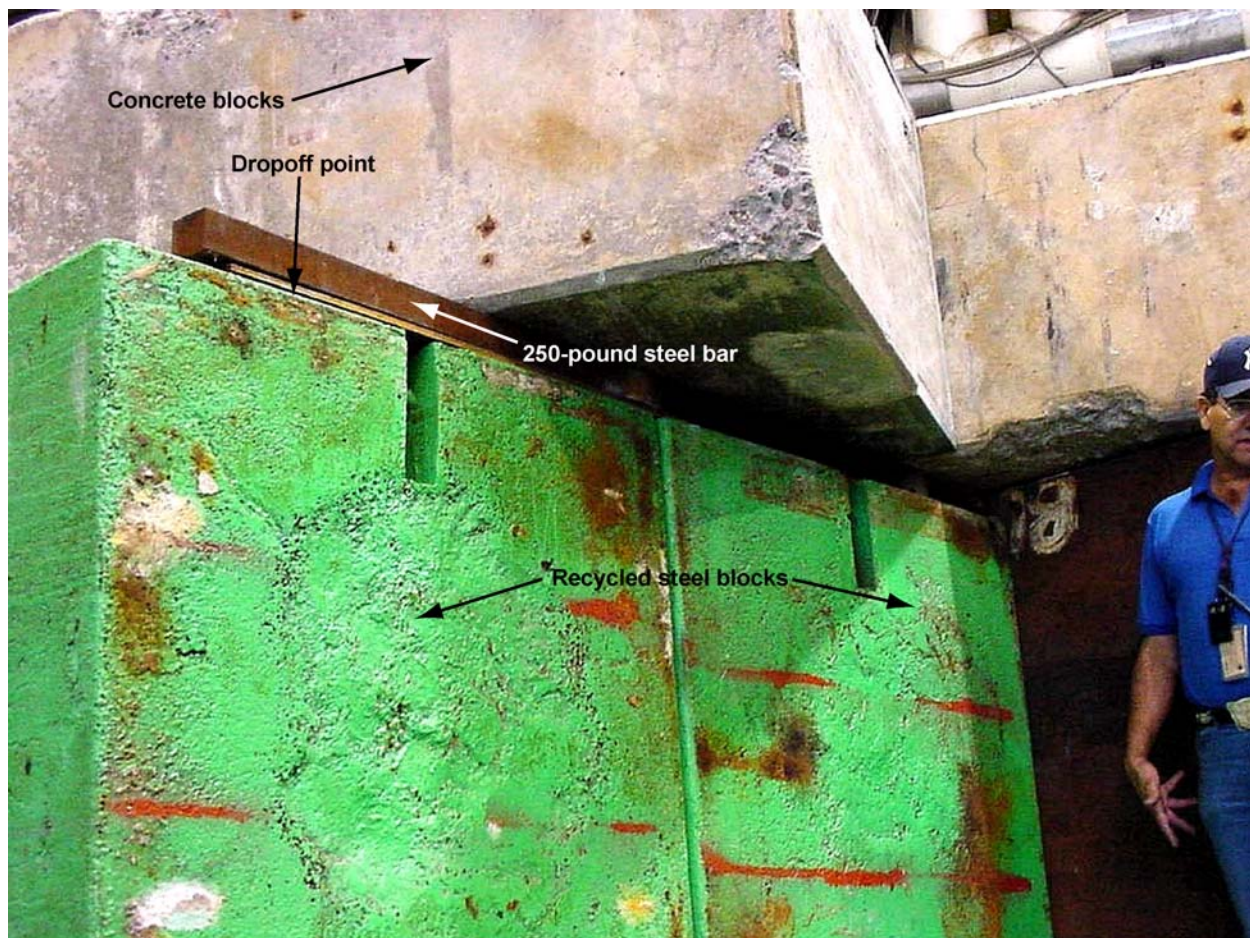
A team of workers was erecting beam line radiation shielding that included steel and concrete blocks weighing up to 18 tons. Figure 1 shows the steel bar (that struck the worker) positioned between large shielding blocks. The shielding blocks were stacked using both an overhead crane and forklifts. All of the workers involved in the operation were qualified forklift operators and overhead crane operators, and had been regularly involved as a team in disassembly and reassembly of shielding for over 15 years. Workers are required to wear safety shoes when engaged in lifting and shielding work.

Figure 1. Steel bar between shielding blocks and position of the spotter

During this particular operation, an equipment operator moved a 4-ton capacity forklift into an alcove that required the forklift to enter at an angle because of its large size and limited space in the alcove. The steel bar was positioned across both tines of the forklift towards the tips of the tines. When the operator drove the forklift up to the dropoff point on top of a large shielding block, the worker who was a spotter directed him to back up a few inches. The spotter was standing on top of a ledge created by the stacked shielding block located below the dropoff point. The spotter and a second person intended to slide the steel bar from the forklift tines to its resting place on top of the shielding block. However, when the forklift backed up, the left tine (driver's perspective) was positioned immediately above the top of the shielding block while the right tine was several inches away from the shield block. When the spotter attempted to move the steel bar toward its resting place, it dropped between the tine and the vertical shield block, bounced, and struck the spotter's right boot in the area of the big toe.

This event underscores the importance of wearing the required personal protective equipment. In this event, if the worker had been wearing steel-toed safety shoes instead of standard work shoes, he may not have suffered such a severe injury. Workers who are exposed to potential foot injuries from falling or rolling objects, materials piercing the sole of the shoe, or exposure to electrical hazards are required to wear protective footwear. When working in an area where there is a potential for falling, rolling, or puncture hazards, foot protection can be afforded by wearing steel-toe safety shoes or add-on devices such as metatarsal guards, metal foot guards, puncture-proof inserts, or shin guards. Safety shoes and safety boots can not only prevent injuries, but can reduce the severity of an injury. Safety shoes must
