OPERATING EXPERIENCE SUMMARY

Office of Environment, Safety and Health

**Summary 2002-10
May 20, 2002**

Operating Experience Summary 2002-10

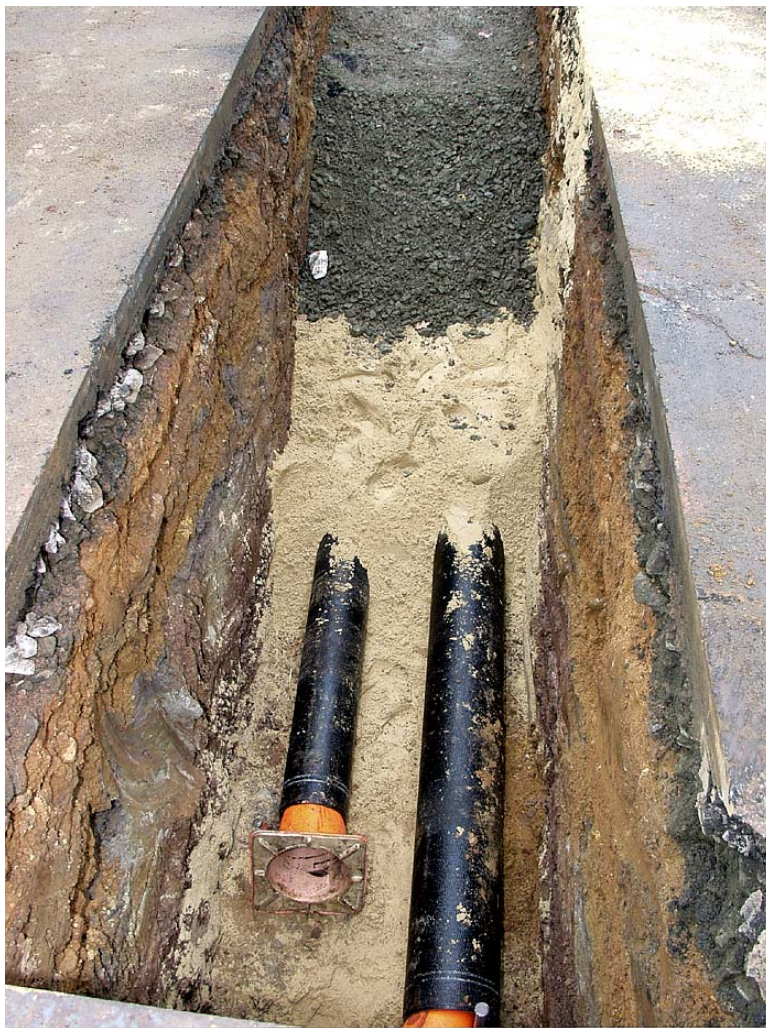
The subcontractor was tasked with replacing the canal water service lines throughout the facility. Each new canal water line is located at a depth of 4 to 5 feet; trenches are dug to a depth of 5 to 6 feet and then backfilled with 6 to 12 inches of sand base for the new piping, as illustrated in Figure 1. At locations where utility lines cross the trench, workers must enter the trench to manually locate the lines and hand-dig around them

Figure 1. Western section of the trench with new pipes on sand backfill

On the morning of the accident, the worker, a foreman, entered the trench to determine a potential path for the new line around the existing utility lines. The trench had been excavated to the appropriate depth except at locations where utility lines were known or expected to cross the path of the trench. While he was in the trench, a mass of soil fell from the north face of the trench and struck him on his right leg above the ankle. The mass consisted of a mixture of compacted soil, clay, and rock, and struck the worker's leg with sufficient force to fracture both lower leg bones.

After completing its investigation, the review board found that the root cause of the accident was the failure to identify the hazard posed by the condition of the trench wall. A contributing factor was failure to properly define roles and responsibilities for inspecting and overseeing the task. Neither the

subcontractor nor project management assigned a competent person to perform soil assessments as required in 29 CFR 1926, *Safety and Health Regulations for Construction*, sections 651 and 652.

- Re-assess the roles and responsibilities of project management and oversight.
- Assign a competent person, as described in 29 CFR 1926.652, with the documented training and experience to anticipate and recognize conditions that can lead to soil collapse.

- Project management must ensure strict adherence to the requirements in 29 CFR 1926.652 relative to excavations; in particular, protective systems such as sloping, benching, or shoring must be used in trenches greater than 5 feet deep.

- Perform soil inspections on a daily basis and after a change in conditions has been observed. The Occupational Safety and Health Administration (OSHA) provides an inspection checklist that can be used as a guide. A record of these inspections should be maintained.

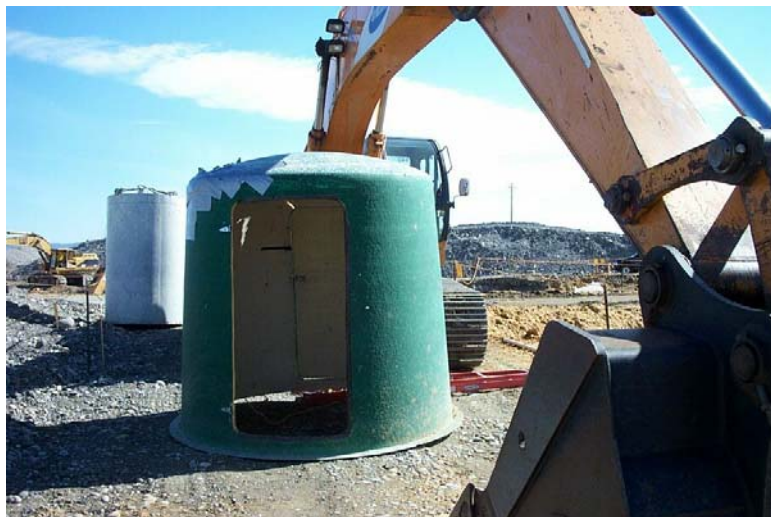
Figure 1. *The hut*

The hut, measuring 7 feet wide by 10 feet high (Figure 1), was suspended from an excavator bucket using a doubled $\frac{3}{8}$ -inch nylon rope (Figure 2), which was strung through a $\frac{1}{2}$ -inch nylon rope attached to the hut by stringing it through two holes at the top. Both ropes had been installed before the hut was delivered to this project. The excavator raised the hut approximately 10 feet in the air to maneuver it over a concrete bunker. While the excavator was turning a

corner on an access road, the hut began to swing. The ½-inch nylon rope failed, presumably frayed by the swinging motion of the hut, and the hut fell to the ground. No workers were closer than 20 feet to the hut at the time of this incident.

- A safety stand-down will take place with contractor and subcontractor management to address the conditions affecting the incident and to emphasize procedure compliance by all personnel and safety expectations, including stop-work authority.
- All operators will receive refresher training on the subcontractor's hoisting and rigging procedures, desk instructions, and operator responsibilities.
- The contractor will provide information to other organizations at Hanford on the incident and on potential problems with similar loop rigging arrangements.

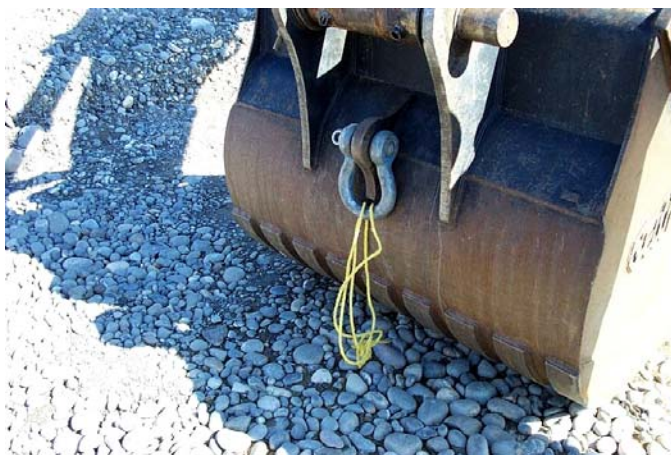
Figure 2. The excavator bucket
