OPERATING EXPERIENCE SUMMARY

**Summary 2002-11
June 3, 2002**

1. STOWING HOOK FAILURE CAUSES NEAR MISS

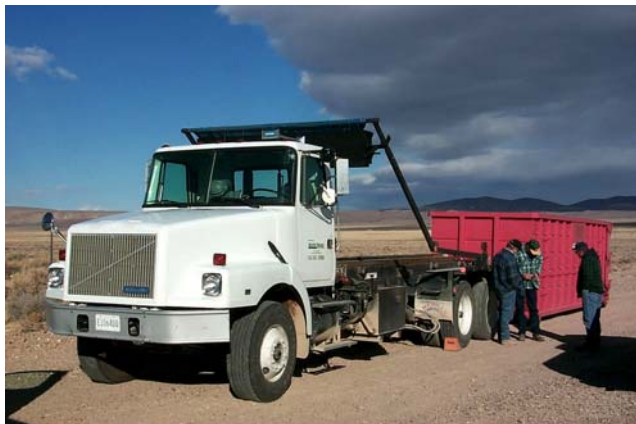
On January 22, 2002 at the Nevada Test Site, a contractor worker was securing a cable on a rolloff box truck (Figure 1) when the stowing (retaining) hook failed and the cable recoiled past the worker, striking the front windshield of the truck cab. The recoil from the cable cracked the top left corner of the

Figure 1. Truck unloading a rolloff box

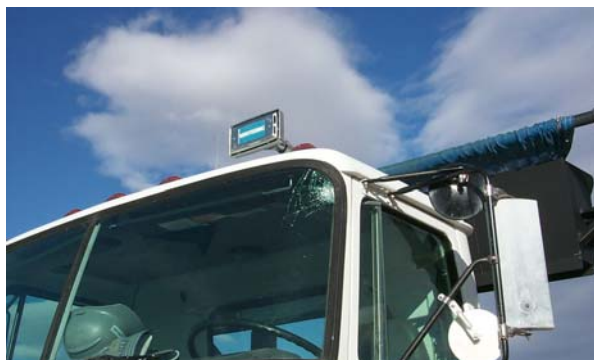
heard a pop. The hook failed and fell straight to the ground while the cable recoiled behind him in an arc, hitting and cracking the windshield (Figure 2).

Figure 2. The cracked windshield

The direct and root causes of this occurrence were defective design because consideration was not given to relocating the stowing hook, which allowed it to become load-bearing, although it was neither intended nor designed to bear tension loads.

The stowing hook showed a stress intensifier crack that caused it to fail. The contractor Fleet and Equipment organization has adopted a policy that requires equipment engineering to research proposed modifications and make recommendations to management as to the feasibility of the modifications. Modifications to the design of any equipment, system, or sub-system will not be authorized until equipment engineering has reviewed the proposal and issued detailed instructions.

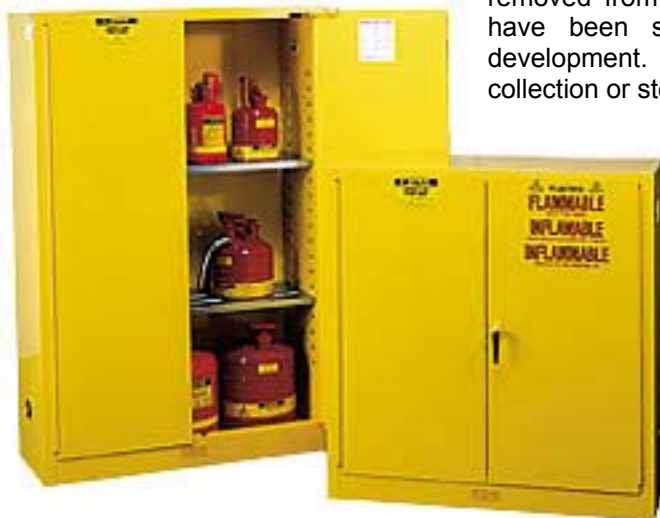
On March 5, 2002, at the Rocky Flats Environmental Technology Site, facility personnel found approximately 14 containers of combustible liquids that were not stored in flammable liquid storage cabinets as required. Spark-, heat-, and flame-producing activities were curtailed in affected areas until the combustibles were removed from the facility. Facility management identified this occurrence as a programmatic deficiency because the applicable program requirements for controlling flammable/combustible liquids were not met. (ORPS Report RFO--KHL-371OPS-2002-0014)

Figure 1. Combustible/flammable liquid storage cabinets

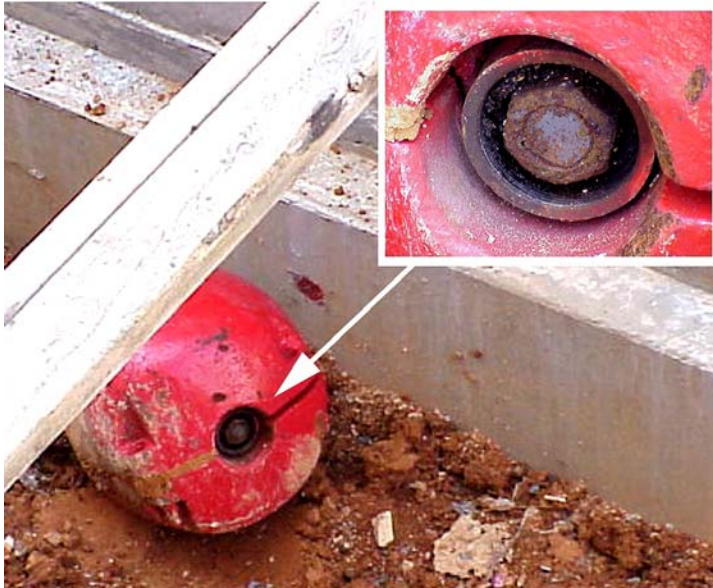
Investigators determined that internal bearings seized because of lack of lubrication, which prevented the ball and the load from swiveling. This apparently created significant rotational torque on the ball's upper threaded connection that attached to the load line. Despite a setscrew, the threads turned and disengaged, causing the ball and the load to fall. Figures 1 and 2 show the ball and disconnected threads after the incident.

Figure 1. Fallen headache ball and connection threads (insert)

The crane supplier's investigation report blamed the poor design of the headache ball for the failure, noting that there are no external grease fittings for the bearings and that the ball had to be completely disassembled for lubrication. However, the manufacturer of the headache ball stressed that despite this maintenance inconvenience, the ball should have been inspected and lubricated routinely – varying between a daily and a two-week basis, depending on use. The crane supplier and crane operators were not aware of those maintenance requirements. The manufacturer and the SNS contractor concluded that the real cause of the failure was inadequate inspection and maintenance of the ball, not its design. The contractor implemented the following corrective actions.

- A third-party crane inspection firm re-certified all SNS cranes provided by the crane supplier.
- A third-party crane inspection firm assessed the crane supplier's certification process.
- The crane supplier, site construction manager, and the construction subcontractor personnel were re-trained to current crane manufacturer and industry requirements.
- The construction manager will complete a self-assessment of the crane inspection and lubrication process and will evaluate all lifting equipment certification processes.

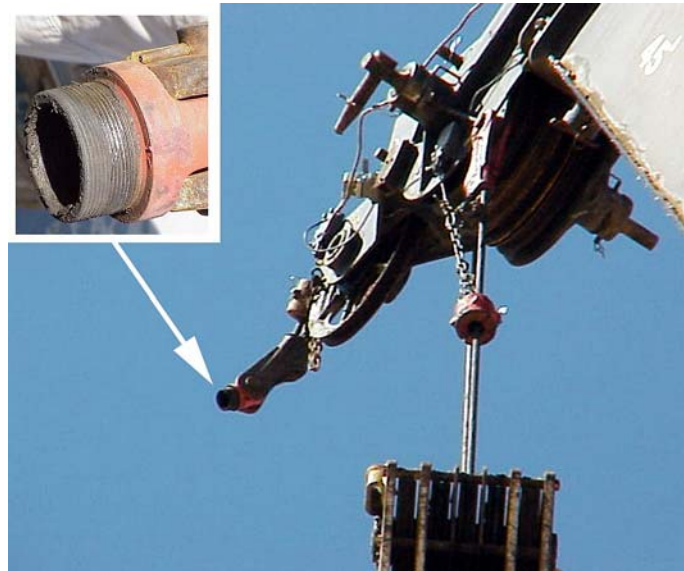
Figure 2. Threaded connecting pin at end of load line
