OPERATING EXPERIENCE SUMMARY

Office of Environment, Safety and Health

**Summary 2002-12
June 17, 2002**

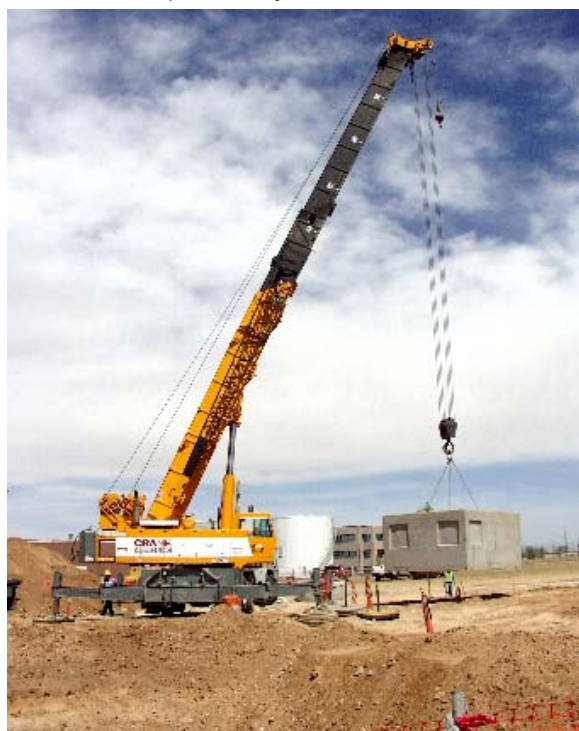
On May 1, 2002, at the Sandia National Laboratory, a crane operator was using a 90-ton hydraulic crane to lift a 30,000-pound communications manhole when the crane became unbalanced and tipped forward, raising the back outriggers approximately 4 feet off the ground. The crane operator immediately released the load, which was approximately 3 feet off the ground at the time, righting the crane. The lift was temporarily stopped to adjust the position of the crane before the lift could finally be completed safely. No injuries, material damage, or programmatic impact occurred as a result of this event. (ORPS Report ALO-KO-SNL-1000-2002-0002; final report issued May 20, 2002)

The prime construction contractor subcontracted a crane services company to lift and place the communications manhole. The crane subcontractor provided a state-licensed crane operator and a 90 ton-capacity hydraulic crane to perform the lift. The crane was inspected by a Sandia-certified crane inspector and was approved to perform the lift. Employees from the construction contractor rigged the manhole structure, and the lift was initiated (Figure 1). At about one minute into the lift, after laterally maneuvering the crane approximately 40 feet, the crane operator extended the boom in order to exactly place the manhole in the excavation. The crane tipped forward, raising the back outriggers off the ground, requiring the load to be immediately released.

The direct cause of this event was the operator's inattention to detail because he failed to correctly calculate the boom angle relative to the load weight. A significant contributing cause was the lack of specific direction in the construction contractor's Contract-Specific Safety Plan regarding supervisory oversight of subcontractors during crane operation.

The root cause of this event was a failure to follow established procedure by the crane subcontractor, which specifically requires "...a qualified crane superintendent or supervisor to check the job, size the crane, and be present and responsible to see that the job is carried out as planned and on time." If this requirement had been met, the event could have been prevented.

Figure 1. Crane lifting the manhole structure

- The construction contractor issued an addendum to the Contract-Specific Safety Plan that provides specific guidance to their supervisory personnel regarding oversight of crane subcontracting activities. This oversight will ensure the subcontractor's procedures require that a supervisor approves the lift plan and is present during the lift, the operator is experienced and licensed, and the crane is rated for the load and has documented inspections.
- The Sandia Construction Inspection and Acceptance organization will increase the level of inspector involvement in crane lift activities for all Laboratory construction.

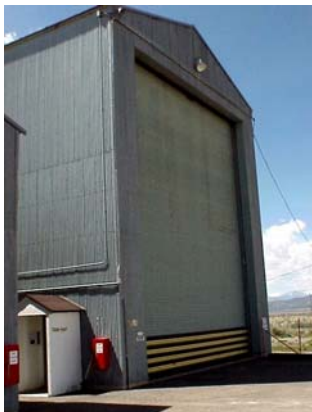
Figure 1. *Rollup door*

The operator was performing a weekly inspection required by the Resource Conservation and Recovery Act compliance program, which included a test of the metal roll-up door for proper operation. The door is 35 feet in height (Figure 1), and is equipped with an electric/manual door opener. The door opener mechanism comprises several gear reductions, a clutch, a motor, and a brake. The bearing locking collar that came loose is held in place by two setscrews, and is on an idler shaft to prevent the idler sprocket from moving laterally (Figure 2).

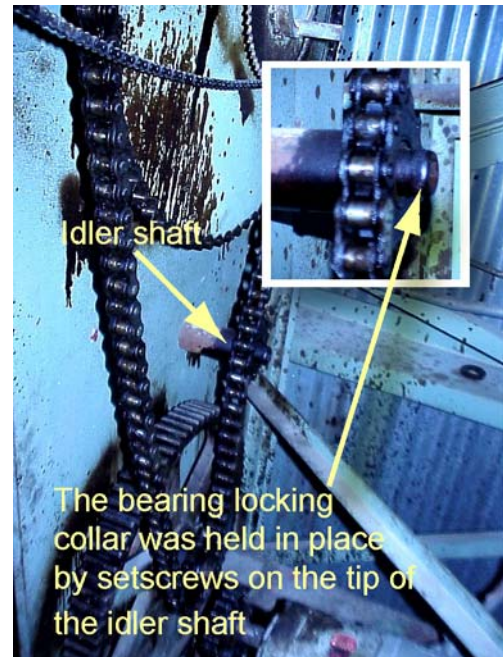
In August 2001, a drive gear-retaining washer fell from the operating mechanism of this door during door operation. Investigation of this event revealed that the drive gear bushing was severely worn, causing the gear-retaining washer and bolt to work loose. A craftsman repaired the bushing and returned the door to service. Upon reviewing this previous failure, two issues were identified: (1) the falling part was not identified as a near-miss occurrence, and (2) the craftsman's comment in the work order — that the door operating mechanism “had poor gear mesh engagement and warranted frequent visual inspection” — was not acted upon.

The contractor's review of the preventive maintenance status for this door revealed that no preventive maintenance had been performed on the door since February 1999. During 2000, preventive maintenance on overhead doors evolved into a semiannual general inspection of the door and the electric operating mechanism. The locking collar was not specifically checked, and the only check specified in the preventive maintenance work order that could have helped maintenance personnel detect loose setscrews was the procedural step, “Check clutch and brake for condition and drive parts for loose bolts.”

Figure 2. The gear arrangement

The contractor's corrective actions included the following measures: The door in question was locked and tagged out of service and a work order was prepared to replace the locking collar and inspect the door for loose or damaged parts. Other overhead doors that have not had regular preventive maintenance were taken out of service and inspected for loose or damaged parts under a Minor Maintenance work order. Doors that are required to be opened for essential operations before inspections are completed must have a barrier that precludes personnel access to the area underneath the operating mechanism. Doors that passed inspection were put back in service, and doors that failed will remain out of service until corrective maintenance is performed. Preventive maintenance schedules will be developed for all overhead doors that are considered in service. The gear mesh issue will be formally evaluated, and corrective actions will be developed based on the results.

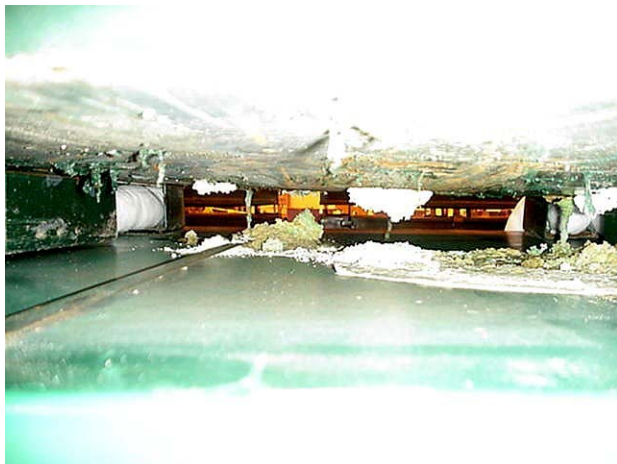
On May 13, 2002, at the Portsmouth Gaseous Diffusion Plant, a compliance inspector discovered a leaking shipping container in a waste storage facility. On May 16, further inspections discovered two other containers that were blistering. The containers had been loaded with demolition debris (mostly acid brick) in the summer of 2001, but scheduling delays had prevented shipment of this waste for disposal. (ORPS Report ORO-BJC-PORTENVRES-2002-0012)

The damaged containers are of the MacTec B-25 type, and are used without liners. Most of the B-25 containers exhibited obvious outward dents and bulges from workers dropping the bricks into the containers as they filled them. Some have bowing bottoms and are filled to capacity, but none appear to be overloaded. The bricks contained residual water when they were loaded into the containers. A solid material was accumulating and hanging from the bottom of the leaking container and building up on the container directly beneath it (Figure 1). Sample testing of the liquid from the leaking container indicated a pH of between 3 and 4.

Figure 1. Material leaking from container

Workers placed the leaking B-25 container into a B-26 overpack and patched the two blistered containers. There has been no noticeable leakage from these repaired or overpack containers. However, there is concern that the acid leakage from the B-25 container will eventually cause leaks in the B-26 overpack as well. The contractor has also decided that the B-25 containers will no longer be stacked.
