OPERATING EXPERIENCE SUMMARY

**Summary 2002-13
July 1, 2002**

Operating Experience Summary 2002-13

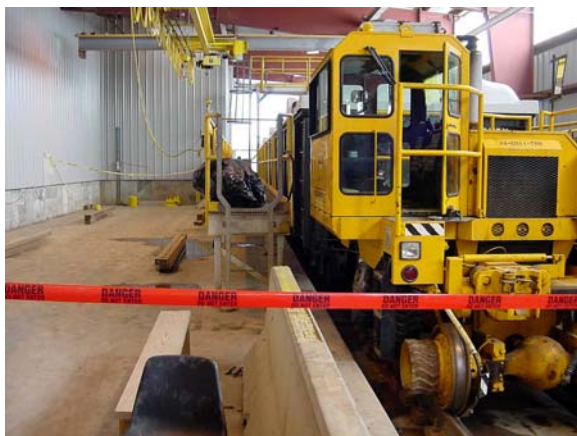
Figure 1. A view of the platform and trackmobile

Meanwhile, one of the technicians motioned to the engineer that he wanted to turn a placard, and the engineer nodded, having given three-step protection to the conductor. The technician believed that he had been given permission to complete the entire placarding task, but the engineer did not. Another technician and trainee arrived and asked the lead hazardous waste technician if they were cleared to begin placarding. Based on his observation of the first technician changing one placard, the lead technician said they could start placarding the railcars. The trainee climbed to the west platform to turn the placard. The other technician went to the north end of the platform to turn the placard on the railcar in front of the trackmobile.

The engineer could not see the technicians on the north end of the platform; the only visible technician was the first to arrive, standing away from the railcar. The conductor could not see the platform area and was unaware that others had entered and begun placarding.

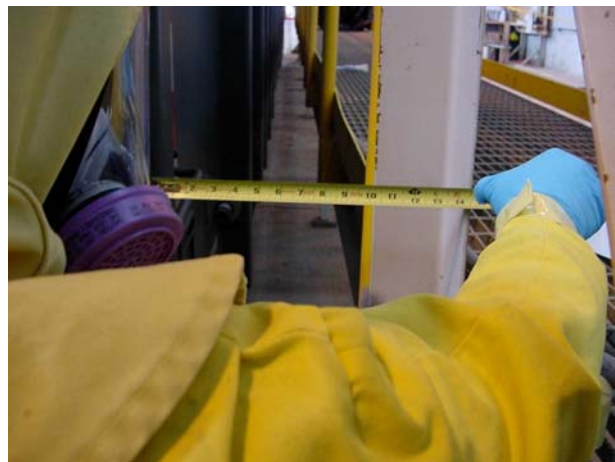
The root cause of this event was a lack of enforcement of policies and procedures. Neither the railcar loading procedure nor the job safety analysis addressed the task of placarding. Implementation of rail safety requirements had become informal and deviated from rail operations procedures. Had policies and procedures been current, complete, consistent, clearly understood, and followed by all personnel, it is unlikely that this accident would have occurred.

Figure 2. The clearance space between the railcar and the platform

- an inadequate work environment for placarding railcars, as evidenced by the insufficient clearance between the railcars and the platform or space from which to quickly escape the tracks;
- the plan to move an additional car out of the building before beginning normal railcar placarding/loading activities was not understood by all members of the crew;
- the absence of the supervisor in the area at the time of the accident; and
- failure to survey railcar placarding/loading operations and procedures.

- The task of placarding railcars was moved to the north rail yard, and a job safety analysis and interim policy were developed specifically for placarding.

- The railcar loading procedure was revised to address deficiencies identified during the investigation; specifically, it mandates the use of high-visibility, color-coded vests for the various railcar operations personnel, a series of horn signals to indicate three-step protection release, and the issuance of a radio with a common frequency to the loadout supervisor to facilitate communication between the train crew and loadout personnel (hazardous waste technicians). Using the revised procedure, loadout personnel completed a dry run of the railcar loading evolution.

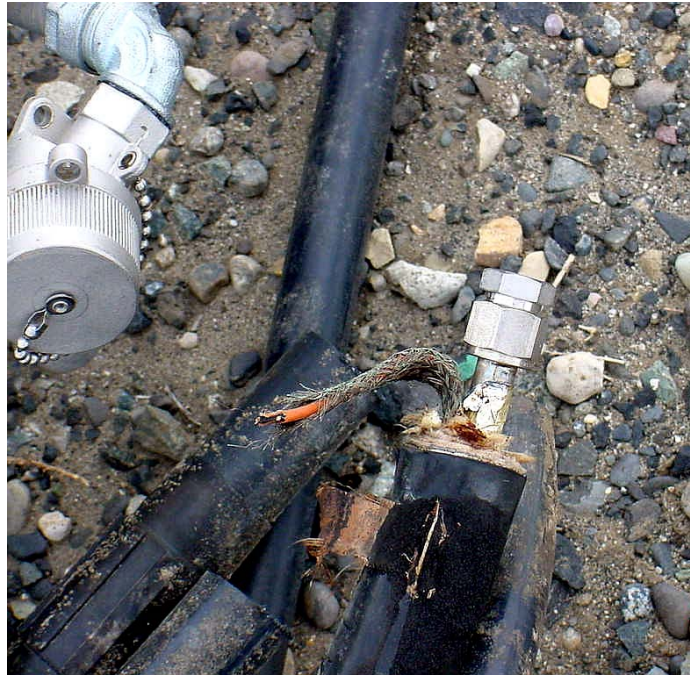
On May 28, 2002, at the Hanford Tank Farms, a maintenance worker in the process of disconnecting a pump skid cut through heat trace wires that were assumed to be de-energized by the associated lockout/tagout. The worker observed sparks when the line was cut with a hand-held band saw, resulting in the immediate tripping of a 120-volt circuit breaker. It was discovered that the heat trace wires were powered by a separate tank farm electrical system. The worker was not wearing personal protective equipment because the work team assumed that they were not at risk. No injuries resulted from this event. (ORPS Report RP--CHG-TANKFARM-2002-0054)

The direct cause of this event was the failure to de-energize the circuit supplying power to the heat trace line. Existing drawings did not adequately depict the routing or the energy source for heat tracing, and human errors were made in allowing the work to proceed based on incorrect assumptions made in an attempt to compensate for inadequate information. A contributing cause was the fact that the work was behind schedule, and there was a sense of urgency related to performing the work on the swing shift on the day of the event. Figure 1 shows the heat trace wires after they were cut.

Figure 1. The cut heat trace wires

- Immediately stopped work and placed the work site in a safe condition.
- Immediately suspended electrical work requiring lockout/tagout placement pending the outcome of a review by the Event Investigation Team.
- Revised a site document entitled *Use of Insulated Tools for Energized Electrical Work* to include the following requirement:
