OPERATING EXPERIENCE SUMMARY

Office of Environment, Safety and Health
OE Summary 2002-14
July 15, 2002

Operating Experience Summary 2002-14

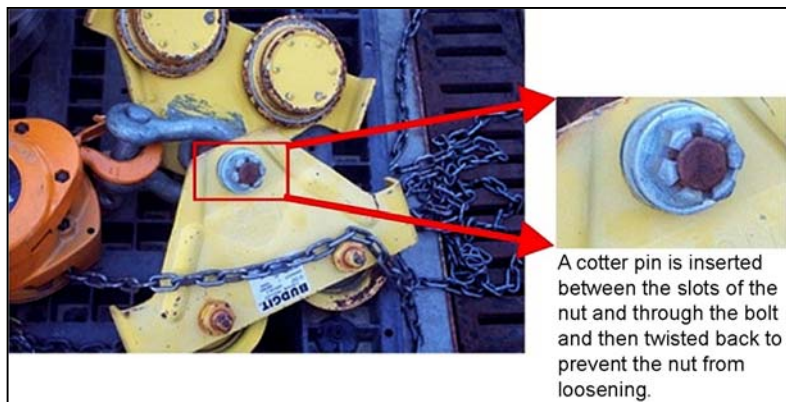
Investigators determined that the trolley failed because the retaining nut that held the two halves of the trolley together had loosened. There was no cotter pin or locking device installed

in either of the two castle nuts, as is shown in Figure 1-1. During a root cause evaluation it was learned that the manufacturer's information (obtained after the event) contained a warning that the trolley could separate from the I-

beam if the nuts were allowed to loosen, causing excessive trolley wheel clearance with the I-beam. However, no manufacturer's instructions were available at the facility. The Hanford Hoisting and Rigging Manual does not specifically address trolley and A-frame inspections. The castle nuts were verified hand-tight during the prior-to-use inspection.

The direct cause of this event was inattention to detail because equipment inspectors did not identify all adverse conditions on the trolley and A-frame. The root cause was determined to be a training deficiency because training courses did not specifically address inspections of trolleys and A-frames, nor did they instruct personnel to obtain and use the manufacturer's information as inspection criteria. One of the contributing causes was that personnel failed to understand that periodic inspections identified in the Hanford Hoisting and Rigging Manual applied to trolleys and A-frames. Another contributing cause was that when the equipment was obtained from another facility in 1998, inspection criteria were not developed, nor was the manufacturer's information for the trolley and A-frame obtained.

Figure 1-1. Separated trolley showing castle nut arrangement

retaining nuts on I-beam-type trolleys can loosen enough to allow the trolley to disengage from the I-beam under load, retaining devices should be used to secure the nuts. Qualified personnel should inspect them in accordance with the manufacturer's written instructions. The inspections should include proper adjustments and a check that retention devices are in place. Properly maintained and inspected hoisting and rigging equipment is important be-

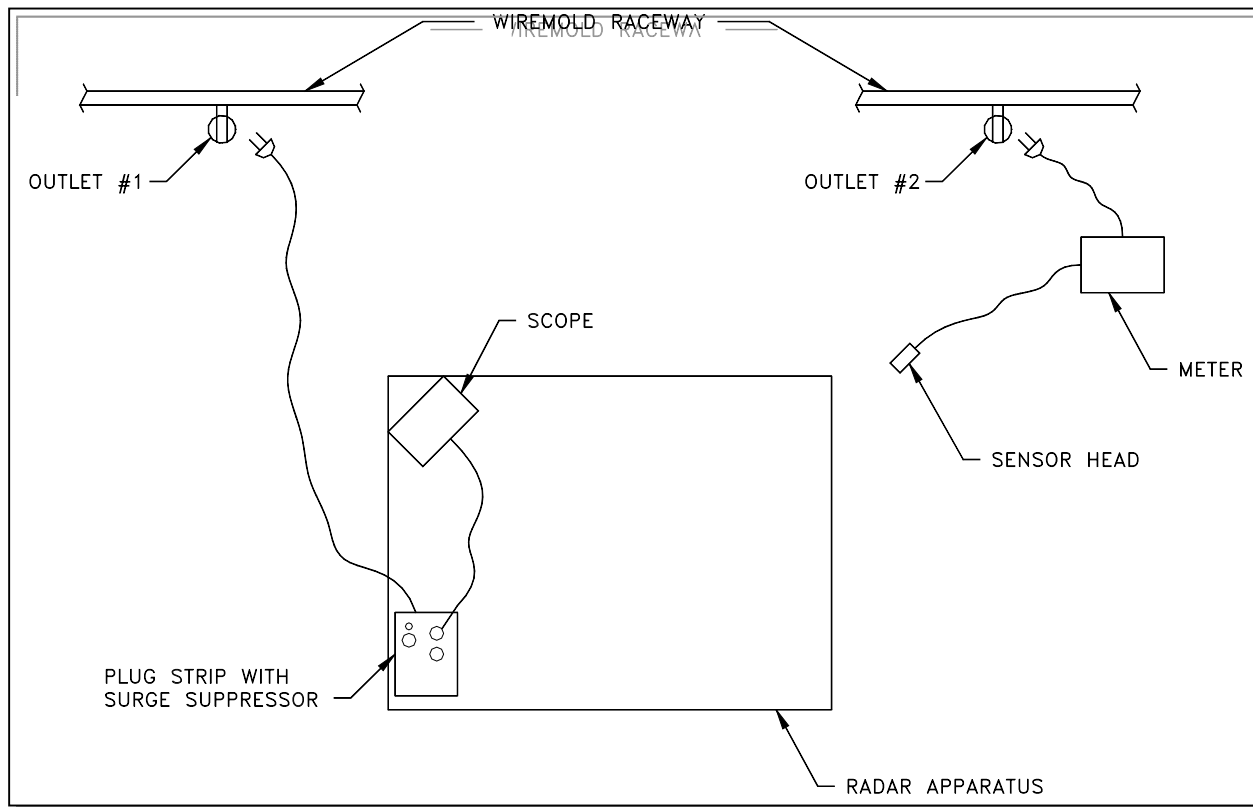
The researcher was assembling a 35 GHz radar unit and testing it with a microwave power sensor. Figure 2-1 shows the general layout of the equipment and receptacles involved in the occurrence. In the event description that follows, the problem receptacle is identified as outlet #1 and a second receptacle in use is identified as outlet #2. A surge suppressor was plugged into outlet #1, and an oscilloscope was plugged into the surge suppressor. Both the surge suppressor and the oscilloscope sat on the radar unit's metal housing. A power meter was plugged into outlet #2, and a microwave power sensor was attached to the power meter.

Figure 2-1. General layout of equipment and receptacles

PNNL electricians tested outlet #1 with the surge suppressor still connected to it, and discovered 60 VAC between the neutral lead and ground, where no voltage should have been present, indicating that the receptacle was not properly grounded. After reviewing the results of the tests, PNNL electrical engineers concluded that the likely shock pathway involved voltage from the surge suppressor transient control circuit causing a small current to pass through mounting screws on its housing to the housing of the radar unit, through the researcher and the microwave power sensor to the proper ground on outlet #2.

Event investigators conducted a preliminary causal analysis and identified the direct cause as equipment/material problem (defective or failed part) because of the defective receptacle. The root cause was a design problem (error in equipment or material selection) because the original design did not provide proper grounding of the receptacle. The flawed design relied on an inadequate ground strap and mounting screws contacting the electrical raceway for establishing a ground. There was no separate ground wire from the receptacle ground lug to the body of the raceway.

Corrective actions included checking all Wiremold® electrical raceway receptacles in the building for correct polarity and proper grounding with a plug-in circuit tester and evaluate whether the radar unit can be provided a means for grounding while it is being assembled.

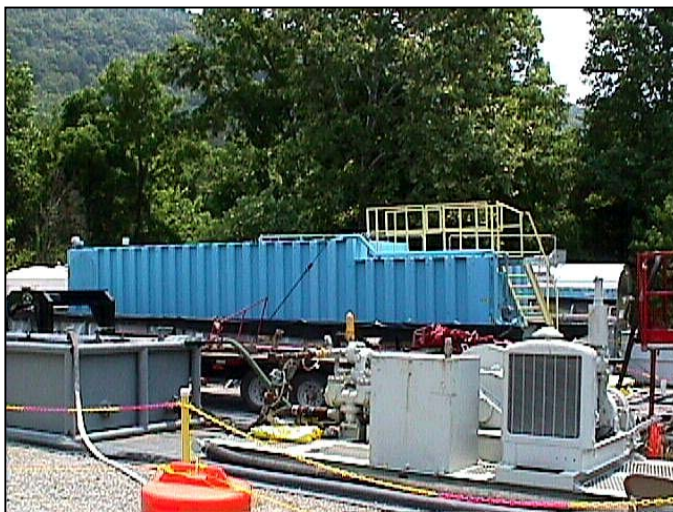
The storage tank, shown in Figure 3-1, was being used to hold wastewater from ongoing concrete drilling operations. A pre-job briefing was held on the morning of the event; however, the briefing addressed neither the need for handrail installation nor the fact that the work would be conducted at a height of approximately 10 feet. In addition, the third-tier subcontractor workers who would be performing the work did not attend this briefing.

Figure 3-1. The liquid storage tank

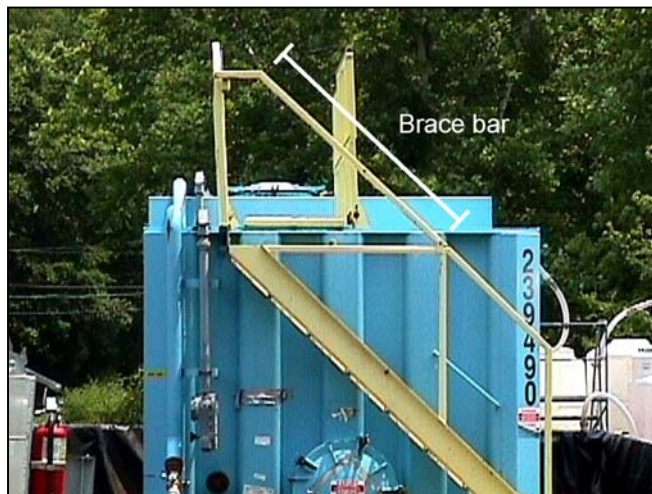
Several hours later, two workers began installing handrails on top of the tank. One of the workers took the brace bar (Figure 3-2), weighing approximately 25 pounds, and began to attach it to the upright, but not secured, handrail.

He was not wearing fall protection because there was a handrail at the right side of the working area. He held the brace bar in his left hand and attempted to support himself with his right hand on the unsecured handrail, which folded down. The worker lost his balance, stumbled down the steps, and fell about 3 feet to the gravel surface with the brace bar under his back.

The direct cause identified by the investigators was the failure of the pipefitters and workers to

use fall protection when working at an elevated position. The root cause was inadequate work planning, as no instruction or training was given for the handrail installation. Contributing causes included the failure of the subcontractor to participate in the pre-job briefing and inadequate communication between the contractor and the various levels of subcontractor workers

Figure 3-2. The worker was attempting to attach the brace bar to the handrail when he fell

The contractor identified and implemented a number of corrective actions. Facility management conducted a readiness review in which all workers took their positions on the job site, and each discussed his or her role as management performed a walkthrough. In this way, all workers verified that they understood both their own roles and that of the others on the job. In the long term, management will ensure that contracts that are developed for future work clearly specify lines of communication and the safety requirements that subcontractors must follow.
