# OPERATING EXPERIENCE SUMMARY

Office of Environment, Safety and Health  
OE Summary 2002-15  
July 29, 2002

# Operating Experience Summary 2002-15

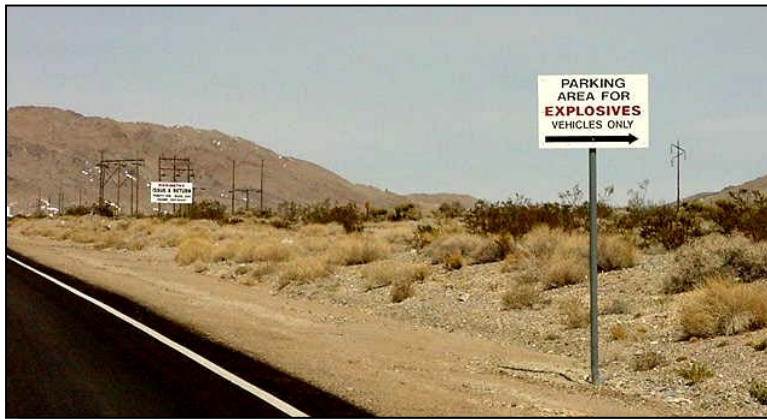
The employees, a project engineer and technical staffer, drove to an explosive material turnout area to escort a commercial motor carrier that transported the boxes of explosives. When they met the truck drivers, the project engineer learned that the cargo had changed carriers en route and that these truck drivers were not the ones who had been pre-processed by security to access the Nevada Test Site. In addition,

***Figure 1-1. The turnout area for vehicles carrying explosives***

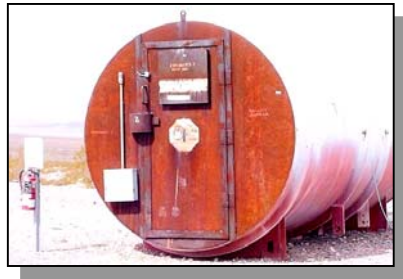
tion, the project engineer was concerned that the truck could not enter until after hours to unload the cargo because of a large media event occurring at the Site. In an attempt to prevent this delay, the two employees and the truck drivers left the explosive cargo at the turnout area, shown in Figure 1-1, and drove to the Site entrance where the technical staffer entered the commercial bill of lading and driver information into the Hazardous Materials Transportation Tracking System (HAZTRAK). When this was complete, they all returned to the explosives turnout area and transferred the explosives from the commercial carrier to a contractor company vehicle. The technical staffer then drove the explosives onto the Nevada Test Site and to an explosives magazine (bunker) (Figure 1-2) for storage.

*Figure 1-2. An explosives bunker*

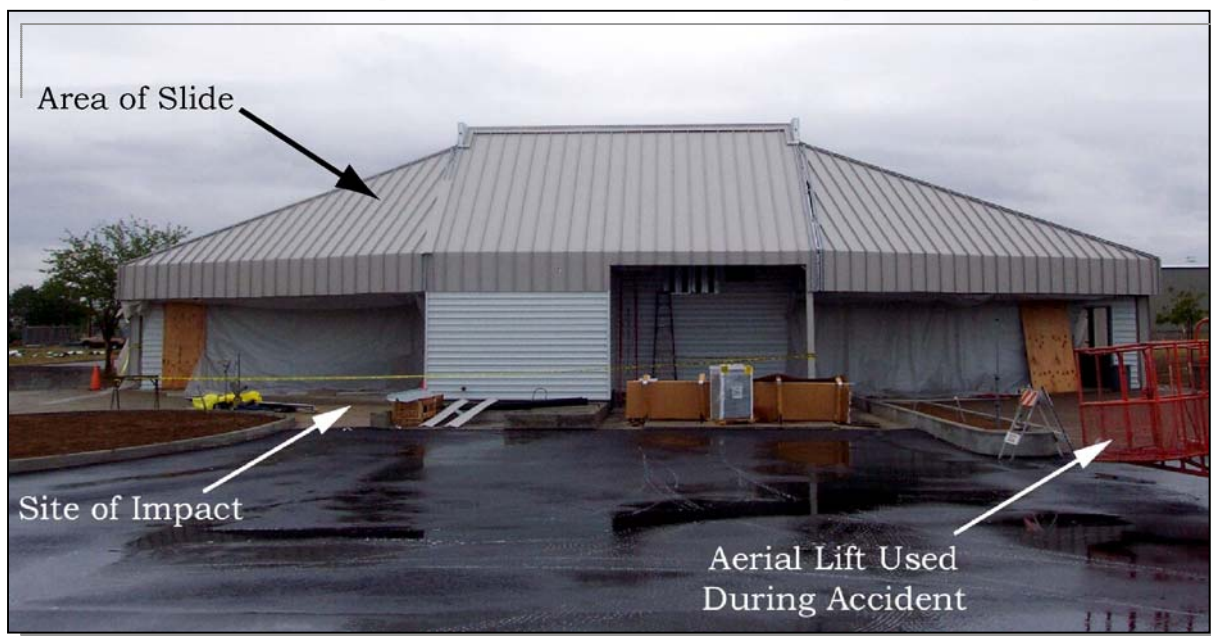
**Figure 2-1. Building 960 construction site**

The worker reached the work area using a boom lift. There was a light rain at the time, causing the roof, which had an approximately 40-degree pitch, to be very slippery. The worker was unable to perform the assigned task from the lift basket, so he opened the gate on the lift basket and exited the confines of the basket. He slid down the side of the roof, and upon reaching the

edge, fell feet first onto a concrete surface (see Figure 2-1). The worker did not put on the required fall-arrest equipment when he entered and operated the boom lift. The work area was at an elevation that required mandatory fall protection, according to OSHA regulations and the subcontractor's Safety and Health Plan.

The causal analysis for this occurrence cited personnel error as the root cause because the worker failed to use mandatory fall protection. The direct cause of the accident was also personnel error in that the worker decided to step out of the lift basket onto the wet sloping roof, resulting in his fall to the ground. On previous occasions, this work had been postponed until roof conditions were dry. The fact that the work proceeded under rainy conditions suggests that the subcontractor's enforcement of the project Safety and Health Plan was less than adequate. Thus, a contributing cause was inadequate administrative controls.

Corrective actions included reviewing the process for managing construction safety on subcontractor-directed projects and updating the ad-

ministrative procedure entitled *Construction Safety for Contracted Construction* to incorporate the results of these reviews.

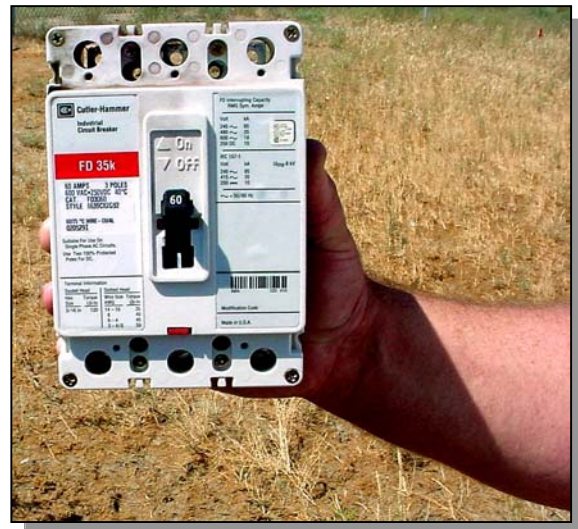
The accident occurred when the journeyman electrician was replacing a 20-amp breaker with a 60-amp breaker in the distribution panel. Figure 4-1 shows the replacement breaker that was to be installed. The electrician intended to minimize downtime to the facility by mounting the replacement breaker without de-energizing the panel. He then planned to isolate the panel with a lockout/tagout before attaching the breaker to the bus bar and load side connectors.

Figure 4-1. Replacement 60-amp breaker

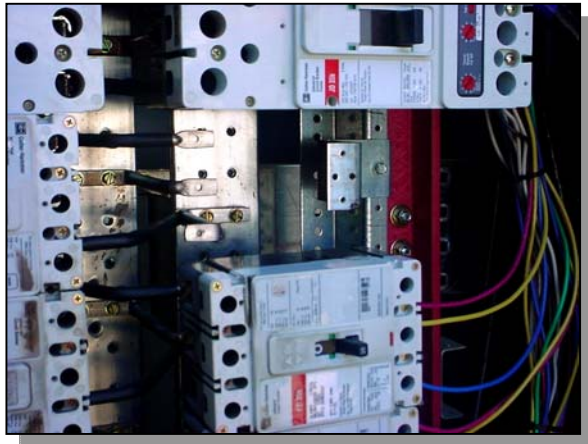
screws but without connecting to the bus bar or load side. As he attempted to screw in the lower mounting screw, his screwdriver made contact between the breaker C phase line-side lug and the mounting plate, which was grounded. The resulting arc flash caused him to jump back as he was burned. The arc continued down the bus bar and through the adjoining breakers, causing physical damage to the equipment. The main breaker tripped, causing a loss of power to the entire complex. Figure 4-2 shows some of the arc flash damage to the panel internals.

*Figure 4-2. Arc-blast damage to panel*

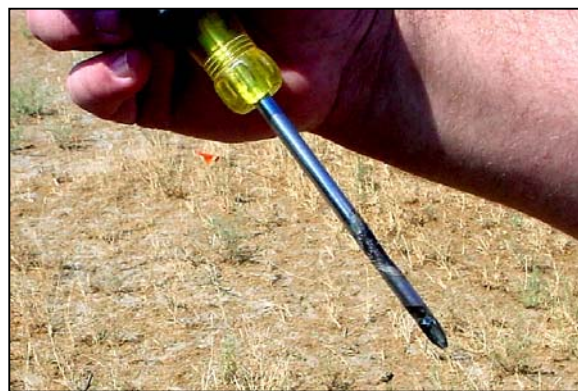
*Figure 4-3. Damaged screwdriver*

The injured electrician was wearing standard leather gloves, a hard hat, and tinted safety glasses. The screwdriver he used had a rubber handle, but was not insulated or voltage-rated for the job. Figure 4-3 shows burn marks on the shaft of the screwdriver. Proper PPE for this work would include a hard hat, a face shield, voltage-rated gloves, voltage-rated insulated tools, and a rubber mat for the worker to stand on.

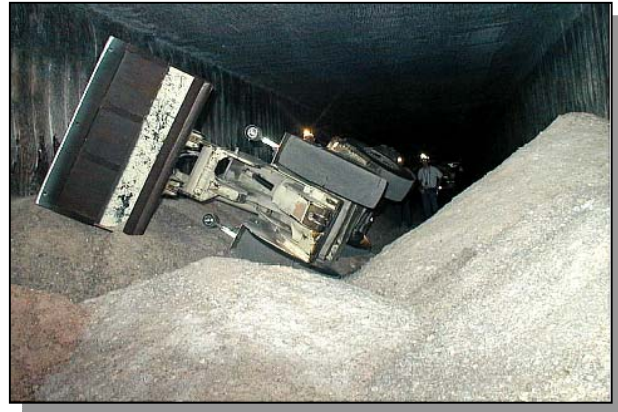
The operator filled the bucket with salt and drove the LHD between the two piles to reach the dumping area. The LHD was positioned on the two piles at an angle, with the left wheels sitting higher than the right wheels. As he raised the bucket to dump the load, the center of gravity shifted, and the LHD turned onto its right side and landed at a 45-degree angle on the salt pile at the right side of the drift (Figure 5-1).

*Figure 5-1. The overturned LHD*

The direct cause of this event was a personnel error. The operator, qualified to operate an LHD since August 2001, drove onto uneven, loose salt and raised the bucket, shifting the center of gravity. Although the operator has years of experience working in industrial and mining environments, he had not operated this type of equipment in a confined, unstable environment.

A contributing cause is inadequate training content. The LHD Equipment Operator Program Guide that accompanies the qualification card includes a section entitled *Equipment Safety*. The section fails to address operating an LHD on an unstable surface or machine stability when a loaded bucket is elevated. The manufacturer's operator manual states only that, while moving, operators should "Keep the bucket as low as possible."

Facility management has recommended a number of corrective actions. These include conducting a safety stand-down with all personnel working underground and other personnel using heavy equipment. The qualification guide for LHD and other underground equipment will be reviewed and revised to discuss all potential hazards that could arise during operation. This event will be reviewed with managers and supervisors overseeing underground operations to reinforce the need to review the work site before operations begin so that all potential hazards can be identified, and to communicate those hazards to the workers. In addition, the site plans to develop and maintain hazard analyses for each piece of equipment to assist operators in knowing beforehand the types of hazards they could encounter.
