OPERATING EXPERIENCE SUMMARY

U.S. Department of Energy
Office of Environment, Safety and Health
OE Summary 2002-17
August 26, 2002

Operating Experience Summary 2002-17

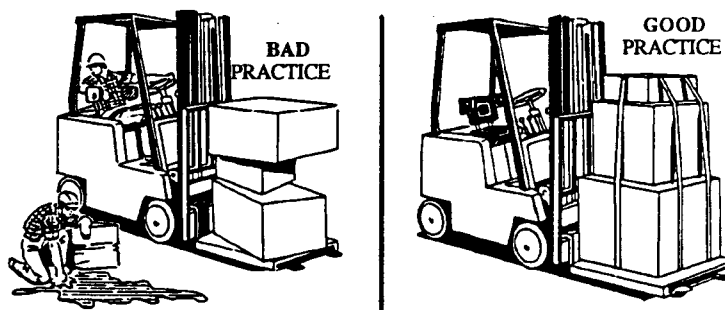
Figure 2-1. Bad and good practices for forklift operations

DOE Standard DOE-STD-1090-96 (URL <http://tis.eh.doe.gov/whs/bookshelf/std1090.pdf>), *Hoisting and Rigging*, Section 10.5.5, "Moving the Load," states that a designated person "...shall ensure that the load is well secured and properly balanced before it is lifted." Figure 2-1 illustrates this principle. The Occupational Safety and Health Standards, 29 CFR 1910, *General* (URL http://www.access.gpo.gov/nara/cfr/waisidx_01/29cfr1910a_01.html) and 29 CFR 1926, *Construction* (URL http://www.access.gpo.gov/nara/cfr/waisidx_01/29cfrv8_01.html) also provide guidance on securing objects on forklifts.

These events illustrate the importance of properly securing all forklift loads, no matter how small the loads or how briefly they will be transported.

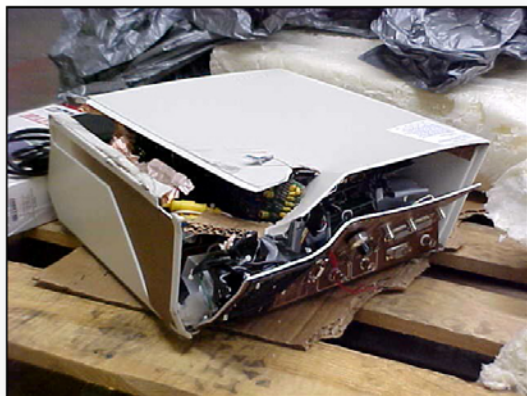
Figure 2-2. The damaged spectrometer

A similar event took place on July 24, 2002 at Idaho, where a warehouse delivery driver was transporting a gamma ray spectrometer that had been placed on top of a loaded pallet but not secured. When the load shifted the unsecured spectrometer fell onto the road where the forklift ran over it, damaging it beyond repair (Figure 2-2). No one was injured. (ORPS Report ID--BBWI-CFA-2002-0007)

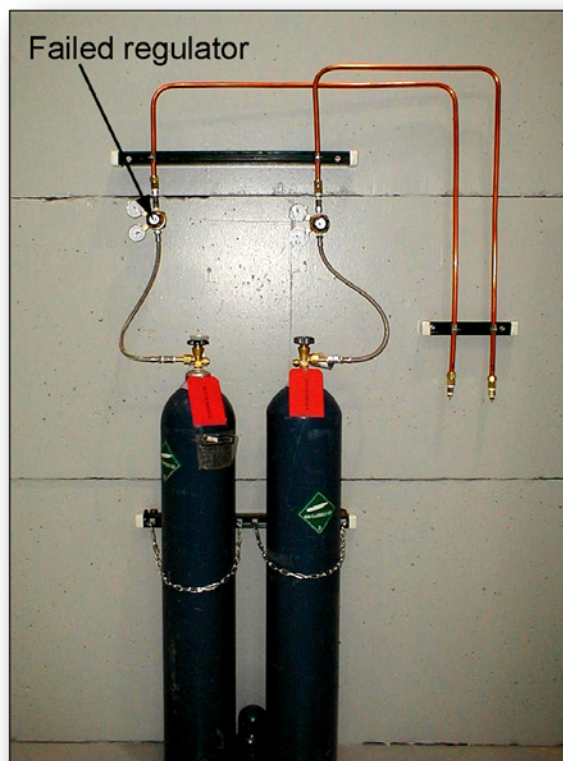
Figure 4-1. Configuration of gas cylinders

To support the operation of a radiation portal monitor, Facility Operations installed the cylinders, regulators, and manifold. After installation was completed, calibration technicians began connecting the P-10 gas system to calibrate the monitor. The system comprises two gas cylinders, as shown in Figure 4-1. Each cylinder has a pressure regulator that contains two gauges; a high-pressure gauge (0 – 3,000 pounds per square inch, gauge (psig)), and a low-pressure gauge (0 – 30 psig). When the isolation valve on the first cylinder was opened, the low-pressure gauge lens blew off. Following the event, technicians disconnected the cylinders

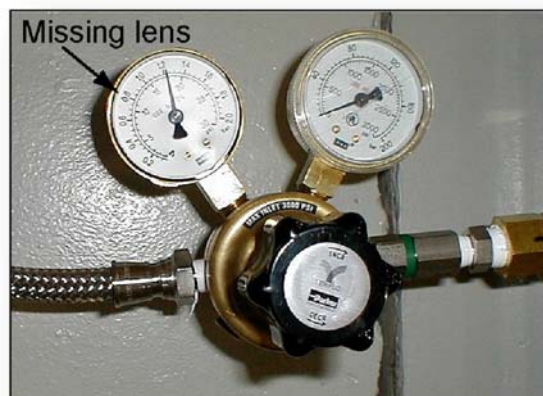
Figure 4-2. Damaged regulator
(picture rotated 90 degrees)

Figure 4-2 shows the damaged pressure regulator with the lens blown off the low-pressure gauge.

At the event critique, it was learned that the installer had incorrectly connected the low-pressure side of the regulator to the cylinders, thus exposing the low-pressure side to the full cylinder pressure of 2,000 psig. There were no injuries because the calibration technicians followed their training and positioned themselves away from the regulators in case of failure.

The installation was performed without a procedure or verification that the configuration was correct. However, even without a procedure there are ways to distinguish the low-pressure side of the regulator from the high-pressure side when connecting to it. First, the body of the regulator is stamped “LP” and “HP,” and second, the range on the pressure gauges and their orientation on the regulator indicate whether they are on the high-pressure or low-pressure side.

These occurrences underscore the importance of maintaining attention to detail when working with compressed gas cylinders and associated regulators and manifolds because of the potential for high-energy hazards. Compressed gas cylinders must be connected only to regulators and equipment designed for gas cylinders and the operating pressure. Personnel should always stand away from the face and back of the gauge and regulator when opening the cylinder valve and should always open the valve slowly.
