OPERATING EXPERIENCE SUMMARY

U.S. Department of Energy
Office of Environment, Safety and Health

OE Summary 2002-20

October 7, 2002

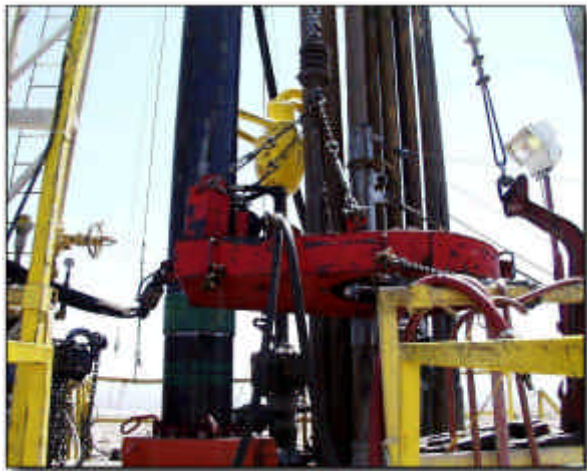
Figure 1-1. The tongs and casing

On July 29, 2002, at the Nevada Test Site, as workers were running 20-inch casing, a 3/8-inch wire cable holding power tongs (Figure 1-1) clamped to the casing parted, dropping a 25-pound counterweight about 21 feet. When the counterweight hit the tongs, both the cable and the counterweight fell to the drill rig floor, narrowly missing a power tong operator standing 2 to 3 feet away. (ORPS Report NVOO-BN-NTS-2002-0010; final report issued September 12, 2002)

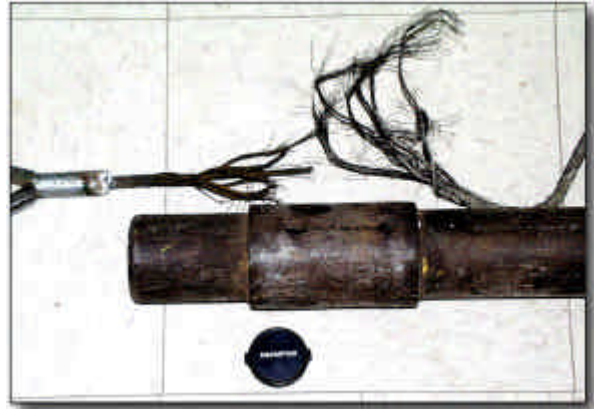
Figure 1-2. Broken cable and counterweight

In a critique the next day, investigators determined that the wire cable failed due to damage that had occurred over time. The cable, with the counterweight attached, had been in place for some time and was seldom used. Figure 1-2 shows the broken cable and the counterweight that fell.

The direct cause of this event was the failure of the cable. Although the cable was inspected before this lift, no one had checked the part of the cable that was hidden by the counterweight. Moisture buildup beneath the counterweight may have contributed to the cable's degraded condition.

Subcontractor supervisors and safety representatives attended a training session on inspecting wire cables and ropes. They will receive addi-

tional training on inspection, care, and maintenance of rigging equipment. Subcontractor management directed the use of counterweights that do not cover or obstruct the view of the wire rope cable.

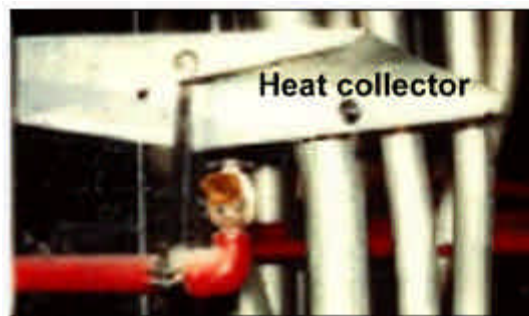
Figure 5-1. *An upright sprinkler with a heat collector*

On July 19, 2002, the Nuclear Regulatory Commission (NRC) issued an Information Notice, *Potential Problems with Heat Collectors on Fire Protection Sprinklers*, after NRC fire protection engineers and inspectors raised technical concerns regarding the ability of sprinklers that rely on metal plates (commonly referred to as heat collectors, shown in Figure 5-1) to activate. (NRC Information Notice 2002-24)

The Department of Energy has addressed this issue by inspecting facilities and removing heat collectors where discovered. For more information on DOE's response to this issue, please contact Dennis Kubicki at 301-903-4794.

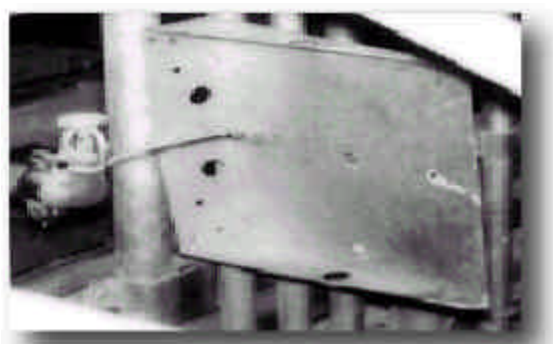
Figure 5-2. Heat collector obstructing sprinkler spray pattern

During plant walkdowns, NRC inspectors identified other heat collector concerns. One concern is the location of sprinklers with heat collectors below the primary combustible source (e.g., cables installed in cable trays). In this configuration, the sprinklers would not activate if a cable fire occurred. Other concerns relate to the configuration and orientation of heat collectors over sprinklers. Inspectors discovered some heat collectors tilted at an angle over the sprinklers or installed sideways. The technical concern is that tilted or vertical heat collectors over sprinklers could obstruct or deflect the spray pattern of the sprinklers (provided the sprinklers activate), preventing the sprinkler from effectively controlling the fire. Figure 5-2 shows how an improperly placed heat collector can obstruct the sprinkler spray pattern.
