OPERATING EXPERIENCE SUMMARY

U.S. Department of Energy
Office of Environment, Safety and Health

OE Summary 2002-21

October 21, 2002

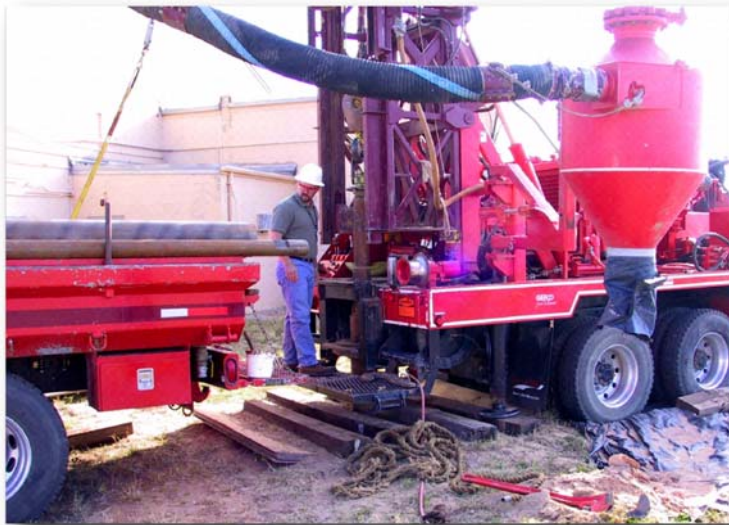
Figure 1-1. Truck-mounted drill rig

In the Pantex occurrence, workers were on the drilling platform of a truck-mounted drilling rig (Figure 1-1) attempting to disconnect two sec-

tions of the drill stem. They used a 60-inch pipe wrench as backup for a hydraulic wrench, with the rig applying the torque needed to break the connection between the sections. Figure 1-2 shows the 1.5-inch, metal pin they attempted to use as a stop for the pipe-wrench handle. The pin failed as they applied torque, and the wrench lurched forward, pinching the worker's right hand between

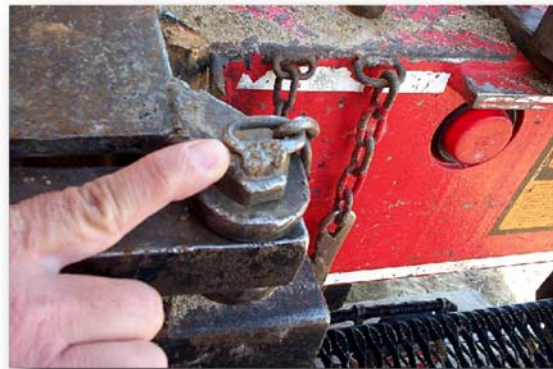
Figure 1-2. Failed 1.5-inch pin

Investigators determined that the direct cause of the accident was failure of the 1.5-inch pin stop. The pin, a modification to the drill rig, was not designed for use as a stop (i.e., to prevent movement of the pipe-wrench handle). Corrective actions included requiring disclosure of any modifications to heavy equipment used on site. These modifications must be approved before the equipment is used. Inspections will also be performed to identify any defects on the equipment and allow repairs to be made before work begins.

- Do not use equipment (such as the 1.5-inch pin stop on the Pantex drilling rig) for purposes for which it was not designed.

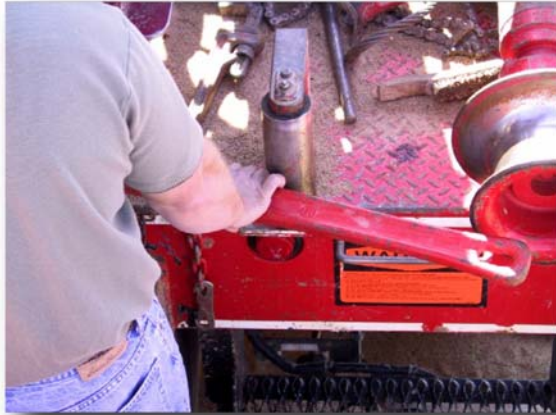
Figure 1-3. Pipe wrench pinch point

the wrench handle and a fixed steel roller (Figure 1-3). The worker sustained a compound fracture of his ring finger.

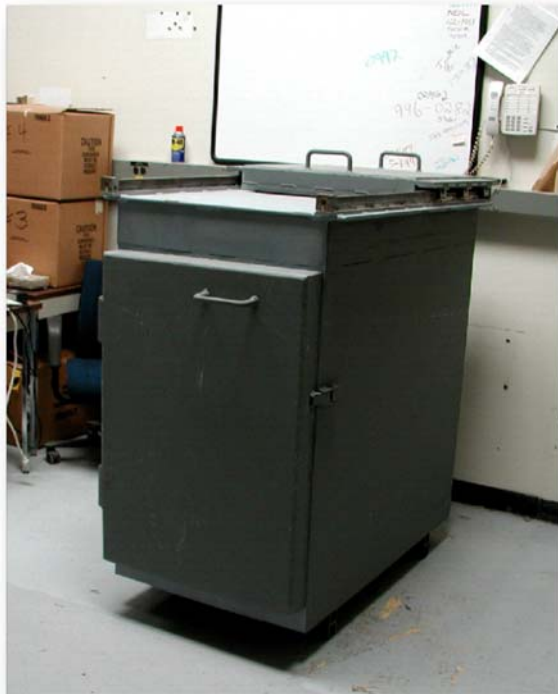
Figure 1-4. Steel cabinet with sliding top

In the LANL occurrence, workers were installing a custom-made 11,000-pound steel cabinet (shown in Figure 1-4) when an unfastened 700-pound sliding door located at the top of the cabinet moved unexpectedly. The door crushed the worker's fingers against the stop (Figure 1-5).

Although a pre-work Activity Hazards Analysis identified potential pinch points at the base of the cabinet, movement of the sliding door was not anticipated. The door did not have a latch or locking device to hold it in a closed position, but two struts had been installed to prevent movement of the door during transport. The struts were removed before the cabinet was in its final location, and the workers who installed the cabinet were not informed.

- Identify all potential pinch-point hazards (such as the sliding door on top of the LANL cabinet) in the Activity Hazards Analysis performed as part of the work planning process.
- Communicate information on pinch-point hazards to workers performing the work.
- Implement controls on pinch-point hazards to prevent worker injuries.

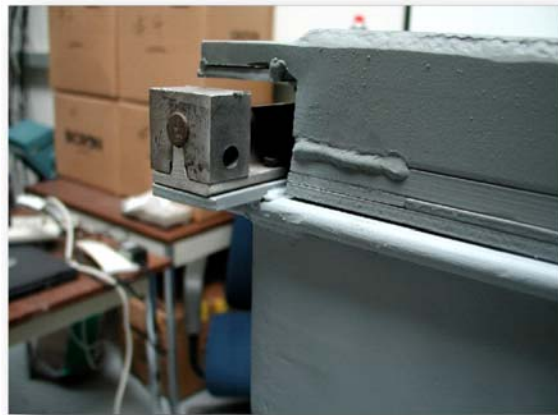
Figure 1-5. Cabinet pinch point

Two causal factors in this event were (1) the premature removal of the struts installed to restrain door movement during transport; and (2) the inattention to detail when the obvious pinch points at the base of the cabinet were identified in the work package, but the rolling door pinch points were not. The struts preventing door movement could have been reinstalled before final installation of the cabinet, but the workers doing the lifting did not know about the struts.

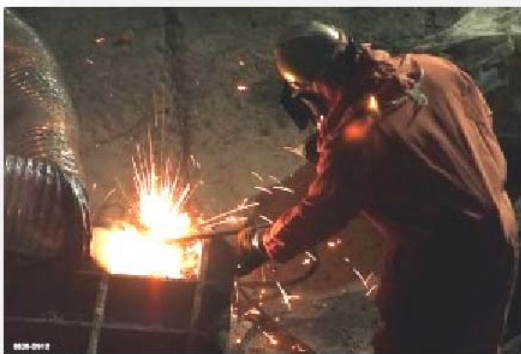
Figure 2-1. Torch cutting at Fernald

On February 7, three subcontractor workers were cutting the outer metal shells of denitration pots when hot slag fell to the floor and reacted with an unknown material thought to be uranyl nitrate. All three workers wore flame-resistant coveralls and full-face powered air-purifying respirators (PAPRs) with high-efficiency particulate air (HEPA) filter cartridges (which provide protection against particulate matter, not gases). The workers exhibited symptoms of NO₂ exposure: two of them began coughing and felt irritation in their eyes and throats. The contractor emergency duty officer categorized this event as loggable but non-reportable in the Occurrence Reporting and Processing System.

On March 12, another three-member work crew performed a similar torch-cutting operation like the one in Figure 2-1. This crew wore rear belt-mounted PAPRs and personal single-gas monitors calibrated for NO₂. While he was cutting metal shells, the torch cutter's personal single-gas monitor alarmed, and the entire work crew backed away. The alarm cleared almost immediately, and the workers resumed torch cutting. Later, the torch cutter had to re-route a secondary exhaust hose from one ventilation unit to another. While the worker was reaching into the exhaust hose to retrieve an alarming, in-line single-gas monitor that had fallen in, he did not hear his personal single-gas monitor begin to alarm. Industrial hygiene personnel later discovered that the worker received an exposure with an average concentration of 11.6 ppm per 1-minute interval, more than twice the OSHA limit of 5 ppm. None of the workers, however, reported symptoms of overexposure. (ORPS Report OH-FN-FFI-FEMP-2002-0012; final report issued April 19, 2002)

Corrective actions for the February event specified using fire blankets on the brick. Combination acid gas-organic vapor-HEPA cartridges were specified for PAPRs to provide some degree of protection against NO₂.

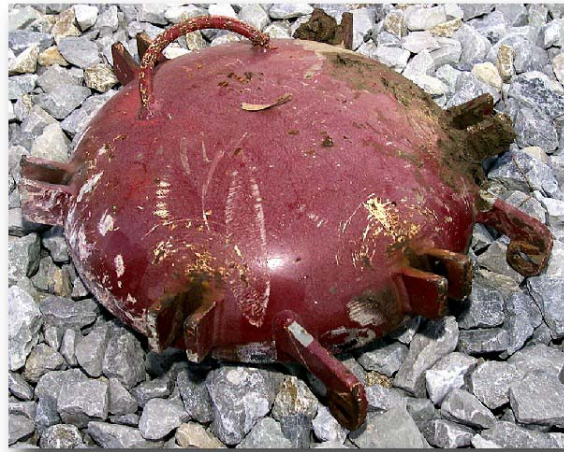
Figure 3-1. Lid to bulk sandblasting pot

On August 20, 2002, at the Fernald Environmental Management Project, a hinged access cover (lid) on a bulk sandblasting pot blew off and landed approximately 500 feet away. A painter was pressurizing the pot (tank) with compressed air when the studs holding down the 50-pound lid failed. No one was injured; however, the contractor reported this event as a near miss because of the potential for injury from the flying lid, hold-down studs, and sandblasting grit. (ORPS Report OH-FN-FFI-FEMP-2002-0034, final report issued October 16, 2002)

At the time of the incident, the painter had started the compressor and was opening the air supply valve to the blasting pot. About 1 minute later the cover blew off of the top of the pot with a loud explosion-like sound. When the 18-inch diameter lid (Figure 3-1) blew off, a large amount of grit from the tank blew approximately 50 feet into the air. The painter, who was wearing a hard hat, safety glasses, and ear protection, immediately secured the air compressor as grit rained down on him.

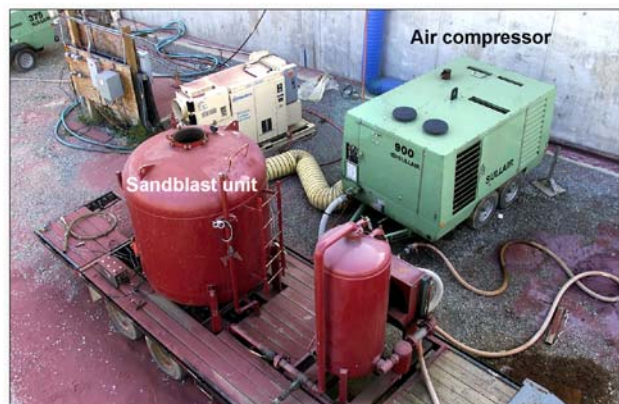
Figure 3-2. Sandblast unit next to air compressor

A painting subcontractor brought the sandblasting unit to the site in April 2002. As shown in Figure 3-2, the entire unit (a Key Houston, Ind., Model T8-L) is mounted on a flatbed trailer. The unit includes a chiller, moisture separator, 8-ton weight-capacity bulk blasting pot, and associated valves, pipes, and hoses. A 150 psig-rated air compressor provides the motive force for the blast grit. The contractor investigated

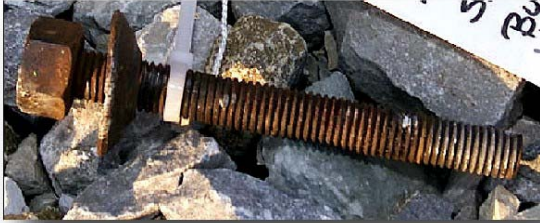
Figure 3-3. Hold-down stud with damaged threads on the right

the incident and determined that the direct cause was that the cover hold-down fasteners failed. The fasteners consisted of six sets of 5/8-inch diameter by 6-inch long threaded studs, 5/8-inch nuts, washers, and drilled and tapped steel blocks made from round stock. In all cases the failure was by pullout of the studs from the steel blocks.

The threads between the hex nuts and the upper end of each stud showed no visible damage. However, the external threads on the lower end of each stud and the internal threads of each steel block showed significant damage and wear. Figure 3-3 shows one of the recovered studs with a deformed washer and damaged threads that pulled free from one of the steel blocks attached to the pot opening.

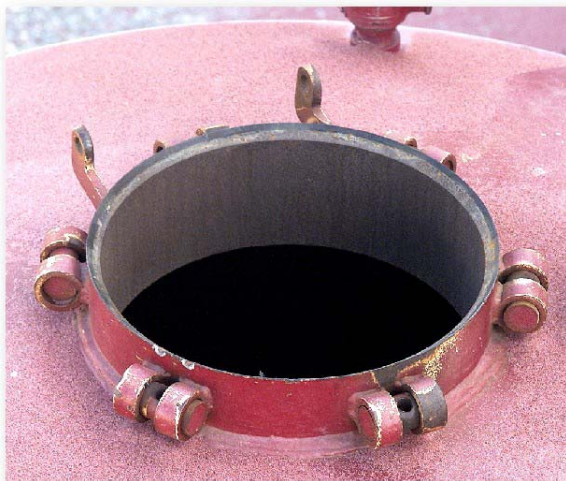
Figure 3-4. Pot opening and six threaded steel hold-down blocks

Because threaded fasteners are designed so the fastener will break before the engaged threads can shear, engineers concluded that the lid failed because of thread wear, especially in the steel blocks (Figures 3-4 and 3-5). The fasteners

failed before the safety relief valve installed on the pot was challenged.

These events illustrate the potential hazards associated with pressurized systems that have not been properly maintained or inspected in accordance with manufacturer's instructions. Pressure boundary closure devices that may require frequent operation, such as filling a sandblast pot, should be inspected for wear, corrosion, and indication of abuse (i.e., over torque). Inspections and testing of safety relief valves are required in 29 CFR 1910.169, *Air Receivers*.

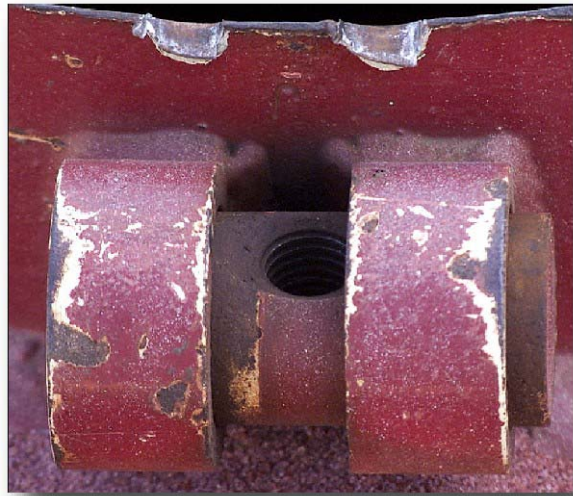
Figure 3-5. Steel block with damaged threads

Before the contractor allowed the sandblasting unit to be used at Fernald, project safety personnel performed a safety inspection. However, they did not consider checking for thread wear on the hold-down fasteners. To prevent recurrence of this type of event, the contractor will modify their pressure vessel safety program to ensure that vendor-owned pressure vessels are also properly inspected before and during use at Fernald.

erate on their site. A vendor may or may not have the same commitment to quality and safety as the contractor, and the contractor must realize that a serious problem with vendor-owned equipment could result in serious health and safety consequences for their employees. Therefore, all vendor-owned and operated equipment, especially pressure vessels, must be inspected for indications of wear, abuse, or unintended operations before the vendor is permitted to use the equipment on site.
