OPERATING EXPERIENCE SUMMARY

OE Summary 2002-23

November 18, 2002

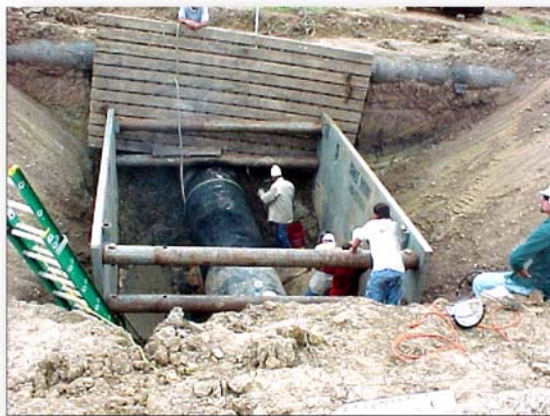
Figure 1-1. The original placement of the trench box in the excavation

The crew used a trackhoe lift bucket and a transportation-grade chain as a substitute chain sling, securing the box at two diagonal points to place it into the excavation. The excavation had two sloped sides, a stepped end, and a vertical end, as shown in Figure 1-1. The crew realized that the slope of the trench was greater than the 34 percent maximum for Type C soil as specified in [29 CFR 1926 Subpart P, Appendix B, "Sloping and Benching."](#) They also knew that the vertical end (shown with a wooden mat in the figure) needed to be stepped, so they removed the trench box and excavated more soil (Figure 1-2).

When the trackhoe operator tried to re-place the trench box, it caught on the stepped end, so he extended the trackhoe excavator arm to dislodge it. The additional force caused the box to drop off the bottom step suddenly. When the box shifted, the chain broke, dropping the trench box approximately 1 foot into the trench. No one was struck by the chain or falling trench box, but the worker in the trench lost his balance when the box dropped and he fell against it.

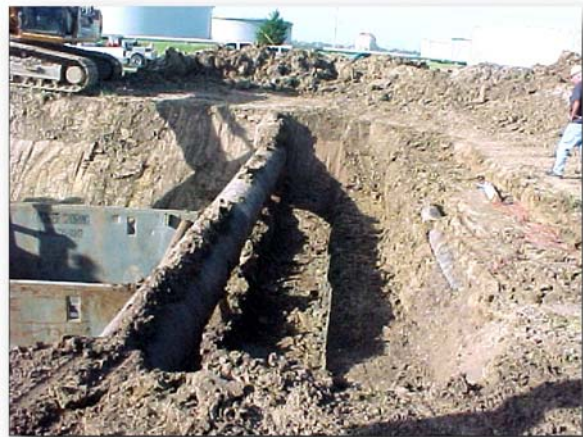
Figure 1-2. The excavation after the slope was corrected

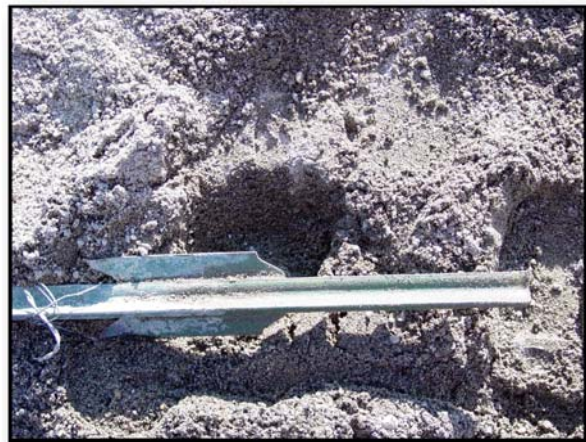
The first worker began to clear the backfill sand beneath the conduit with his hand and felt a mild shock, which he described as a "tingle." The workers immediately stopped work and informed the job supervisor. He locked-out and tagged the 480-volt conductor. The supervisor noticed that the breaker had not tripped and observed no evidence of electrical arcing between the conduit and the T-post fin. Figure 4-1 shows the T-post and attached fins.

Figure 4-1. T-post and attached fin

The following day, workers removed more sand from beneath the conduit to allow a visual inspection. They discovered that the conduit was damaged, and one phase of the three-phase line

was compromised. They also found two cuts in the conduit, each approximately 1 inch long. One of the cuts went through the 0.25-inch conduit wall.

The contractor's incident investigation report stated that the root cause of the occurrence was "performing work out of sequence." The workers should have removed the T-posts before the backfill sand was sufficiently deep to make removal difficult. A contributing cause was inattention to detail in failing to recognize that the fin could cut into the conduit and failing to prevent its contacting the conduit wall.

The contractor identified several corrective actions in the incident investigation report. These included (1) conducting meetings to inform all crafts personnel about the occurrence and the potential hazards related to the use of T-posts, (2) inspecting all site excavations to identify any similar conditions, (3) re-evaluating support devices for installation of utility lines to ensure that the devices will not inflict damage when being used or removed, and (4) ensuring that temporary supports are removed from newly installed utility lines before they are backfilled.

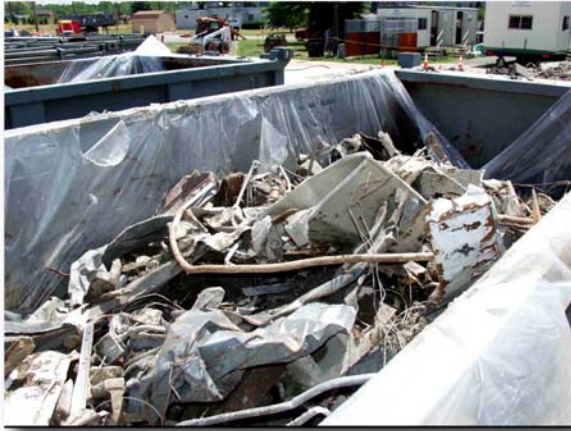
On October 25, 2002, at the RMI Decommissioning Project in Ashtabula, Ohio, immediately after workers had loaded and compacted steel sheeting into an intermodal (i.e., truck/rail) shipping container, a 1/8-inch by 8-inch, 25-pound angle iron was ejected from the container. The angle iron struck a corner of the window frame on the excavator, breaking but not penetrating the window, and thus missing the operator and a spotter assisting in the debris loading operation. This event constitutes a near miss to a serious injury. (ORPS Report OH-AB-RMI-RMIDP-2002-0006)

The workers were using the excavator to load the shipping container with demolition debris. After striking and breaking the excavator window, the angle iron fell to the ground approximately 8 feet outside the nearest wall of the shipping container. Figure 5-1 shows a similar container partially filled with debris. Figure 5-2 shows a similar Bobcat® excavator/debris loader

Figure 5-1. RMI intermodal shipping container

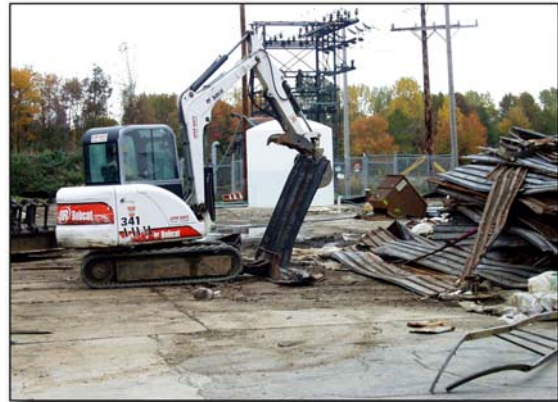
with a clamp attachment for grappling debris. The excavator operator was sitting in the cab approximately 1 foot from the window. It is likely that the flying angle iron would have struck the operator if the cab window had not protected him.

Figure 5-2. RMI excavator/debris loader

The ejection of material from a debris container during loading is a very rare occurrence, and hundreds of intermodal containers have been loaded with similar material at this site without a similar event. Nevertheless, several changes have been made to the debris container loading process to reduce the probability of a similar event in the future. These changes include:

- Providing the loading spotter with a higher set of steps and moving these steps as far away from the loader as practicable, while still allowing the spotter to perform the function of assisting the excavator operator.
- Placing relatively high-density metal pieces (like angle irons) only in the bottom half of the debris container.
- Loading relatively lightweight material (e.g., sheeting) in the top half of the container whenever possible.
- Refraining from sliding loaded items from side to side (or end to end) in the container using the excavator claw-hook or bucket.
- Placing only light pressure in a downward direction to compact the material in the container.
