# OPERATING EXPERIENCE SUMMARY

OE Summary 2002-24

December 4, 2002

# Operating Experience Summary 2002-24

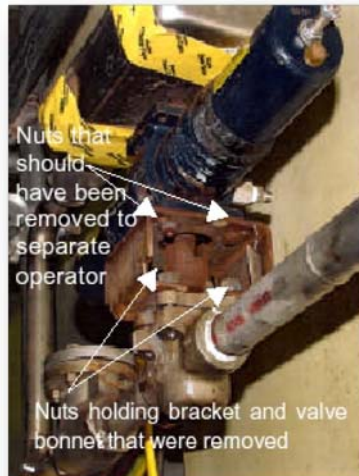
**Figure 1-1. The air-operated valve configuration**

One of the operators had removed actuators from air-operated valves before, and presumed that this valve was similar to the others he had disassembled: four fasteners (nuts) holding the bracket and additional fasteners holding the valve bonnet. Figure 1-1 illustrates the valve and bracket with the fasteners, and Figure 1-2 shows the valve assembly with the actuator removed. He removed four fasteners holding the bracket and valve body, anticipating that other fasteners secured the valve. Instead, the fasteners held the valve bonnet to the valve body as well, allowing nitric acid to leak from the bonnet-to-body joint. The operator quickly secured the valve, and he and the other four workers in the room evacuated. Plant firefighters responded to the scene, and the ventilation system was aligned to exhaust the fumes from the building. The spilled acid was cleaned up the same day and industrial hygiene personnel verified the atmosphere free of acid fumes.

The direct cause of this event was the operator's error in assuming that this valve assembly was configured like those he had disassembled previously. The root cause was inadequate work planning. No one had recognized the potential

for confusion as to which nuts should be removed; as a result, neither the work package nor the pre-job walkdown identified the nuts to be removed, or indicated that only one set of fasteners held both the bracket and valve bonnet. The work package failed to utilize lessons learned from a similar event at Rocky Flats, described below.

Facility management took a number of corrective actions. The engineering group evaluated a method for removing air-operated valve actuators without breaching the system. Walkdown training was given to foremen, operations, engineering and maintenance personnel, and job planners on using the proper disassembly method and verifying the valve configuration before work begins. All outstanding work packages and job hazard analyses have been reviewed and evaluated to ensure that the hazards are properly identified and the procedures are accurate and complete. A Lessons Learned Toolbox was distributed throughout the site, and the project manager held an all-hands meeting on the importance of invoking stop-work authority whenever a safety issue arises or if there is doubt about how to proceed.

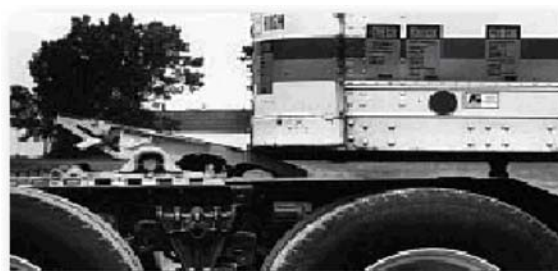
**Figure 2-1. Uncoupled tractor and trailer**

Figure 2-1 shows the fifth wheel of a tractor in position to couple with a trailer.

- Lubricant was not properly applied to the fifth-wheel mechanism.
- There was no procedure for inspecting the fifth wheel.
- Drivers failed to verify proper coupling.
- Manufacturers' recommendations for cold weather service were not followed.
- The latching tongue on the fifth wheel cracked while towing a trailer.
- The height between trailer and tractor was such that a high-hitch condition resulted.
- The safety latch pin was either not installed or vibrated out.

- Perform maintenance on all fifth wheels that stick, hang-up, or do not operate freely.
- Clean and degrease fifth-wheel mechanisms and apply new grease before cold weather.
- Use 90-weight oil in freezing temperatures for latching mechanisms rather than using grease.
- Ensure latching mechanisms operate freely.
- Perform a test tug on the trailer.
- Check the alignment of the tractor to the trailer as well as the surface of the ground. If the trailer is slightly higher or at an angle, the latching mechanism may not completely latch, which may not be revealed during a test tug.
- Ensure the fifth wheel makes contact with the trailer and raises it during latching.

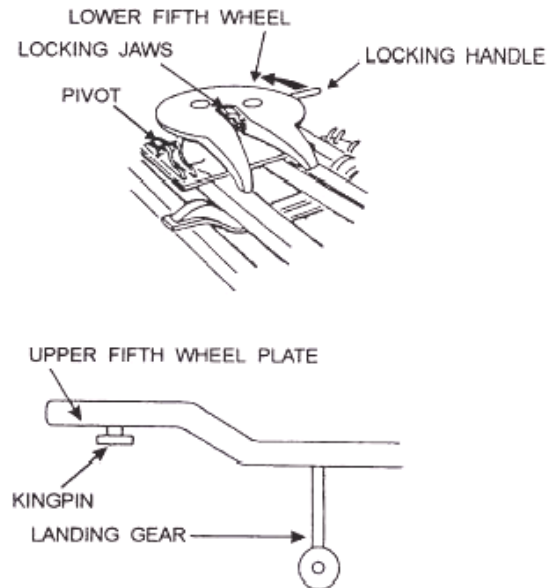
*Figure 2-2. Fifth-wheel arrangement*

A tractor and trailer are separate units joined together by a fifth wheel (Figure 2-2). The fifth wheel consists of two metal plates: one on the

tractor (lower fifth wheel) and one on the trailer (upper fifth wheel). The upper and lower fifth wheels form a flexible coupling that permits both rotational and vertical movement between the tractor and trailer. The upper fifth wheel consists of a flat plate and a kingpin. The lower fifth wheel has locking jaws that lock around the kingpin to couple the tractor-trailer together. Figure 2-3 shows a well-greased lower fifth-wheel plate.

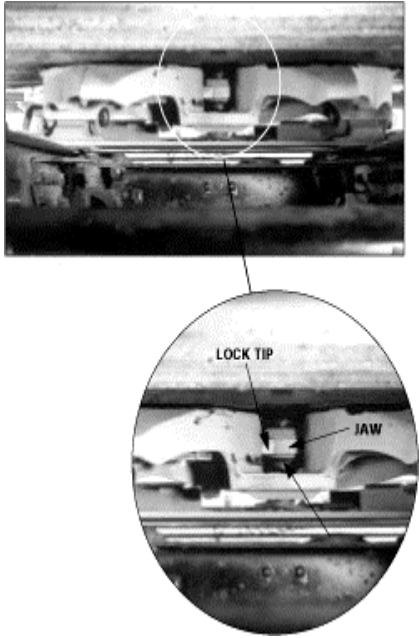
**Figure 2-4. No gap between upper and lower plates**

Commercial driver's manuals typically provide guidance and instructions for tractor trailer coupling and uncoupling, including coupling inspections and general vehicle walkaround inspections. These inspections should include a check to ensure that the trailer bed plate is resting on the top surface of the fifth-wheel plate with no visible gap or indication of high hitching (Figure 2-4).

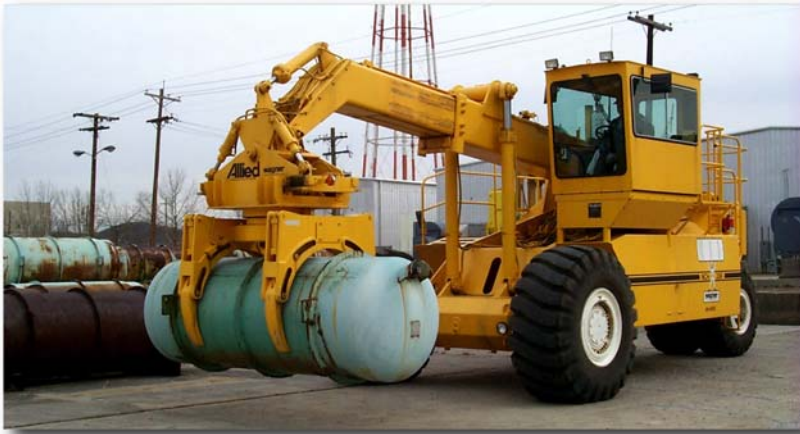
*Figure 3-1. Allied-Wagner cylinder handler*

The Model NCH-35, Allied-Wagner cylinder handler (Figure 3-1) is classified as a safety-significant component in the safety basis for the  $UF_6$  cylinder storage yards at ETTP. The handler was being used to transport a 10-ton depleted  $UF_6$  cylinder (Model 48, Serial #9209, gross weight 24,010 pounds at 0.2 percent assay). As the handler moved forward, the tines on one end of the cylinder opened unexpectedly, and the cylinder dropped. Workers lowered the supported end of the cylinder to the concrete, placed the cylinder in a secure position, and inspected it for damage. They moved the cylinder handler to the ETTP garage for additional inspections and tests.

Facility personnel critiqued the event, and partially reconstructed it using a concrete-filled cylinder. During event reconstruction, an interlock design feature failed in two of four trials, with the concrete cylinder dropping only when the operator intentionally actuated the lever to open the tines. An Allied-Wagner factory representative stated that, because of the interlock design feature, the arms should never release under

Investigators identified the direct cause of this occurrence as personnel error (inattention to detail). Tests indicated that the only way a cylinder

could be dropped was if the operator actuated the lever to open the tines. The root cause of the event was identified as a design problem. There was no designed fail-safe feature to preclude an operator from accidentally actuating the open lever while carrying a cylinder. An equipment/material problem was a possible contributing cause. The hydraulic cylinder packing may have reached its end of life and allowed the hydraulic pressure in the actuating mechanisms for the tines to decay.

- Install a proximity sensor to signal the presence of a cylinder in the tines and disable the operator's open/close actuating lever for the tines.
- Install a set of pilot-operated check valves designed to maintain the hydraulic pressure level in the tine-closing line when the open/close actuating lever is in the neutral position.
- Inspect and rebuild the hydraulic cylinder piston packing on the handling units as necessary to reduce the probability of hydraulic pressure decay in the tine closing lines.
