OPERATING EXPERIENCE SUMMARY

U.S. Department of Energy
Office of Environment, Safety and Health

OE Summary 2002-26

December 30, 2002

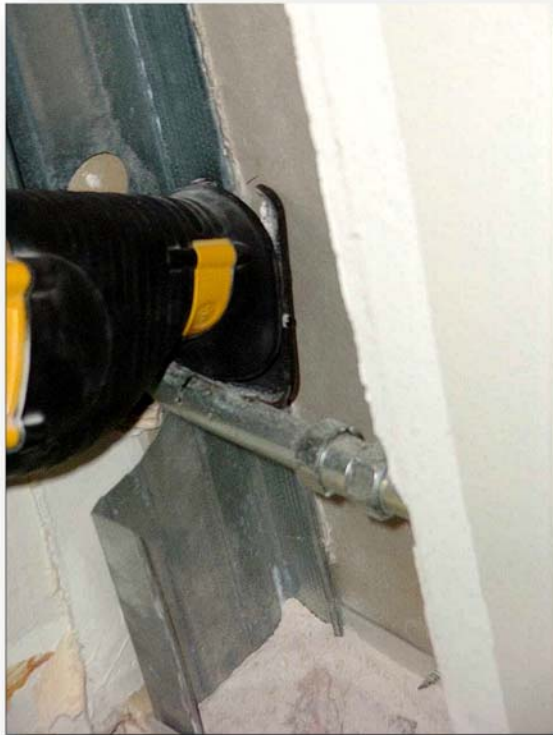
sheetrock could be moved. Earlier, the work crew removed a section of the wall to expose any electrical interference and discovered a ½-inch electrical conduit located near the floor. The worker rested the boot of the reciprocating saw on the conduit (Figure 2-1) and continued cutting. The saw blade apparently became caught in a metal stud, bound up, kicked back, and recoiled, cutting into the conduit (Figure 2-2) and a 110-volt conductor, resulting in a power outage to computers in another room.

Figure 2-1. The boot of the saw resting against the conduit

The subcontractor conducted a safety meeting and safety stand-down, including a mockup of the event. Investigators attributed the direct cause of this event to the worker's failure to use the proper tool to saw through the sheetrock in the vicinity of a known electrical interference. The worker should have used a handsaw to cut the sheetrock around the conduit.

The root cause was the lack of clear guidelines for subcontractor workers when working around a known electrical conductor. Subcontractor management prohibited the use of power tools within 12 inches of electrical wires or conduits.

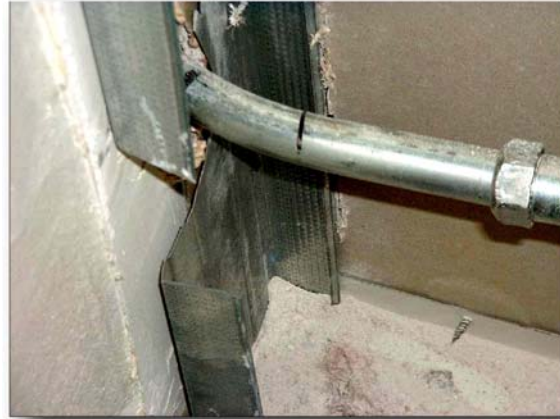
Figure 2-2. The cut conduit

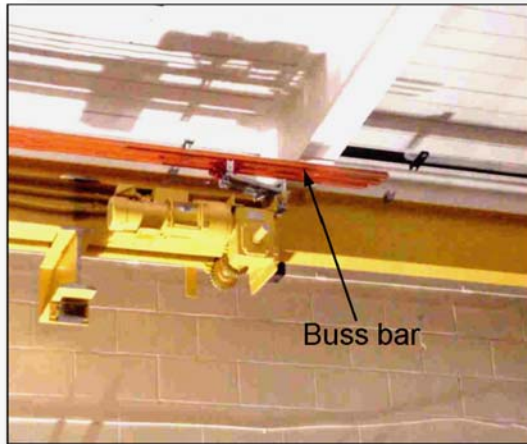
Three workers were removing the buss bar from an I-beam in an airborne radioactivity area. All three members of the work team wore anti-contamination clothing and full-face respirators. Figure 3-1 shows the I-beam with the partially removed buss bar.

Figure 3-1. I-beam showing partially removed buss bar

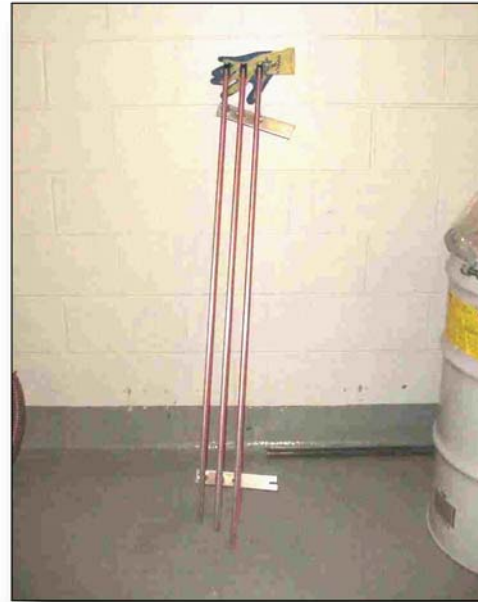
The section of buss bar (shown in Figure 3-2) that struck the worker was approximately 4 feet long, weighed between 7 and 10 pounds, and fell from a height of 18 feet. The injured worker was assigned to restricted duty status at the facility, but did not miss any work time as a result of his injuries.

Figure 3-2. Section of buss bar that fell

technique used to cut and remove the buss bar. The worker cut through two of the three channels in the buss bar (see Figure 3-2). He intended to cut part-way through the third channel, put down the cutting tool, bend the piece back and forth until it detached, then hand it down to another worker on the floor below. However, the cutting tool unexpectedly cut too far into the third channel. The buss bar section bent under its own unsupported weight, separated from the fixed portion, fell and struck the worker. Modifications to this technique will be implemented before the buss duct removal task is resumed.

Another change to be instituted as a result of the preliminary investigation is to withdraw the existing conditional control on overhead protection for workers based on a field decision by the task supervisor. This provision in the work package will be replaced by a requirement for all personnel in the room to wear hard hats, reflecting the change in work focus from glovebox removal to overhead work. Also, the area beneath any ongoing overhead work will be roped off and controlled as a restricted area.
