OPERATING EXPERIENCE SUMMARY

OE Summary 2003-01

January 13, 2003

Operating Experience Summary 2003-01

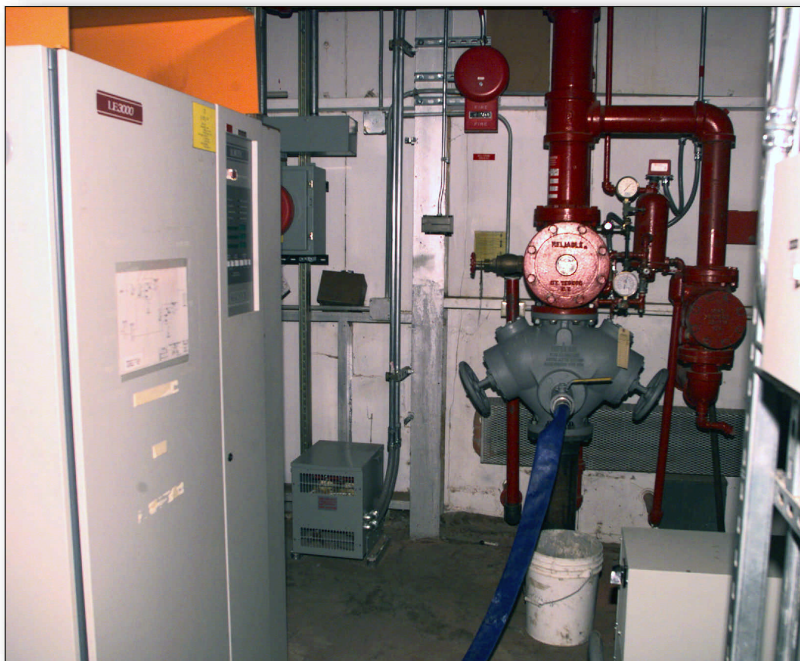
Figure 3-1. Equipment room arrangement

The subcontractor was flushing the strainer on a riser for a deluge system in accordance with Pantex testing requirements. Workers had set up to flush the strainer in an equipment room that housed an emergency UPS. A fire hose was connected to the strainer to direct flush water outside the building. One worker was inside the building to open a valve on the riser while another worker was outside to hold the fire hose over a wire screen to collect debris from the flush. Figure 3-1 shows the equipment room arrangement with hose (blue) connected to the strainer (gray) and the damaged UPS panel on the left.

The boom and flash were caused by water dripping from the ceiling onto a two-unit emergency UPS system. Electricians were able to restore power to the one of the units, but the other suffered internal water damage that required replacing several circuit boards.

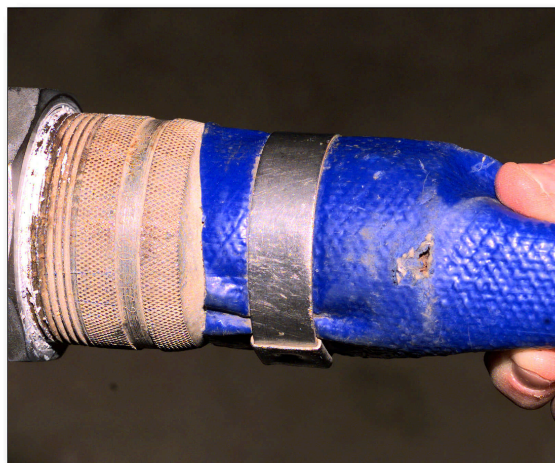
Figure 3-2. Defective fire hose

The direct cause of the event was the defective fire hose, which had developed a hole near the

nipple that connected to the riser (Figure 3-2). Pantex sent a letter to all contractor and subcontractor organizations informing them of their responsibility for identifying and removing defective equipment and explaining their liability for repair or replacement costs for any damaged equipment.

3. Subcontractor personnel and Pantex fire protection engineers failed to recognize the potential hazards posed by the leaking hose and take action to remove it from service, even though they had several opportunities to do so before this incident occurred. The subcontractor superintendent detected two pinholes in the hose on November 4 and used his hand to cover one pinhole while pressing his leg against the second pinhole to

control the water. On November 6, the fire protection engineer also detected a pinhole in the hose. Neither the subcontractor nor the fire protection engineer believed the holes presented a safety problem.

2. The design of the strainer system was inadequate because a construction change authorization issued to install the strainer system did not address how water would be discharged during a flush. Hard piping in lieu of a fire hose was not considered. To preclude recurrence, the subcontractor hard-piped the discharge from the strainer to the fire riser main drain.

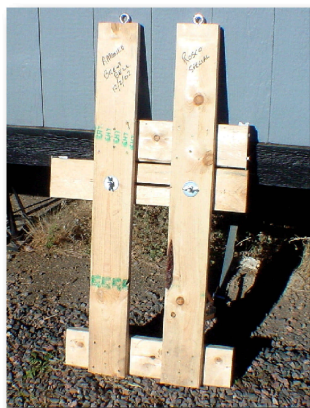
Figure 4-1. Field-designed lifting fixture

slings and shackles connecting the hoist to the adjustable wooden lifting fixture. The workers had used the lifting fixture (shown in Figure 4-1) the previous day and had already successfully removed about 25 plates from the lower rows. Figure 4-2 shows the wall with lower plates removed (empty mounting studs) and upper plates still attached to the mounting studs.

Immediately before this event, the bottom plate retaining bracket on the lifting fixture had been engaged with the bottom edge of the plate. Workers removed the nuts on the mounting studs holding the plate to the wall and freed the plate from the mounting stud. They were uprighting the plate to install a clamp on the

top edge for added stability when it shifted and came loose from the bottom retaining bracket.

Investigators identified several causal factors. Contrary to established procedures, neither the appropriate manager nor his designee approved the rigging plan. Supervisors and operators did not stop work and evaluate the situation when two plates partially slipped out of the lifting fixture earlier in the day. The field-designed lifting fixture did not comply with Occupational Safety and Health Administration (OSHA) regulation 29 CFR 1926.251, *Rigging Equipment for Material Handling*, section (a)(4), which specifies that "Special custom design grabs, hooks, clamps, or other lifting accessories, for such units as modular panels, prefabricated structures and similar materials, shall be marked to indicate the safe working loads and shall be proof-tested prior to use to 125 percent of their rated load." The lifting fixture was not marked to indicate a safe working load, nor had it been proof-tested before use.

- Stop all facility work and conduct a safety stand-down.
- Conduct refresher training on stop-work authority during the project safety stand-down.
- Conduct refresher training on scaffolding erection, inspection, and use requirements.
- Conduct a review of the plate removal operation and obtain appropriately designed and tested equipment.
- Develop and implement a project policy requiring peer review of all design and testing activities related to special hoisting and rigging equipment.
- Conduct a comprehensive review of the plate removal operation and implement appropriate changes to the hazards analysis and associated work documents.

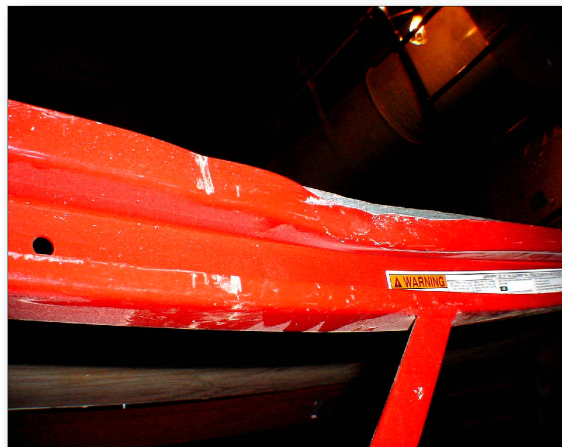
Figure 4-3. Scaffold damage

fixture, and fell to the floor. The worker held onto the scaffold when the steel plate hit it and, after the scaffold stabilized against the adjacent equipment, climbed onto the equipment and subsequently descended a portable ladder. Figure 4-3 shows some of the damage to the scaffold.

In addition, the documented hazards analysis for the work was not specific enough for the complexity of the lifting operation being performed. After the fact-finding meeting, investigators determined that the scaffolding did not meet OSHA regulation 29 CFR 1926.451(c), *Criteria for Supported Scaffolds*, which requires that the scaffold be restrained from tipping by

use of guying, tying, bracing, or equivalent means when the height to base width ratio exceeds 4 to 1. The ratio for this scaffolding exceeded 4 to 1, but no restraint was provided.
