OPERATING EXPERIENCE SUMMARY

U.S. Department of Energy
Office of Environment, Safety and Health

OE Summary 2003-02

January 27, 2003

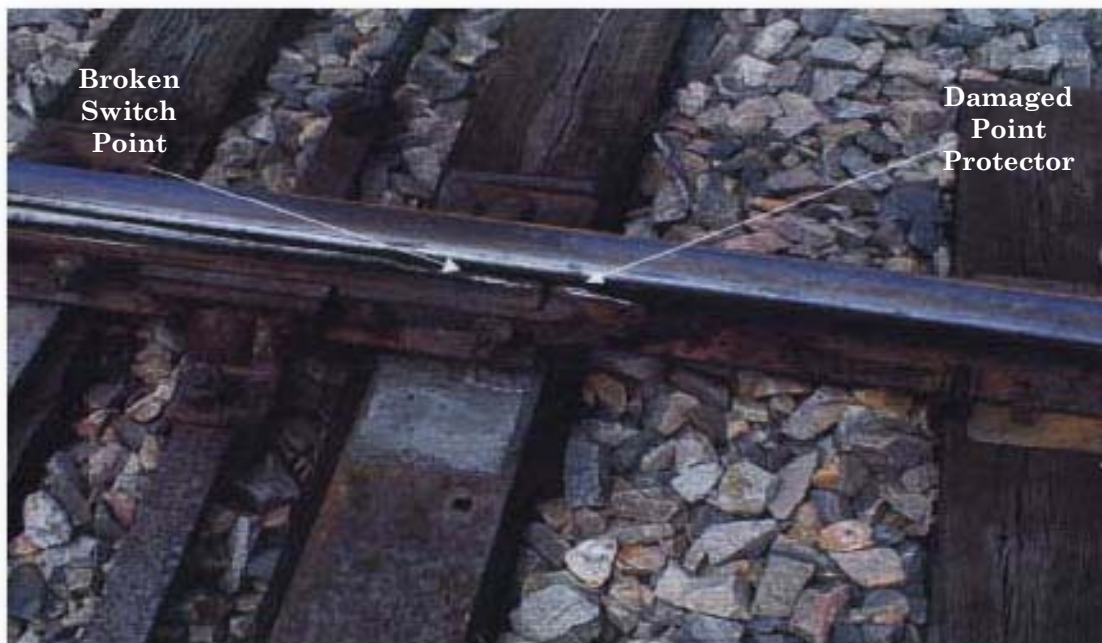
Figure 1-1. Broken Switch Point and Point Protector

Investigators found a broken switch point (Figure 1-1). However, they concluded that the direct cause of the derailment was indeterminate because of a combination of conditions they discovered, including a possible misalignment of the switch point, worn train wheels, and a cracked switch-point protector. Investigators attributed the root cause of this event to a less than adequate railroad inspection program. They also de-

termined that the overall age and condition of the site rail system was a contributing cause. The Savannah River Site rail system is approximately 50 years old and continues to wear because a funding shortfall for rail system maintenance has existed for several years.

As a result of the investigation, rail inspectors checked all switch rail points using magnetic particle nondestructive evaluation. They declared 27 of 207 points as suspect and removed them from service. The following corrective actions will be implemented to prevent recurrence of this type of accident.

- Review the effectiveness of inspection programs for railcars and rail turnouts.
- Evaluate the effectiveness of training for personnel who perform rail car inspections and rail turnout inspections.
- Evaluate departmental instructions or procedures for railcar inspections and for rail turnout inspections.
- Evaluate the effectiveness of current rail lubrication preventive maintenance practices.
- DOE Savannah River will review the adequacy of current maintenance funding for the Savannah River Site rail system.

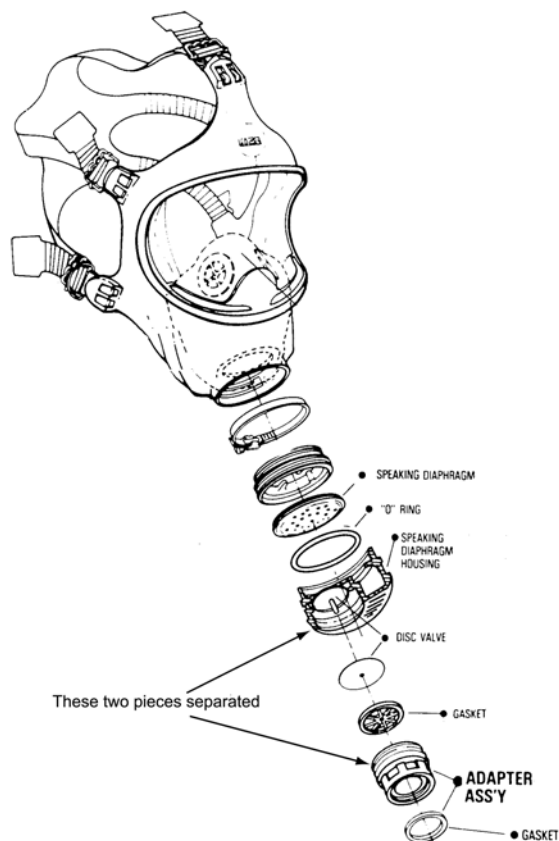
Figure 2-1. Respirator speaking diaphragm and adapter assembly

An evaluation of the event indicated that the facepiece separated from the speaker diaphragm. Investigators postulated that the worker held the adapter assembly, shown here in Figure 2-1, too close to the speaker diaphragm during assembly, which prevented him from properly connecting the two pieces. Corrective actions are still under development at this time.
