# OPERATING EXPERIENCE SUMMARY

**OE Summary 2003-03**

**February 10, 2003**

# Operating Experience Summary 2003-03

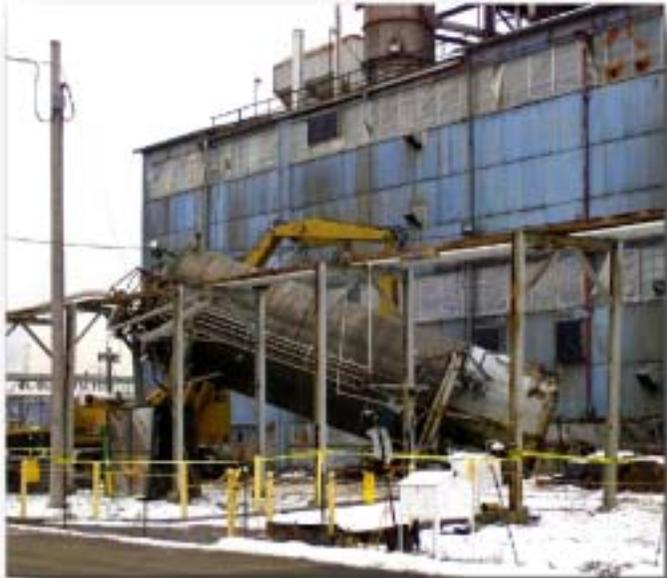
On December 10, 2002, at the Fernald Environmental Management Project, a 14-ton stainless steel tank fell onto an energized 480-volt electrical line and an elevated steam pipe bridge during demolition work. The tank damaged the electrical line, causing a circuit breaker trip that resulted in loss of power to a building and two trailers. A 150-psig steam line ruptured, dislodging a small amount of asbestos insulation. The tank also struck and damaged several abandoned steam lines on the pipe bridge. No one was injured in this event, but it was categorized as a near miss because of the potential for serious injury. (ORPS Report OH-FN-FFI-FEMP-2002-0041)

A subcontractor excavator operator was using a hydraulic shear mounted on the excavator boom to pull down the tank. He grasped the 39-foot-high, 12-foot-diameter tank with the shears and began to back up the excavator to pull the tank down. However, the tank began to lean in a different direction, pulling the boom with it, and rotating the excavator cab. The operator was unable to halt the motion of the tank because of its weight, so it continued to slowly fall until it struck the pipe bridge. The operator saw sparks and immediately released the bite on the tank while it was leaning against the pipe bridge (Figure 1-1).

*Figure 1-1. Tank leaning against pipe bridge*

- The equipment operator violated safety warnings provided by the manufacturer of the excavator/shear equipment (and posted

- Work planners failed to evaluate hazards (e.g., the pipe bridge within the fall-radius of the tank).
- Work planners failed to determine the weight of the tank and the load capacity of the excavator/shear equipment.

- Evaluate and document the operation of shearing equipment.
- Develop formal work control, management, and functional roles responsibilities, as well as accountability documents and procedures.
- Develop a detailed, proceduralized work control process.
- Evaluate the use of heavy equipment to ensure that it is operated in accordance with the appropriate operation and safety manuals.

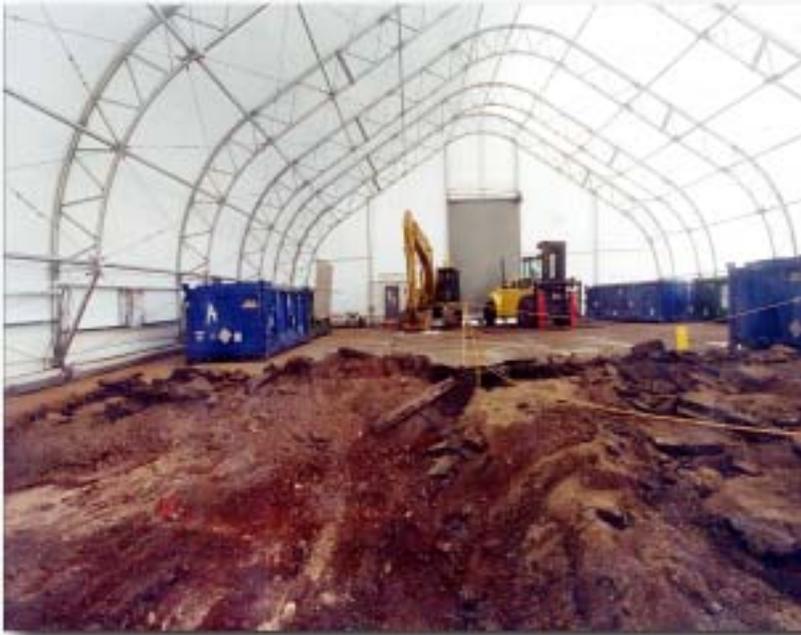
On January 9, 2003, at the Rocky Flats Environmental Technology Site, an operator working in a remediation tent was maneuvering a forklift loaded with an empty intermodal container and nearly struck a waste technician. A health and safety specialist saw the forklift and pushed the technician out of its path. (ORPS Report RFO--KHLL-ENVOPS-2003-0001)

Figure 2-1 shows the remediation tent after it had been mostly cleared out. Intermodal waste containers can be seen in the background.

**Figure 2-1. Empty remediation tent**

The waste technician, who was decontaminating a filled intermodal container, had his back to the forklift operator. Because the tent was crowded with about 14 people and various types of equipment, it was difficult for the forklift operator to maneuver safely.

Project management held a fact-finding meeting to determine the cause and identify corrective actions. Waste management personnel will clean the intermodal containers before they are moved into the tent, thus reducing the number of activities within the tight confines of the tent. The job hazard analysis was modified to require establishing a clear path before heavy equipment operators move loads in or out of the tent. In areas where space and visibility are limited, an alternate spotter will be assigned to assist in maneuvering. Project management discussed the event with the entire crew to demonstrate the lessons learned.

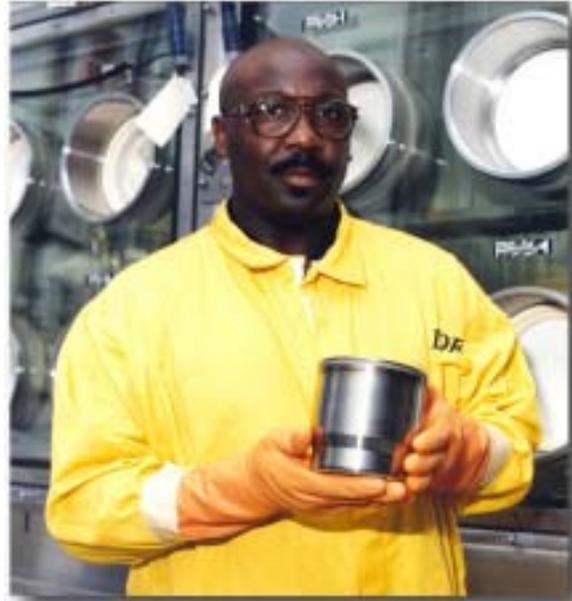
On January 20, 2003, at the Savannah River Site, facility personnel welding a plug on a bagless transfer can (Figure 3-1) missed a step in the procedure, and the weld failed. The operators were using the "reader-worker" method of relaying procedure steps, but the operator designated as the worker did not complete one of the steps. (ORPS Report SRS--WSRC-FBLINE-2003-0001)

The first step in the welding process is to turn the helium backfill valve to the vent position. The operator functioning as the reader instructed his co-operator to turn the valve to the correct position, but the second operator apparently failed to do so, and instead skipped to the next step. When the operators had completed the welding process, system indicators displayed two error messages advising that the weld had failed.

An evaluation of the event revealed that both workers were well experienced in performing the welding operation, and had successfully performed this operation many times before. Investigators attributed the failure to position the valve correctly to inattention on the part of the operator performing the worker role. They also determined that the workers had difficulty communicating because they were wearing respirators.

**Figure 3-1. Bagless transfer can**

Management counseled the personnel involved in the event and distributed an internal lessons-learned transmittal throughout the site. Team leads will assign roles for each operator and operator-in-training during pre-job briefings. They will advise operators to encourage observers hold questions until after a task has been completed, unless they are raising a safety concern, to avoid distractions.

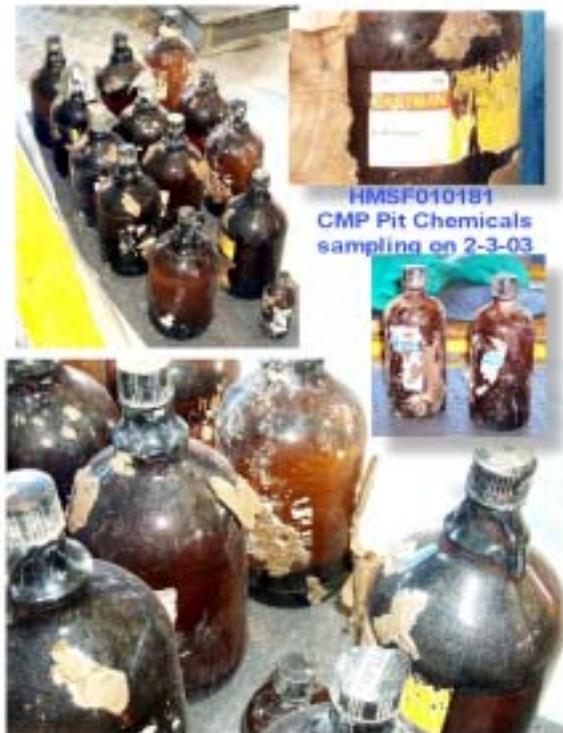
Workers were sampling drums of legacy waste bottles that had been shipped to the hazardous waste facility in 1985. Several bottles bore p-Dioxane labels in poor condition (Figure 4-1). However, the waste characterization form did

**Figure 4-1. Bottles of p-Dioxane**

not indicate that the drums contained p-Dioxane. When workers found the bottles labeled p-Dioxane, they stopped work. The contents of the bottles appeared to have crystallized.

An investigation revealed that a portion of the material inside the bottles was probably ice, as p-Dioxane freezes at 53° F (11.7° C). However, because the bottles had been in storage for such a long time, further evaluation will be needed to determine if peroxides have formed, and a hazardous waste vendor will test and stabilize the contents of the bottles.
