OPERATING EXPERIENCE SUMMARY

U.S. Department of Energy
Office of Environment, Safety and Health
OE Summary 2003-04
February 24, 2003

Operating Experience Summary 2003-04

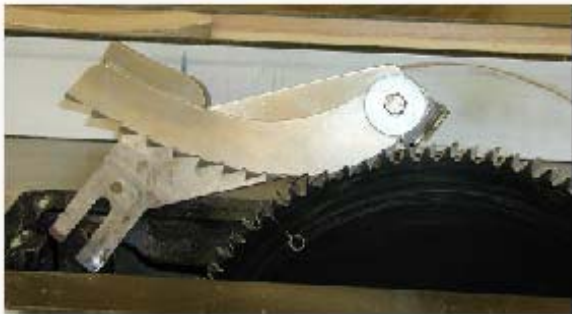
Figure 1-1. Anti-kickback guard not mounted

The carpenter had just finished ripping a piece of lumber on the saw. As he was removing it from the table, the board inadvertently contacted the anti-kickback splitter fingers (guard), knocking the guard off its mounting and into the saw blade, which was turning at 6,000 rpm. Three teeth broke off the saw blade and struck the carpenter in the neck.

Figure 1-1 shows the anti-kickback guard off its mounting, and Figure 1-2 shows the guard in the correct position.

Investigators determined that the table saw had a slight vibration that could have loosened the wing nut securing the anti-kickback to the mounting channel. When the nut came loose, the guard slipped from the channel and hit the rotating saw blade. Investigators learned that workers in the carpenter shop had substituted wing nuts for regular nuts when securing the anti-kickback guard to the mounting channel. After the event, a through-pin (Figure 1-3) was installed on the mounting channel and a hole was drilled (Figure 1-4) into the pin's mounting bracket to ensure that the guard remains in place.

- Install a through-pin near the kickback nut on all table saws to firmly secure the anti-kickback guard.
- Use regular nuts instead of wing nuts to secure the anti-kickback guard to the table saw. (A regular nut tightened using a wrench can be locked down with a higher torque than a wing nut using fingers.)
- Inspect the equipment before each use to ensure it is safe to operate.
- Check the anti-kickback guard to ensure it is not loose, cracked, or misaligned before turning on the table saw.
- Check saw blades for missing teeth that can cause vibration and replace damaged blades before using the saw.
- Shut down the table saw immediately and notify a supervisor if anything unusual is perceived.
- Schedule daily checklist inspections of all stationary shop equipment.
- Develop a routine maintenance schedule for all equipment to check for loose, worn, or misaligned parts.

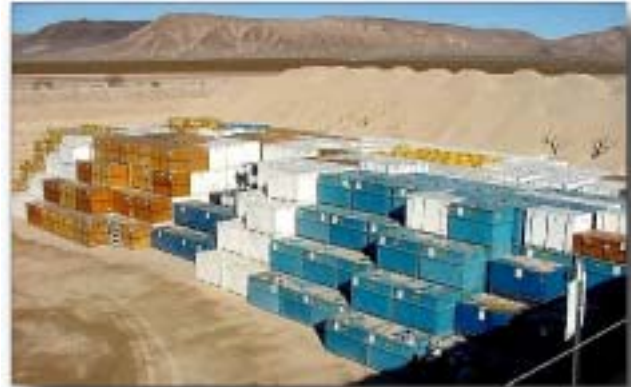
Figure 4-1. Waste boxes at the RWMC

from the bottom tier of stacked waste containers. A nearby fire chief assisted the foreman at the scene of the accident, and paramedics transported him to an offsite hospital for treatment. (ORPS Report NVOO-BN-NTS-2003-0001) Figure 4-1 shows a representative configuration of the boxes at the Radioactive Waste Management Complex (RWMC).

The procedure at the RWMC permitted the waste handling crew to stack low-level waste containers and drums up to four tiers high in a stair-step arrangement across the floor of the disposal cell, with a minimum of 4 feet of clearance between the top of the highest tier and the natural grade. Containers and drums were stacked four tiers high, and each tier was between 2 and 4 feet in height. To accurately place the fourth tier of containers, a forklift and spotter were required. When assisting a forklift operator, a spotter normally used a ladder to climb up onto waste containers.

The foreman was spotting for a forklift operator at the time of the event. Because of staged containers positioned near the access point, he was unable to use a ladder to climb up onto the waste containers. As the foreman stepped down from the bottom tier of waste containers, he lost his footing and fell between stacks of containers with his right leg at an angle. The impact broke both bones in his lower right leg. Another ironworker in the area stopped work and contacted emergency responders. The injured foreman's leg was surgically repaired that day.

Facility management conducted a safety stand-down to discuss the accident. Initial corrective actions developed in response to this event include reducing the maximum height of the stacked containers from 16 feet to about 6 feet to eliminate the need for climbing on packages. Facility managers are also considering relocating low-level waste containers to another area and stacking them only one tier high.
