OPERATING EXPERIENCE SUMMARY

**U.S. Department of Energy
Office of Environment, Safety and Health**

OE Summary 2003-05

March 10, 2003

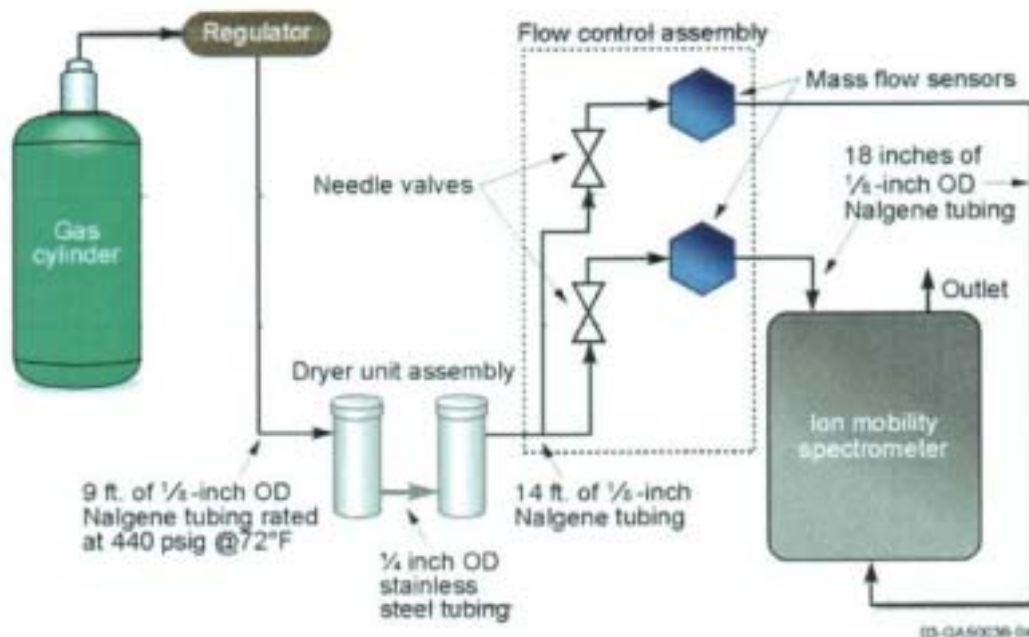
Figure 1-1. Ion spectrometer gas supply diagram

encounter any problems. He used a compressed nitrogen cylinder, pressure regulator, and filter canister arrangement in the carrier gas supply system. Figure 1-1 shows the system flow path beginning at the nitrogen cylinder, through the pressure regulator to the two canisters (dryers), to flow control devices, and to the exhaust. Maximum design pressure for the canisters was 90 psig. The pressure regulator on the nitrogen cylinder had an outlet pressure gauge with a range of 0 to 250 psi.

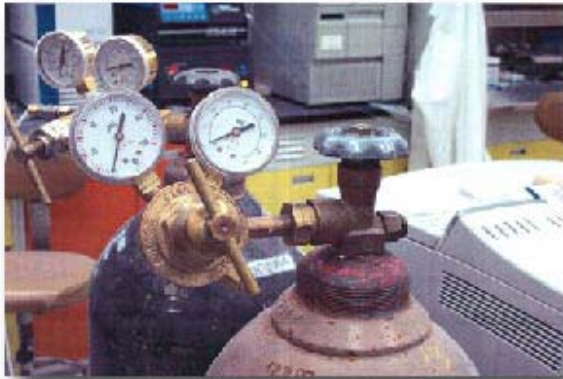
Figure 1-2. Compressed air cylinder with regulator

When the researcher opened the isolation valve to the compressed air cylinder, there was no indication of gas pressure on the regulator supply pressure gauge. Another lab worker came over to inspect the test hookup and tried to determine why the pressure regulator gauge was reading zero. He saw the gauge indicate pressure, heard a “whistling” noise, and suddenly the plastic canisters ruptured, spreading airborne debris around the room. Figure 1-2 shows the top of the compressed air cylinder after the incident, with the regulator still in place.

Investigators determined that the direct cause of this incident was personnel error (inattention to detail). The significant and sudden overpressurization of the plastic canisters that comprised the laboratory gas dryer system was possible because the researcher used a pressure regulator capable of delivering gas flow rates at pressures up to 2,500 psig, considerably in excess of the 90 psig maximum design pressure for the plastic canisters.

- Upgrade the current contractor requirements, policies, and procedures to adequately implement requirements for the safe assembly of compressed gas systems and the safe use of compressed gases.
- Upgrade the current contractor training programs to provide the appropriate level of knowledge for the safe assembly and use of compressed gas systems.
- Upgrade the current contractor inspection program to include critical elements of compressed gas safety, with emphasis on the safe assembly and use of compressed gas systems.

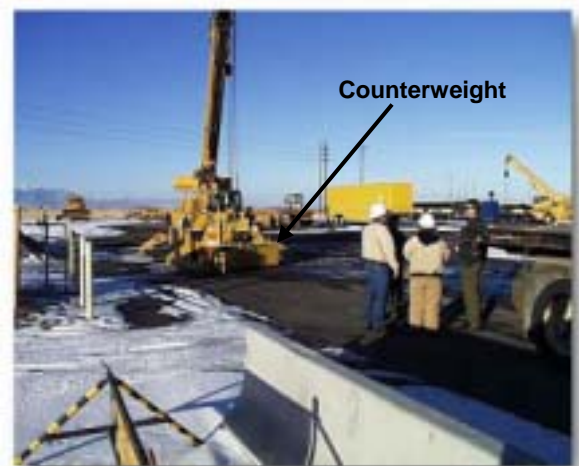
Figure 2-1. Crane and fallen counterweight

counterweight. When the second operator turned a corner, driving at about 4 miles per hour, the 9-ton weight slid off the truck bed and fell to the ground. The equipment operator immediately stopped the truck and called for assistance. A crane was brought to the scene to put the counterweight back on the truck. Equipment operators secured both counterweights before driving the truck to its destination and unloading them. Figure 2-1 shows the crane preparing to lift the fallen counterweight; Figure 2-2 shows the second counterweight after it was secured to the truck bed.

The equipment operators' failure to secure the counterweights before moving the truck was the direct cause of this incident. Contributing causes included inadequate job planning and work control; failure to recognize the need to secure the loads; failure to follow standards and procedures for securing and transporting loads; ambient icy conditions; and operator complacency.

- Review the incident and lessons learned at tailgate (job-site) training sessions with

equipment operators and their supervisors. Discuss the requirements for loading, securing, and hauling cargo safely as identified in site management control procedures, program requirement documents, and the Idaho Commercial Drivers License Manual.

- Conduct an adequacy review of the ratio of managers to workers in the Central Facility Area and reallocate resources as needed to ensure all work is adequately supervised.
- Issue a directive on the proper methods for loading and securing cargo. Develop a tailgate training program for equipment operators and other crafts targeted in the directive. Schedule and conduct tailgate training to the target audiences.
- Schedule management reviews in July and September 2003 to evaluate worker compliance with site requirements for loading and securing cargo. Based upon the evaluation results, determine the need for similar reviews in 2004.

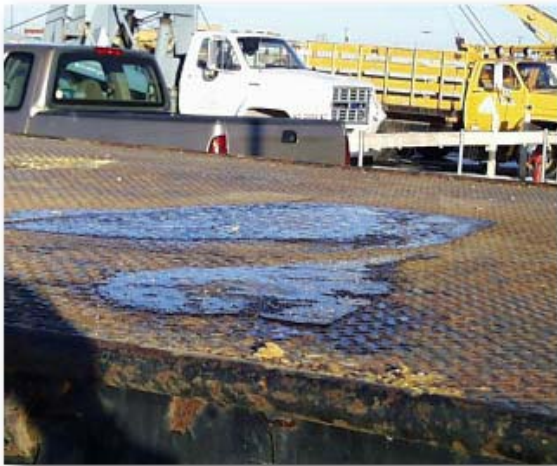
Figure 2-3. Ice on bed of truck where the counterweight had rested

counterweights were not secured, but decided that the weight of the loads would prevent any movement during transport. However, the operator did not know that the 9-ton weight was resting on ice (Figure 2-3) that had formed on the bed of the truck after the weights were loaded 2 weeks earlier. The ice contributed to the counterweight falling off the truck.

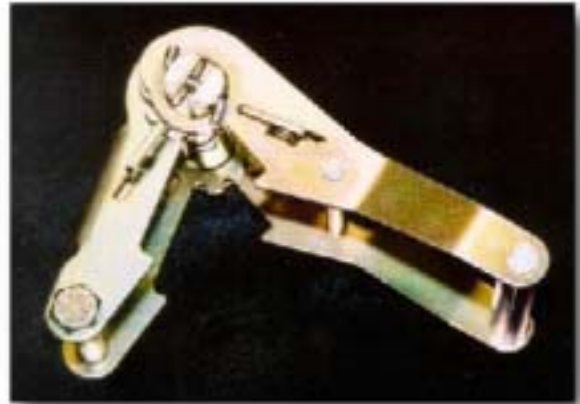
Figure 3-1. Ratchet mechanism for tie-down strap

Six high-integrity containers at the WVDP were being prepared for shipment to the Nevada Test Site by a transport vendor when a QA inspector identified the suspect bolt on one of the ratchet lever tie-down straps. The QA inspector confiscated the bolt from the ratchet mechanism (Figure 3-1).

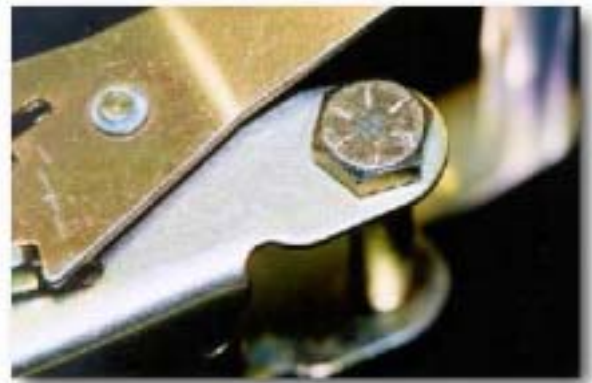
Figure 3-2. Bolt head showing markings

The markings on the bolt head corresponded to the imported grade 8 fasteners identified in a Stanford Linear Accelerator Center (SLAC) ES&H bulletin on counterfeit parts (www.slac.stanford.edu/esh/bulletins/b09c.html). The bolt head carried the six marks of a grade 8 bolt, but did not have a manufacturer's mark (Figure 3-2). The Fastener Qual-

ity Act (www.nist.gov/fqa) requires fasteners to bear an insignia that identifies the manufacturer and indicates that the manufacturer's insignia has been recorded.

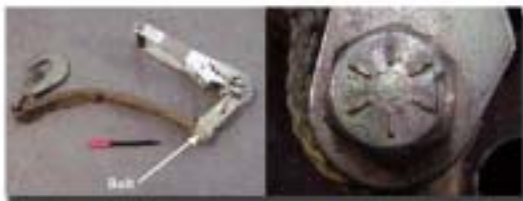
Figure 3-4. Ratchet tie-down strap and suspect/counterfeit bolt

Issue 2002-03 of the Operating Experience Summary reported a similar success story. A QA representative at Argonne National Laboratory – West found ratchet-type tie-down straps that had suspect/counterfeit bolts (Figure 3-4). The inspection leading to this discovery was performed in response to information in an ORPS report filed by Brookhaven National Laboratory (BNL) on this very problem.

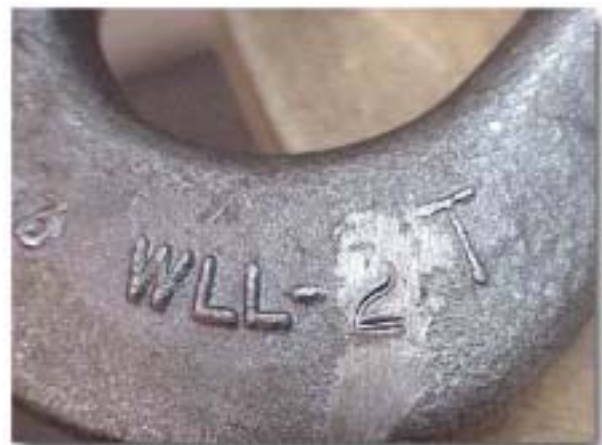
Figure 3-5. Tampering on a swaged lifting sling hook

Suspect/counterfeit items have been a problem for both government and industry and have been a concern across the DOE complex since the early 1980s. Suspect/counterfeit items are not limited to bolts and fasteners. From January 2001 through January 2003, 168 occurrences involved the discovery of suspect/counterfeit items, including electrical circuit breakers, explosion-proof motors, pipe fittings, and hoisting and rigging components. For example, during a receipt inspection of a swaged hook attached to a lifting sling, inspectors discovered that the raised casting mark for the working load limit had been ground off and stamped to indicate a 2-ton limit (Figure 3-5).

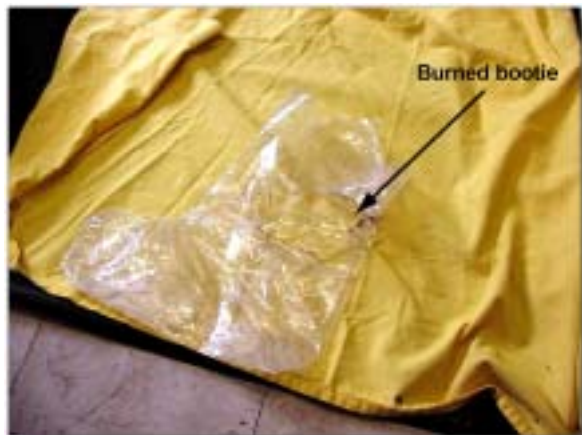
Figure 4-1. Worker's PPE and bootie

Figure 4-1 shows the worker's PPE and bootie where it was scorched. Melted plastic from the bootie dripped onto the worker's jeans. Figure 4-2 shows the scorched PPE, and Figure 4-3 shows the burned rubber shoe cover.

- Fire-resistant PPE should be required for any projects involving grinding and abrasive disc cutting.
- Hydraulic cutters instead of abrasive cutting equipment should be used when size-reducing rebar to prevent sparking.
- The contractor's welding, burning, and hot work procedure should be revised to include the requirement in the 1999 version of NFPA 51B standard that flame-resistant PPE must be used in all grinding or abrading activities.
- A welding, burning, and hot work permit should be obtained for all welding, heat-treating, grinding, abrasive cutting, pipe thawing, powder-driven fasteners, hot-riveting, and any other activities producing sparks, flames, or heat.
