OPERATING EXPERIENCE SUMMARY

U.S. Department of Energy
Office of Environment, Safety and Health

OE Summary 2003-06

March 24, 2003

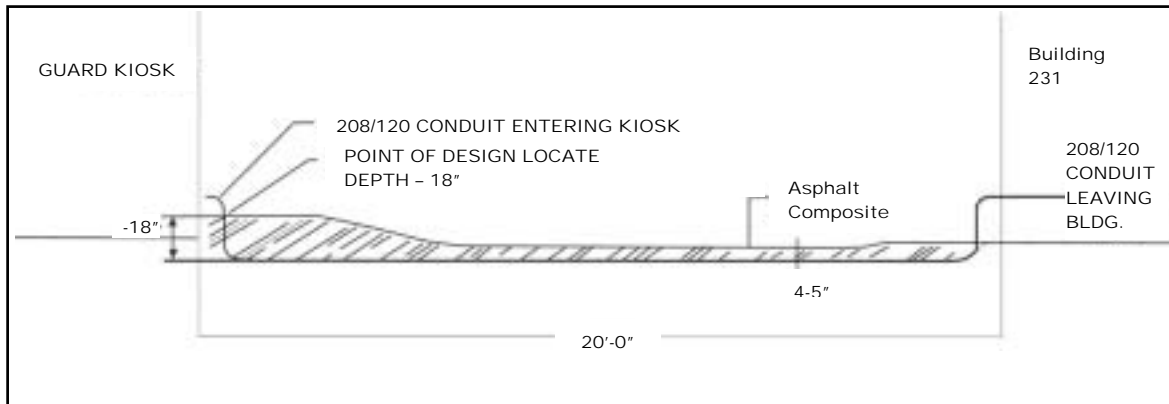
Figure 1-1. Diagram of buried electrical conduit

On January 7, 2003, at the Lawrence Livermore National Laboratory (LLNL), laborers partially severed an electrical conduit containing a 208/120-volt power line while cutting asphalt with a power saw. A circuit breaker tripped, causing power outages in two buildings. The laborers assumed that conduit was buried at least 18 inches deep, when in fact it

The run of conduit beneath the asphalt was approximately 20 feet, as shown in Figure 1-1. Manufacturer specifications for the locating equipment used to survey the area stated that "span distances less than 50 feet may not produce accurate depths on buried utilities."

Investigators determined that one of the causal factors for this incident was that the conduit was probably installed nearly 50 years ago. At that time, the current LLNL practice of burying utilities 18 to 24 inches deep was not in effect, so the conduit was much closer to the surface.

was only 4 inches below the surface. No injuries or significant property damage resulted from this event. (ORPS Report OAK-LLNL-LLNL-2003-0001)

- Use ground-penetrating radar to locate buried conduit in cases where the length of conduit is less than 50 feet.
- Re-emphasize the need to install a lock-out/tagout of any energy sources located within an excavation area.
- Reinforce the need to use appropriate personal protective equipment when performing excavation or penetration activities near potentially energized conduit to reduce the risk of injury to workers.

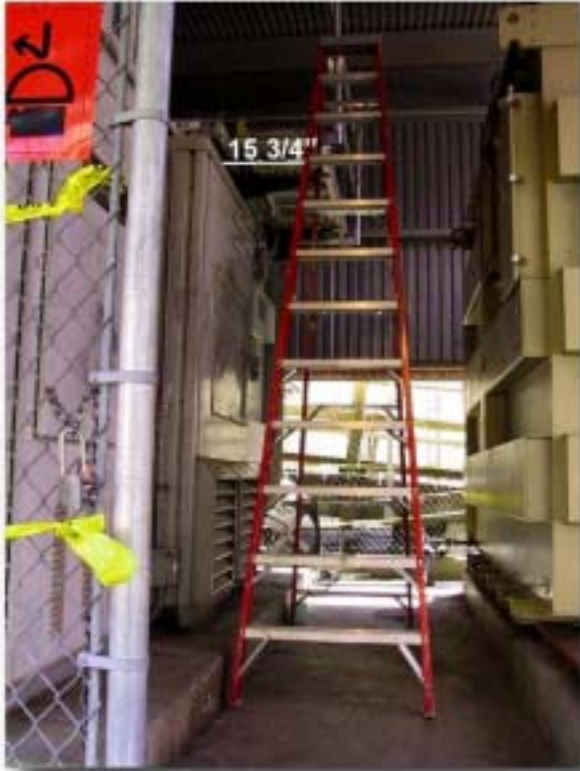
Figure 2-1. The accident scene

The systems engineer entered the building to investigate reported nitrogen leaks in radio frequency high-voltage power supplies. It is not known whether he inspected the 12-foot ladder in the area. Working alone, he climbed the ladder to gain access to the top of the older power supply that was to be replaced (Figure 2-1 shows a similar ladder positioned at the scene of the accident). It appears that the engineer stepped sideways off the ladder onto the transformer; he fell to the concrete floor.

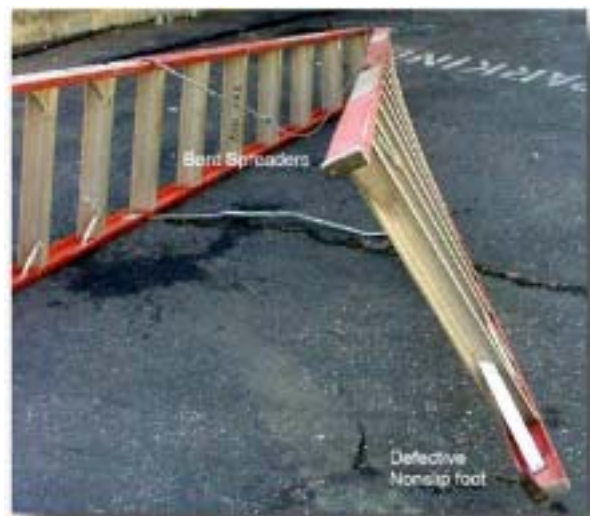
Figure 2-2. The damaged ladder

cally, a pre-work inspection of the ladder would have shown its condition; for example, its non-slip rubber feet were damaged and worn, as can be seen in Figure 2-2. The bent spreaders were a result of the fall.

Other signs of damage and wear existed before the accident, such as longitudinal cracking and a deformed step.

- SLAC needs to develop and implement processes for work planning and control that define the scope of work, establish criteria and develop procedures for performing task-specific hazards analyses, authorize work, facilitate the exchange of feedback between management and workers, and ensure management involvement in controlling hazards.
- The Stanford Site Office needs to assess the extent to which SLAC holds line management accountable to ensure that safety requirements are enforced and addressed as part of the work planning process.
- Management needs to develop and implement an effective oversight program to ensure full implementation of the Integrated Safety Management System (ISMS).

- SLAC needs to develop and implement a process for effectively identifying issues, tracking and trending corrective actions, and reporting results to senior management.

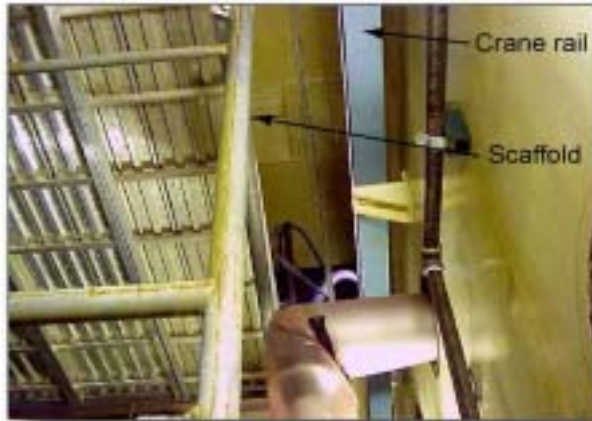
Figure 3-2. Gap between the scaffold and the crane rail

erecting the scaffold had to set it back from the adjacent wall by approximately 1 foot, with its length running parallel to the wall. To allow workers access nearer to the wall, they used a plywood plank as a bridge between the work floor of the scaffold and a crane rail attached to the adjacent wall.

The crew anchored the plywood plank and a spacer underneath it to the scaffold deck with nails. They did not secure the plank on the wall side, and they did nothing to ensure the scaffold could not move. Figure 3-1 shows the erected scaffold, the nearby crane rail on the adjacent wall, and the two manipulator arm tubes exiting the wall of a hot cell. Figure 3-2 is a view from underneath the gap between the edge of the scaffold deck and the crane rail, after the plywood plank that had previously filled this space had fallen.

Investigators identified the preliminary direct cause of this occurrence as a slight movement

of the scaffold away from the wall. This movement allowed the wall-side edge of the plywood plank to slide off the crane rail that supported it and drop, causing the worker on the plank to fall as well. The movement of the scaffold away from the wall may have been caused by the worker leaning into the wall to perform the scabbling operation. Because the footings of the scaffold were on a steel floor, there was minimal resistance to movement in the lateral direction away from the wall.

- Suspension of the use of similar scaffolds at the facility until they have been inspected to ensure that they can perform their intended function safely.
- Inspection of all scaffolds site-wide.

- Resolution of the issues involved in this event by the contractor's Scaffolding Technical Authority organization.
- Evaluation of the need for refresher training for scaffold erectors, inspectors, and users.
- Clarification of the responsibilities assigned to scaffold inspectors and erectors in site requirements documents.
- Completion of an independent safety investigation of the event to provide recommendations for long-term improvements.

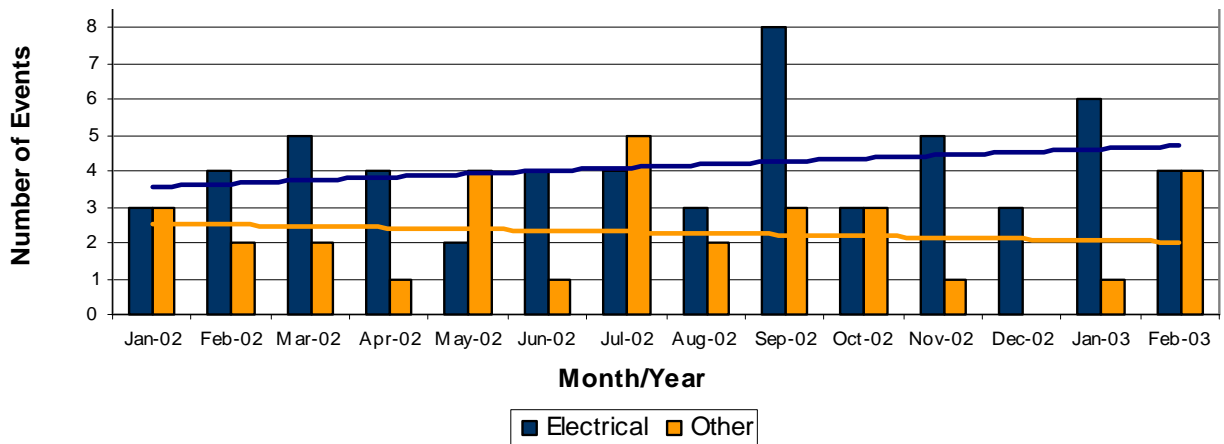
Figure 4-1. Lockout/tagout events by type

A search of the ORPS database indicated that the number of LOTO events involving electrical systems actually increased during the period from January 2002 through February of 2003, while LOTO events involving other hazards decreased (Figure 4-1). During this period, electrical LOTO events were three times the number of those involving other hazards.

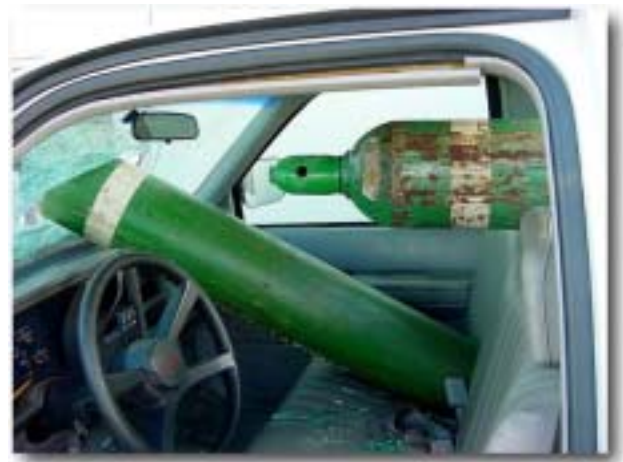
Figure 5-1. The cylinders shifted in the truck bed

The U.S. Army Medical Research and Materiel Command recently reported an incident that occurred at an Air Force installation at Fort Huachuca, AZ. A driver was transporting unsecured compressed-gas cylinders in the back of a pickup truck when he had to stop suddenly, forcing two cylinders forward through the rear windshield. One of the cylinders was propelled through the front windshield on the passenger side of the vehicle (Figure 5-1). The driver was uninjured, and there was no passenger.

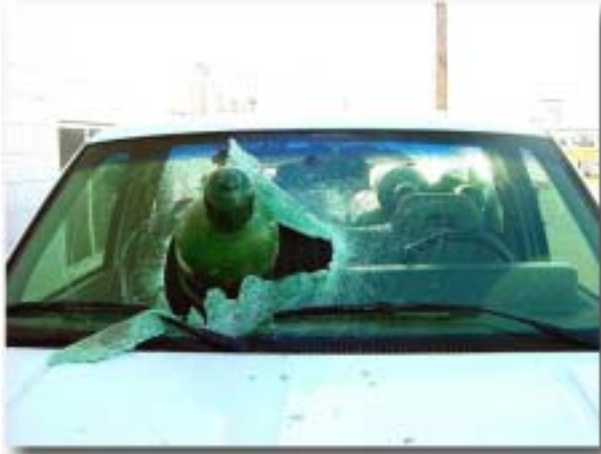
Figure 5-2. One cylinder burst through the windshield

The safety alert identified several issues that contributed to this incident. The bottles were stacked too high and were not secured in the truck bed. The driver was also speeding, so he had to brake suddenly and hard. Fortunately, the cylinders' valve stems were covered, which may have averted a missile hazard. The truck driver drove 2 miles back to the shop in a significantly damaged, unsafe vehicle (Figure 5-2).

When transporting items and materials, personnel should follow all applicable procedural requirements to ensure materials are properly secured to each other and to the vehicle. Inadequate or makeshift methods of securing materials can result in shifting loads and damage to the materials being transported or to the transportation equipment.
