OPERATING EXPERIENCE SUMMARY

OE Summary 2003-08

April 21, 2003

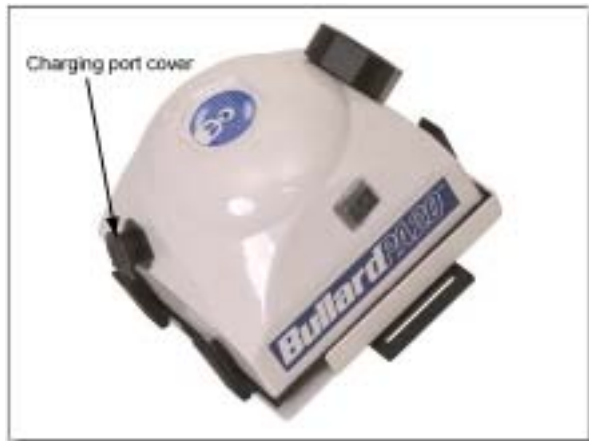
The worker was on top of a head tank vacuuming sediment. He and a co-worker were wearing Bullard® PA20 PAPRs (see Figure 1-1). When the power for the blower assembly shutdown, it caused a loss of filtered air to his hood. Following unsuccessful attempts to restore air flow, the worker left the area and was evaluated for contamination or injury.

Figure 1-1. A Bullard PA20 PAPR blower assembly

A critique took place the next day. A point that was raised during the critique was that Bullard PAPRs, in use at Idaho since July 2002, lack a positive locking mechanism for the charging port plug. As a result, they have been known to come disconnected if bumped, shutting off the power unit. Workers who had experienced this before stated that they cycled the switch off and on to restore air flow. However, in this event, the worker was unable to restore air flow and was uncertain whether he should remove the hood or leave the contamination area when the facepiece began to fog.

Site management issued a lessons-learned statement on the use of the Bullard PA20 PAPR. This statement can be found at the DOE Lessons Learned web site (URL <http://www.eh.doe.gov/ll>) under identifier 2003-INEEL-076. Site personnel will work with Bullard representatives on modifying the design of the PAPR so that the blower assembly is less likely to disconnect from the power unit when bumped. In addition, the training program and job safety analysis are being revised to include direction in PAPR use and evaluation of work areas to ensure that respiratory protection is appropriate for the task and the surrounding area.

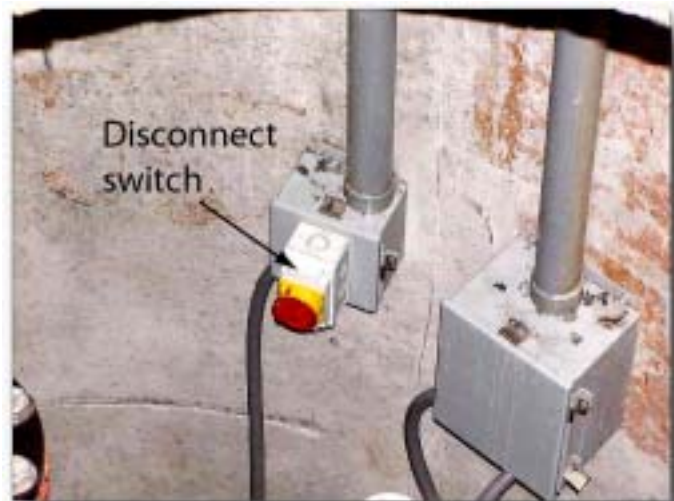
Electricians were preparing to replace a broken cover on a disconnect switch located in a manhole (Figure 2-1). The switch provides local isolation of power to a motor-operated valve (MOV). They installed a lockout/tagout on the circuit breaker labeled as supplying power to the MOV inside Manhole 24 before they started work. One of the electricians completed a confined space entry checklist, then entered the manhole. He noticed that the MOV indicator light was on

Figure 2-1. Disconnect switch for motor-operated valve

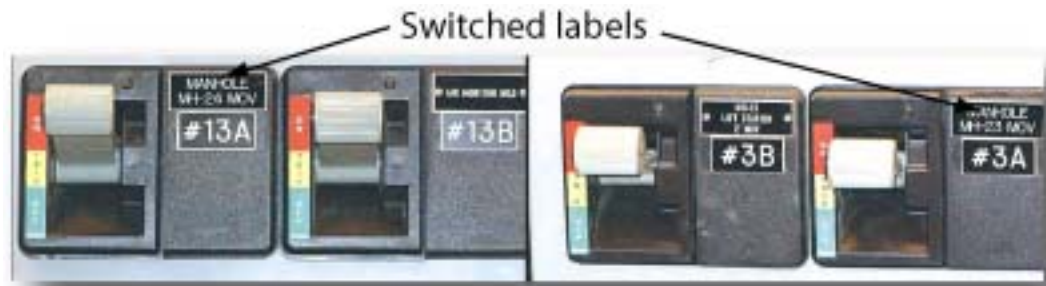
Work was stopped immediately, and a subsequent review of the as-built electrical drawings revealed that the breakers on the electrical panel were not labeled correctly. The equipment label for “Man-hole MH-24 MOV” was installed on the circuit breaker for circuit #3A instead of circuit #13A (Figure 2-2 shows the labels that were switched). The electricians identified the correct breaker, locked and tagged out the circuit, performed a zero-energy check, and completed the repair.

Although acceptance testing was performed in 1998 to confirm that the system was consistent with the as-built drawings following installation, the labels were applied after the testing. Investigators determined that the labeling error resulted from the procedure not being followed correctly during label application. Electricians compared

Figure 2-2. Corrected labels for breakers #13A and #3A

- Conduct self-assessments at other remedial action and waste disposal sites to ensure proper configuration control.
- Check all facility electrical panels against as-built drawings to ensure that the circuits are properly labeled.
- Ensure that there is a uniform label format, and re-attach or replace any missing labels.
- Prepare and disseminate a formal Lessons Learned report.

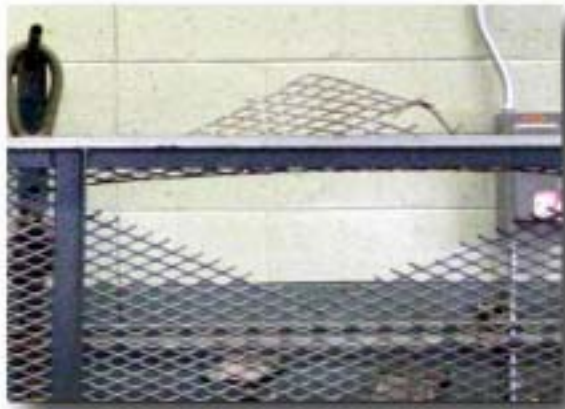
On February 26, 2003, at the Idaho National Engineering and Environmental Laboratory (INEEL), an instructor applied excessive hydraulic force to a sling during a training demonstration, breaking a 60-pound hook holding the sling and propelling a 20-pound fragment to the other end of the test bed. The fragment penetrated the test bed's protective caging (Figure 3-1), struck and broke an overhead light, hit the building wall, and fell to the floor. The fragment did not strike any personnel, and no injuries resulted from this near-miss event. (ORPS Report ID--BBWI-CFA-2003-0006)

Figure 3-1. *The torn protective cage*

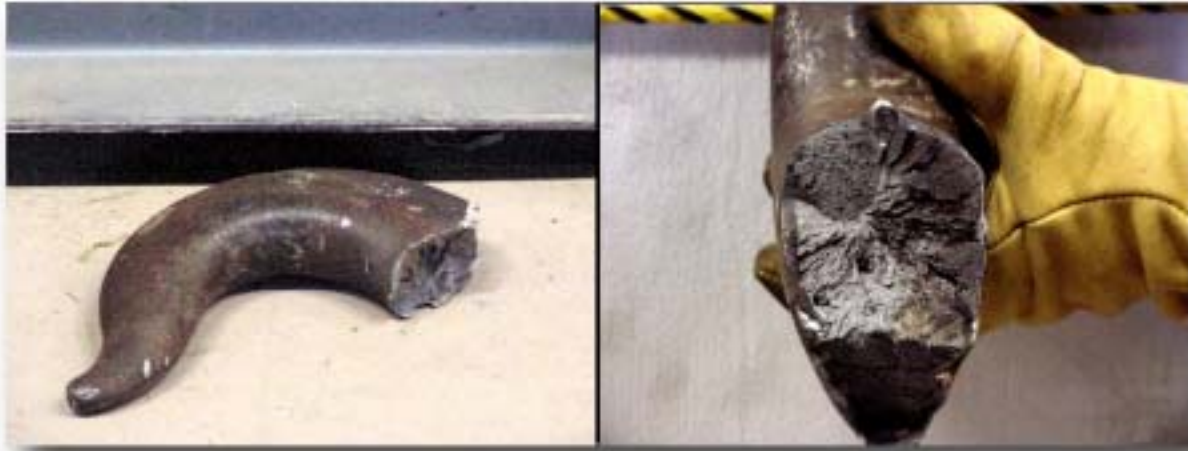
Investigators determined that the hook failed as a direct result of the instructor applying hydraulic pressure that was significantly greater than the design load limit of the hook. They also identified four other factors that contributed to this near-miss event.

Figure 3-2. The expelled hook fragment

- Review the incident and evaluate the need for testing slings to destruction.
- Evaluate the need to magnetically test accessories used with the sling tester.
- Conduct an independent review of the process for conducting sling testing using hooks instead of the installed pins, and review the need to prepare policies and procedures for safely operating the sling test equipment.
- Conduct a configuration management review to determine what accessories are acceptable to use with the sling tester and their impact on the machine's design load limits.
- With the help of subject matter experts, prepare and issue a lessons learned report for this event.

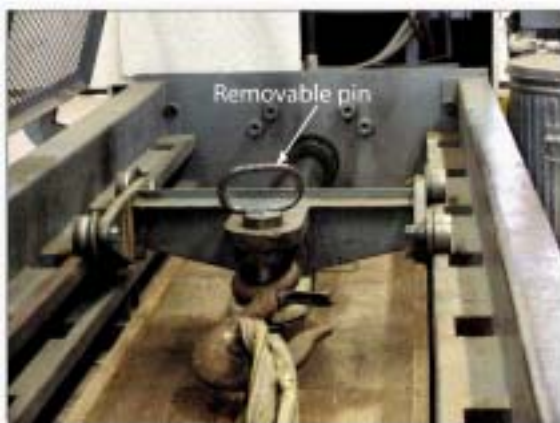
The sling-test machine used at INEEL is a National Swage Sling Tester (Model CN-135) that can apply up to 270,000 pounds of load to a sling and is equipped with large, removable pins to attach slings for pull testing. Sometime before this incident, equipment operators attached hooks to the pins to make it easier to connect slings for testing. The hooks (manufactured by The Crosby Group) are approximately 19 inches high and 13 inches wide with a 6-inch eye. They weigh approximately 60 pounds and are rated at 26,000 pounds of pull capacity. Instructors were not aware of these ratings and assumed the hooks were stronger than the slings under test. The manufacturer does not supply hooks with the sling test machine, and their documentation contains no recommendations on using hooks to attach slings. Figure 3-3 shows the pin and hook arrangement used on the sling test machine.

Figure 3-3. Arrangement of pin and hook

This event demonstrates the adverse consequences of installing components that do not satisfy the design requirements of the original equipment. The equipment operators inadvertently introduced an additional weak link when they attached the under-rated hooks to holding pins of the sling test machine. Equipment operators who were present when the hook broke narrowly escaped serious

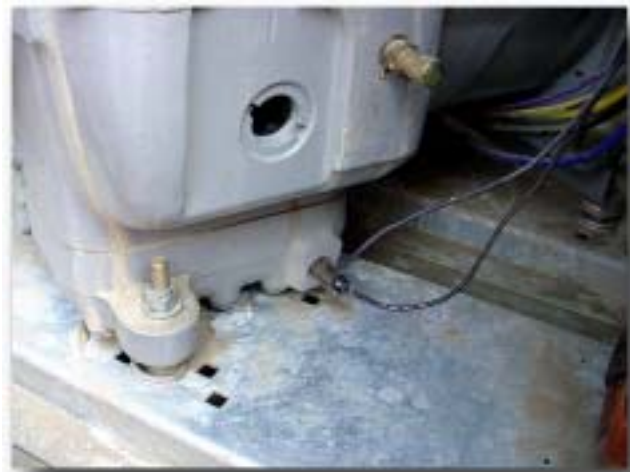
Investigators determined that the HVAC unit is designed so that the circuit energizing both the oil heater and the cooling fan bypass the main circuit breakers for the unit. The oil heater was continuously powered by this circuit. When the metal vacuum cleaner wand struck the heater wiring located at the base of the HVAC compressor, it shorted to ground (see Figure 4-1). Investigators also determined that, although the cooling fan was not continuously energized, its operation was controlled by a thermostat. Had the thermostat reached its setpoint, the unguarded fan would have started up, creating another hazard to the workers.

Figure 4-1. Wiring that was shorted to ground

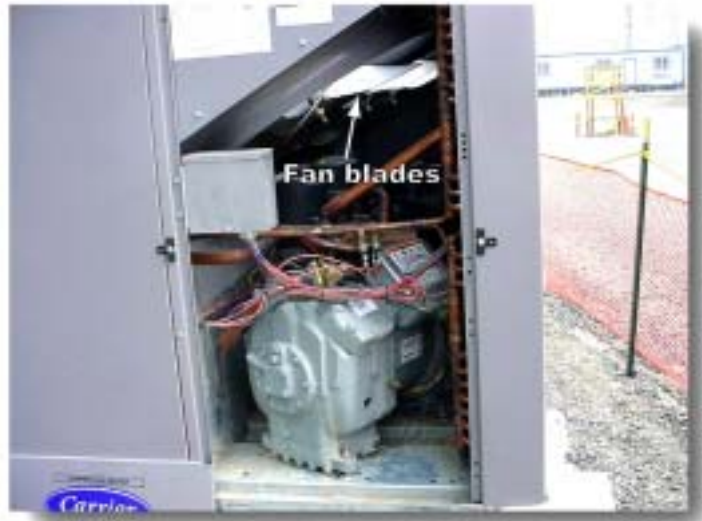
metal wand on the vacuum cleaner, creating an unanticipated hazard. Also, the workers were vacuuming in proximity to fan blades that could have started moving at any time, and this hazard was not addressed in the work card. Figure 4-2 shows the HVAC compressor enclosure with the exposed fan blades.

Figure 4-2. Compressor with fan blades above

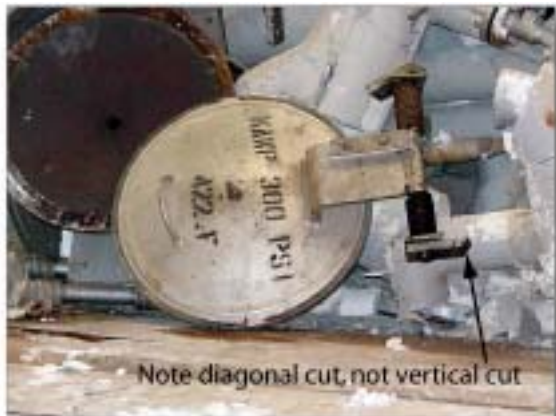
The operator of the hydraulic shear was cutting a lid hinge bracket (shown in Figure 5-1) with a Centaur™ Rescue Tool (Model CEN C9), also known as the Jaws of Life for its use in extricating people trapped in motor vehicles. The tool can generate cutting forces up to 99,000 pounds. The manufacturer specifies that the tool can be used only in a perpendicular position to the item it is cutting. Holding the shear at another angle can cause the cutting jaws to separate, resulting in metal fracturing of the steel blades. This shear was used previously in another facility to cut metal hangers that hung vertically, and no failures or projectiles were reported.

Figure 5-1. The lid and hinge bracket

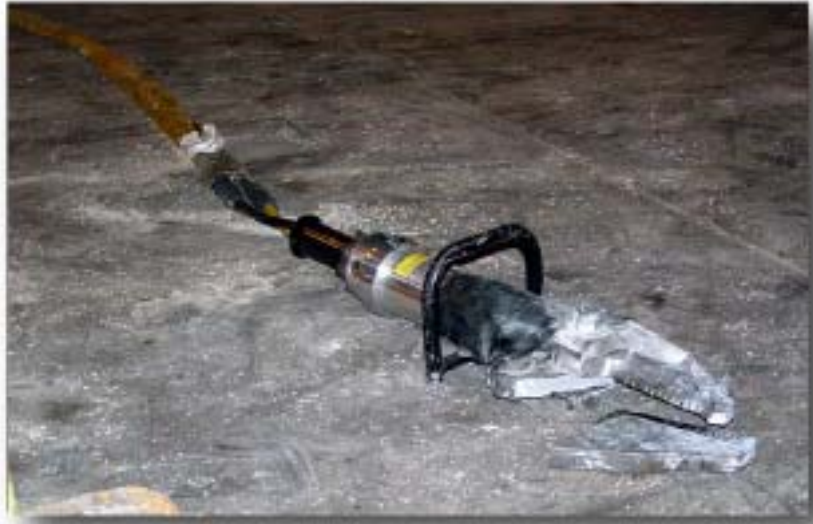
The operator had difficulty accessing the hinge bracket to cut it, so he was not holding the shear perpendicular to the bracket. The

blade fractured, and a piece struck the construction worker, who was standing 14 feet away. The broken shear is shown in Figure 5-2. The construction worker was examined at the site medical facility, then transported offsite for treatment.

Figure 5-2. The broken shear and blade fragment

The vendor, manufacturer, and site subject matter experts examined the tool to determine the reason for its failure and to assist in developing corrective actions. Some of the corrective actions that are under consideration include using an energy blanket to catch projectiles and revising the hazard analysis to require a review of the manufacturer's recommendations on proper tool use. In the meantime, all work involving this model of hydraulic shear was suspended.
