OPERATING EXPERIENCE SUMMARY

U.S. Department of Energy
Office of Environment, Safety and Health
OE Summary 2003-09
May 5, 2003

Operating Experience Summary 2003-09

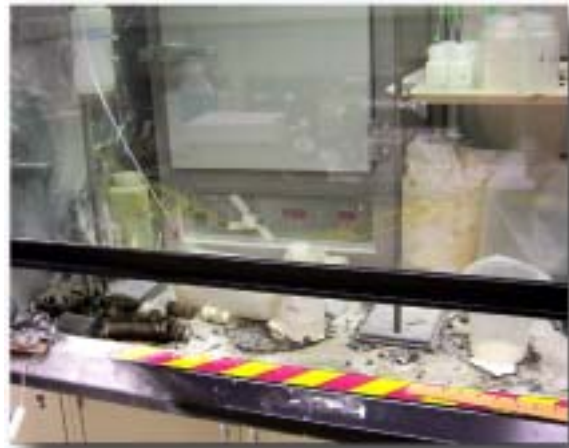
Figure 1-1. Fire damage within the fume hood

In addition to the hotplate, the fume hood contained small plastic containers of natural uranium, which were damaged. Other items in the hood included a balance; small oven; garbage container; analytical balance; sieves; liquid containers; and a sample beaker. There was little damage to the hood, with most of the damage occurring to the contents (Figure 1-1).

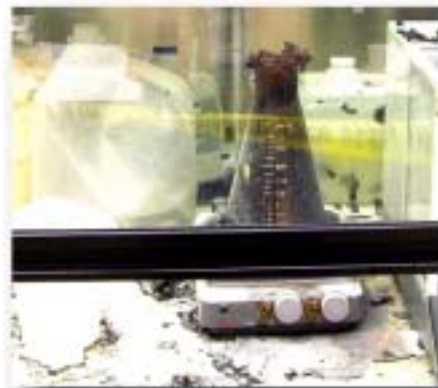
Figure 1-2. Damaged hotplate and beaker

Preliminary inspection by investigators indicates that the fire may have been caused by a malfunction within the hotplate (Figure 1-2). Both switches on the hotplate were in the off position, but the researcher noticed that one of the lights on the hotplate was illuminated when

she discovered the fire, indicating that the hotplate was energized.

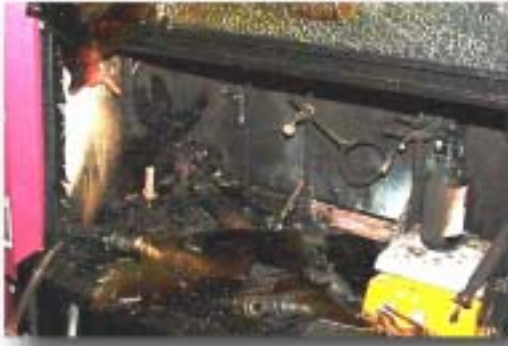
Figure 1-3. Left-front area of the hood

On the day of the fire, a senior scientist had transferred pipettes containing a pyrophoric liquid, believed to have been inerted, from an inerted glovebox into the left-front area of the fume hood (Figure 1-3) next to some Kimwipes®

(absorbent towels) moistened with methanol and hexane (a highly flammable liquid). Established procedures require these materials to be segregated. The fire started approximately 20 minutes after the scientist left the lab.

Investigators theorized that the most likely cause of the fire was a delayed reaction involving an unreacted pyrophoric liquid, tris-

Investigators also determined that there have been inconsistencies by researchers in the inerting and transfer process for pyrophoric materials because there is no formal written procedure for the process. This will be corrected by revising the laboratory safe operating procedure to include a written procedure for inerting and transfer that includes redundant inerting steps. Other corrective actions from this event included the following.

- Require the use of covered stainless steel isolation containers for the storage of pipettes and syringes.
- Replace plastic secondary containment trays with non-combustible trays.
- Provide high-walled stainless steel containment trays for storage of plastic squeeze bottles containing flammable liquids.

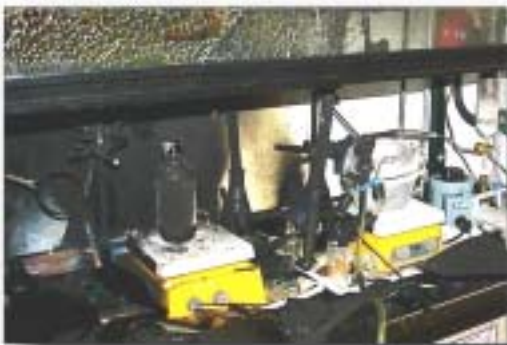
Figure 1-4. Hot plates and equipment

Investigators believe that once the fire started, it quickly heated a plastic squeeze bottle containing hexane causing it to be expelled from the container and ignite. This produced a dramatic flare-up of the fire, which consumed a squeeze bottle containing methanol, generating sufficient heat to ignite other plastic bottles, trays, hoses, and tubing in this area of the hood. A removable access panel on the left side of the hood fell out, allowing an influx of air to push the intense heat and flames toward the right side of the hood near a heating mantel and hot plates, igniting process tubing and hoses (Figure 1-4).

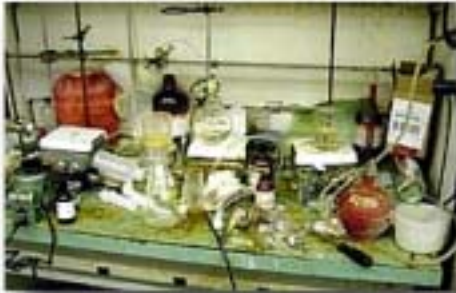
Figure 1-5. Example of poor housekeeping

hamper the ability to work safely. It is also important to minimize the amount of combustible materials in the area because of the use of burners, hotplates, and ovens that provide ignition sources. Figure 1-5 is an example of an accident waiting to happen.

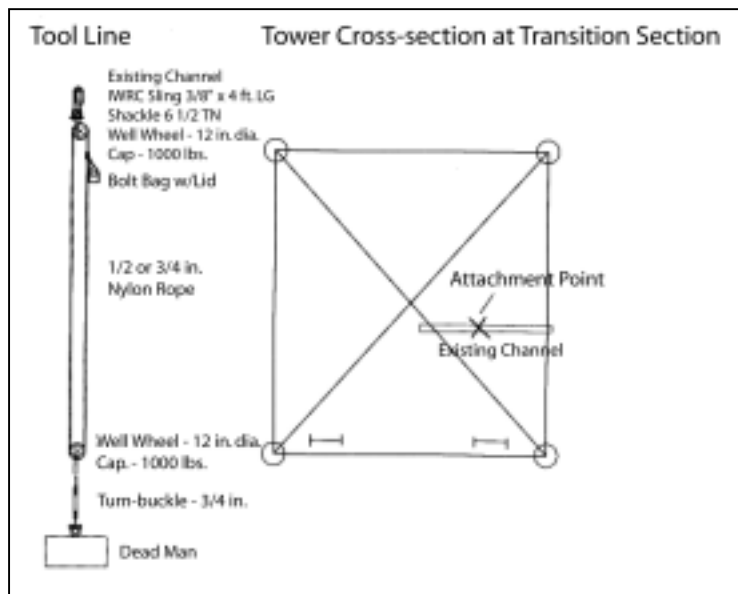
Figure 3-1. Rope and pulley tool line

Workers had repaired the tower crane ladder and were using a pulley to bring tools and materials down to the base of the tower. Figure 3-1 shows a diagram of the rope and pulley system mounted inside the tower crane. Windy conditions caused the bolt bag to get hung up on the top of a cross brace in the tower internal structure. Every time the worker raised the bolt bag to attempt to free it, the wind blew it back over the brace. As the worker "whipped" the rope to free the bolt bag, the carabiner apparently struck something and opened, releasing the bag. Figure 3-2 shows the carabiner involved in this incident.

- Install a new, secured rope and pulley arrangement inside the tower crane to facilitate raising and lowering tools and equipment.

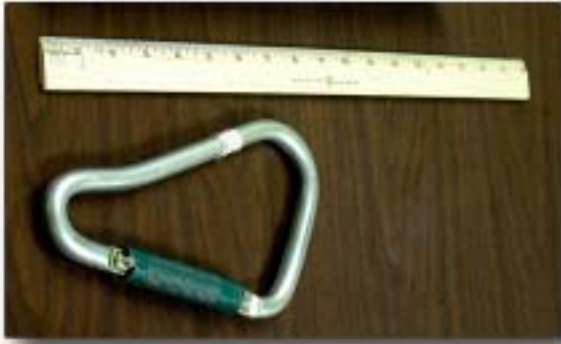
Figure 3-2. Carabiner that opened

Investigators determined that the root cause of this event was that the workers selected an inadequate component to use in the pulley system. They used a carabiner with a locking gate that rolled 90 degrees to lock and could open if it contacted another surface instead of a carabiner with a secure, lockable latch. Contributing causes included inadequate procedures for using the pulley system during windy conditions, not stopping work to secure materials when windy conditions arose, and the design of the canvas bag. The canvas bag had no secure points of attachment, and this allowed the rope to directly contact the rolling lock of the gate, causing it to open.

- Require all tools and parts being hoisted in the pulley system to be enclosed in a bolt bag with a securable cover.
- Discontinue use of carabiners of the type involved in this incident, and require the bolt bag to be attached to the hoist line with a secure, lockable latch mechanism to prevent accidental loss of the bolt bag during hoisting operations.
- Require personnel involved with tower crane activities to communicate with the operator on weather conditions, including wind speed.
- Require the immediate area at the base of the tower be roped off when the rope and pulley system is about to be used and inform personnel working in the area about overhead activity.

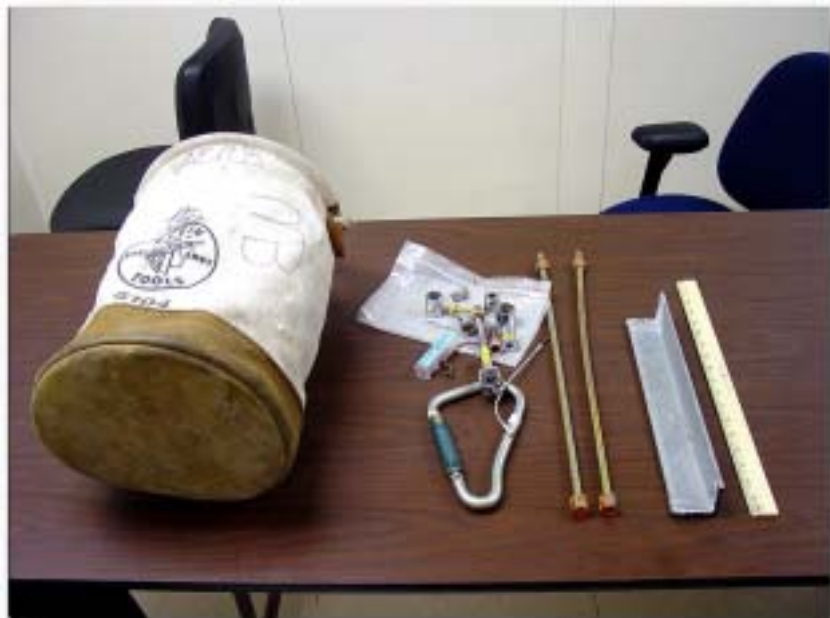
Figure 3-3. The bolt bag and its contents

The items that spilled out of the bag included two, 20-inch-long, 3/8-inch-diameter linkage rods with dou-

double nuts on each end and the 14-inch-long, 2-inch piece of angle iron. Figure 3-3 shows the bolt bag and the materials that fell from the bag to the ground, with a 1-foot ruler for perspective.
