# OPERATING EXPERIENCE SUMMARY

**U.S. Department of Energy**  
**Office of Environment, Safety and Health**  
OE Summary 2003-11  
June 2, 2003

# Operating Experience Summary 2003-11

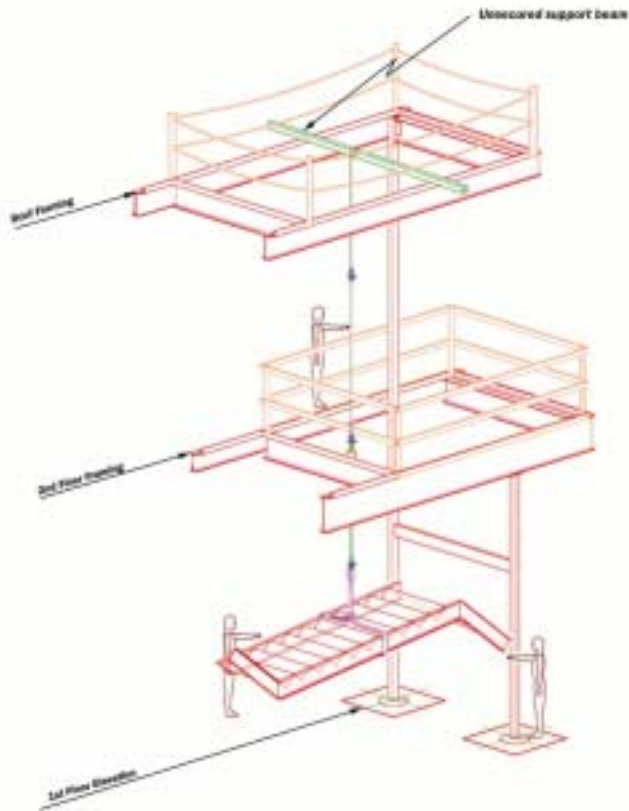
**Figure 2-1. Structural diagram with rigging elements**

The three-person crew of steel erectors was lifting the metal stairway from the ground floor to a landing between the first and second floors. Before the lift, they had placed a 14-foot-long steel beam across the open stairwell on the third floor. The beam, which was not secured from lateral movement, overhung the opening by about 2 feet on either end. A 2-ton manual chainfall was attached to the beam by wire rope slings. The journeyman operated the chainfall from the second floor while the foreman and apprentice on the first floor rigged the stairwell with a 4-inch wide nylon choker sling and attached it to the hook on the chainfall. The journeyman was raising the stairway when the weight shifted while the foreman was trying to maneuver the stairway around an obstruction. This caused the beam to slide off the third-floor stairwell opening.

Figure 2-1 is a diagram of the structural framing and rigging elements at the construction site immediately before the accident. Figure 2-2 is a photograph of the accident scene showing where the support beam (cross-wise at the base of the stairs) and the stairway section (with the yellow sling strap) came to rest after falling.

The Accident Board determined that the direct cause of the accident was the temporary hoisting beam falling from its rooftop supporting structural beams into the stairwell opening, striking a worker, and dropping the stairway load, injuring another worker. The report states

that the root cause of the accident was that “installation of the temporary hoisting beam and movement of the load during the lift were not performed in accordance with the requirements of [OSHA regulation] 29 CFR 1926,” [*Safety and Health Regulations for Construction.*]

- (1) Sandia needs to ensure that subcontractors more fully implement the requirements of the Sandia construction management specifications in the areas of:
  - task-specific hazards analysis;
  - effective safety meetings that communicate activity-specific hazards analysis and controls to workers;
  - job-site safety inspections at appropriate frequencies that focus on compliance with OSHA regulations in 29 CFR 1926 ([http://www.osha.gov/pls/oshaweb/owast.and.display\\_standard\\_group?p\\_toc\\_level=1&p\\_part\\_number=1926&p\\_text\\_version=FALSE](http://www.osha.gov/pls/oshaweb/owast.and.display_standard_group?p_toc_level=1&p_part_number=1926&p_text_version=FALSE)); and

- verification of safety practices at this and similar construction work sites.
- (2) Sandia needs to ensure that the Sandia construction safety and project management personnel clearly understand and implement the site construction management specifications in the areas identified in item (1) above.
  - (3) The DOE Sandia Site Office needs to establish clear roles and responsibilities concerning construction safety management in the areas identified in item (1) above.
  - (4) Sandia needs to enhance its accident scene preservation practices.

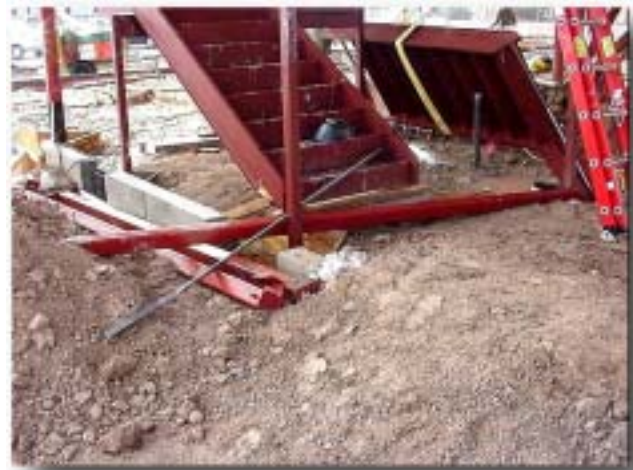
**Figure 2-2. Construction site ground level after accident**

On March 20, 2003, at Sandia National Laboratory – Albuquerque, two workers sustained injuries at a building construction site when an unsecured steel beam, being used with a chainfall to lift a metal stairway, slipped sideways and fell. The falling beam struck the job foreman in the right foot, inflicting a serious crushing injury. A support brace attached to the metal stairway hit a journeyman ironworker as it fell, lacerating his left shin. An apprentice ironworker was also struck and knocked to the ground by the falling stairway section, but he

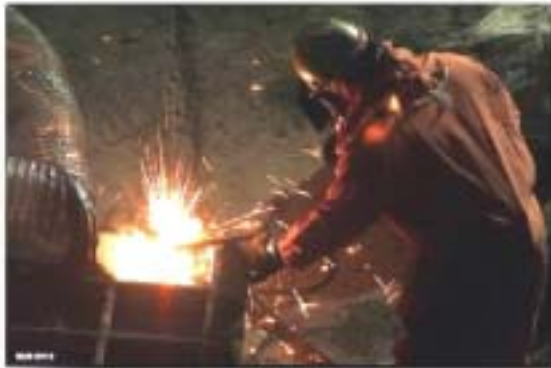
***Figure 4-1. Typical torch cutting operation***

The fire is thought to have been caused by a hot piece of slag falling from the building foundation into a small pile of debris, which included extremely dry wood pieces. No one detected smoke during the 30-minute period of surveillance after torch-cutting operations ceased or during the remainder of the period that personnel stayed in the area (approximately 10 minutes). Torch cutting and welding activities typically generate a lot of sparks and hot slag, as shown in Figure 4-1.

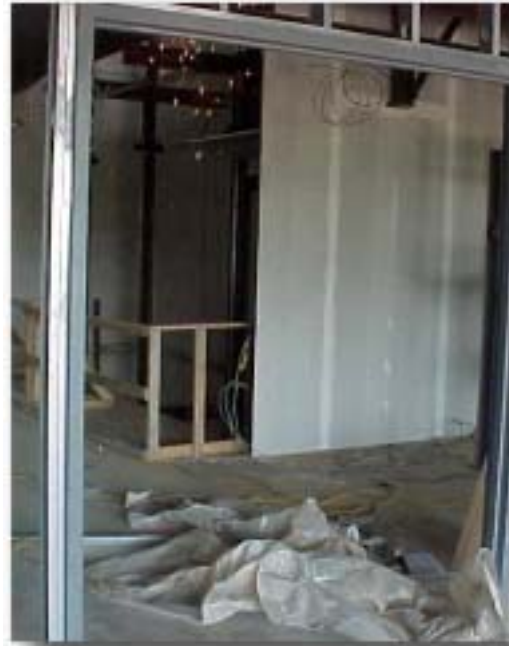
***Figure 4-2. Sparks falling onto combustible material***

The procedures and job hazard analysis required removal of all combustible material in the affected area, as well as requiring a fire watch to remain in the area for 30 minutes after the work was complete. Investigators determined that the subcontractor failed to remove all combustible materials.

cutting near combustible materials. These changes, summarized below, most likely would have prevented the fire had they been implemented. Figure 4-2 illustrates sparks from torch cutting falling on combustibles at a construction site.

- Combustible material will be moved or doused with water to reduce the risk of fire.
- A fire watch will remain at the scene for 45 minutes after torch cutting and welding activities are complete instead of for 30 minutes.
- Personnel will perform a post-job inspection of the area at the end of each shift in which torch-cutting or welding activities took place to ensure that smoldering materials are not inadvertently left behind.
