OPERATING EXPERIENCE SUMMARY

U.S. Department of Energy
Office of Environment, Safety and Health
OE Summary 2003-12
June 16, 2003

Operating Experience Summary 2003-12

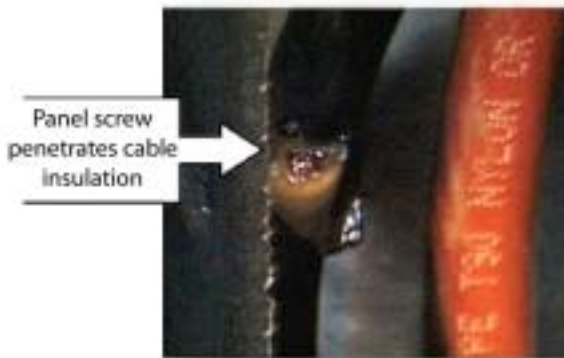
On January 30, 2003, at Hanford, electricians unknowingly drove a screw through the insulation of a de-energized 480-volt cable (Figure 1-1) when they replaced a panel cover. When power was restored to the panel, the screw caused a phase-to-ground fault. Workers saw an arc flash, and the 480-volt branch breaker, the main 480-volt panel breaker, and the panel 480-volt feeder breaker opened. The area surrounding the panel door was scorched (Figure 1-2). No one was injured, and there was no damage to plant equipment other than the cable and screw, parts of which were vaporized. (DOE Lessons Learned Identifier 2003-RL-HNF-0014)

Figure 1-1. The location of the penetration in the cable

A more thorough inspection of the panel installation might have prevented this event because the electricians would have recognized the hazardous condition created by driving a long screw near to the electrical cable. The lessons-learned submission (<http://www.tis.eh.doe.gov/ll>) includes the following recommendations to help electricians avoid intrusions when installing and repairing equipment.

Following this occurrence, the plant electrical engineer reviewed and approved a recovery plan, and the electricians shortened and repositioned the cable, then replaced the panel cover screws with shorter ones.

- Exercise extreme care when installing electrical panel covers.
- Verify the proper location of wires and cables before installing screws into panels, especially when replacing missing screws without removing the cover. Removing the panel cover may be necessary in some cases.
- Carefully inspect electrical panels after modifying them and during periodic inspections to ensure bolts and screws that mount panel covers will not contact or penetrate wiring.
- Use screws of an appropriate length in electrical panels.
- Avoid routing electrical cables close to electrical panels.

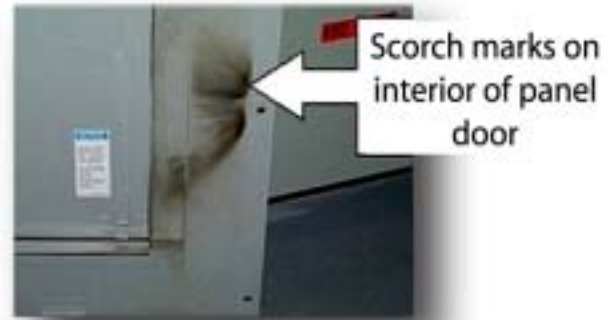
Figure 1-2. The panel door after the arc flash

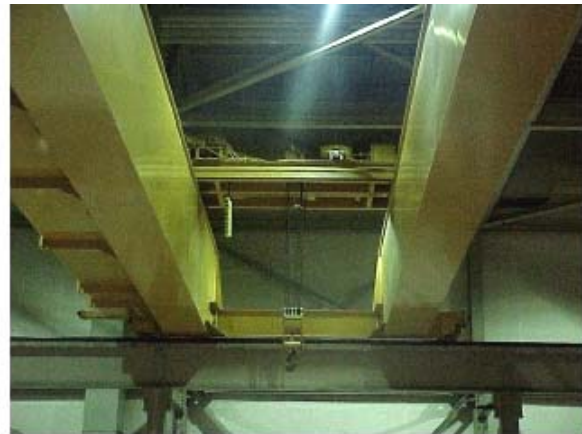
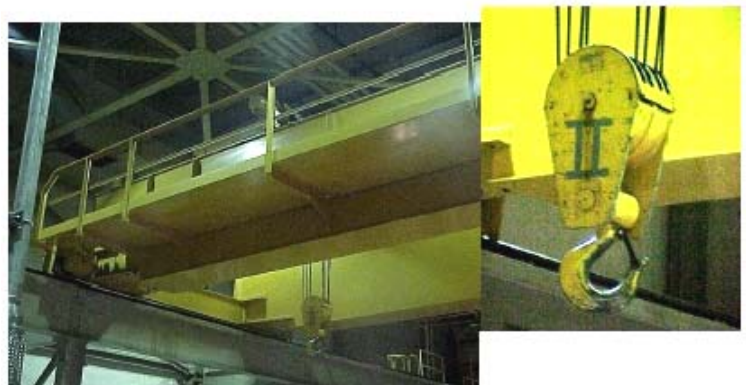
The crane operator was working with an assigned safety watch, but the safety watch had moved away from the crane hook and was preparing to load materials. The crane operator began to move the 25-ton bridge crane (Figure 2-1) without checking the position of the crane hook because he assumed it was in the same position as on the previous day. When the crane hook struck the equipment cabinet (Figure 2-2), it severed

Figure 2-1. 25-ton bridge crane

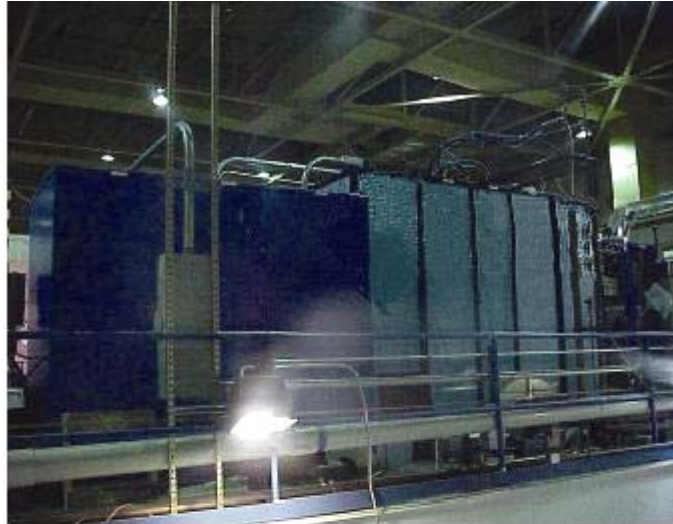
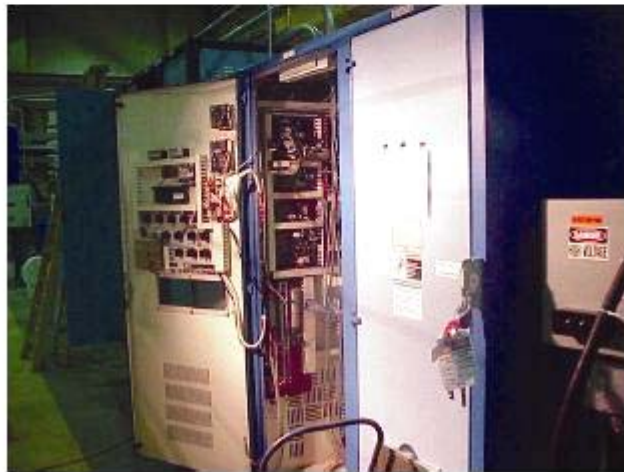
one conduit containing eight control cables and a second conduit containing a 120-volt, 20-amp control power circuit. The hook continued moving, striking several masonry shielding blocks and knocking over an installed radiation monitor before the crane operator stopped it in response to a shout from the safety watch. Investigators estimated that the crane hook traveled about 20 feet before stopping.

Investigators determined that the root cause of the TJNAF incident was personnel error, inattention to detail, on the part of both the crane operator and the worker assigned the task of safety watch. If either of them had checked the location of the crane hook to ensure that it was in the fully elevated position before moving the

Front and rear sides of damaged cabinet

Figure 2-2. Damaged equipment cabinet

Although the results of the causal analyses were similar for both incidents, the corrective actions identified by the responsible managers were not. At TJNAF, corrective action focused on retraining of subcontractor personnel involved in the incident in areas related to safe crane operation. Corrective actions resulting from the SNL incident included the following.

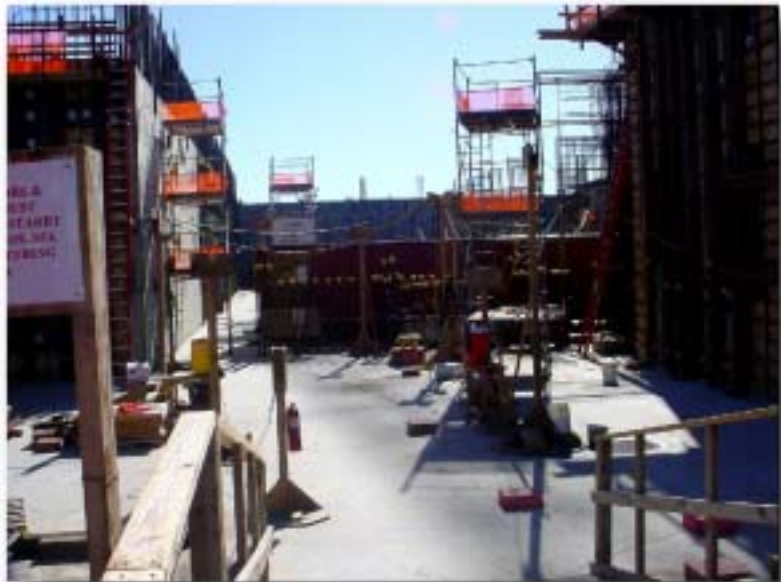
Construction personnel were preparing to pour two concrete walls for a building in an area congested with equipment and people (Figure 3-1). A shackle and two, 20-foot slings were suspended from the crane's load hook (Figure 3-2). The spotter intended to change the rigging configuration and signaled the crane operator by radio to swing left to the area where he had placed the additional rigging. The spotter did not clear the area of personnel or prepare the area for dropping a crane block to ground level. Several workers were standing and working in the area where the new rigging was to be attached.

Figure 3-1. The congested construction site

1. The work area must be cleared of personnel and equipment before, during, and after a lift.
2. The work area must be kept clear from the travel path of cranes and rigging equipment.
3. If personnel must remain in the area, stage the rigging equipment outside the building.
4. Blow the whistle to alert personnel of approaching rigging equipment when rigged to the load hook.

crane spotters have been appropriately trained and that they understand their roles and responsibilities in assisting crane operators when maneuvering around work sites and moving loads. Finally, because of the congestion in the work area, the rigging equipment was moved to a lay-down area outside the building to preclude the need for attaching the rigging in a congested area.

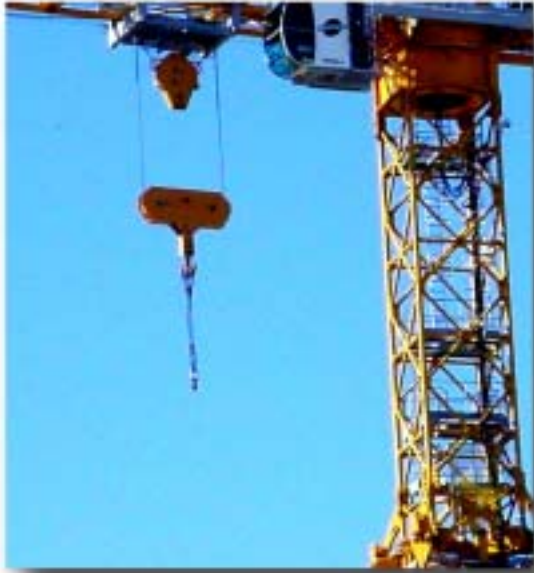
Figure 3-2. The tower crane with its rigging

The spotter directed the crane operator to lower the block and swing the boom, then he realized that the suspended slings were too close to personnel. He directed the crane operator to stop, but the sling struck the laborer. The slings continued swinging, so the spotter grabbed them and pulled them out of the way of other workers.

All crane operations were suspended and the spotter's certification was revoked. To prevent future occurrences, crane spotters attended a meeting in which their primary responsibilities were reinforced. The following corrective actions were taken.

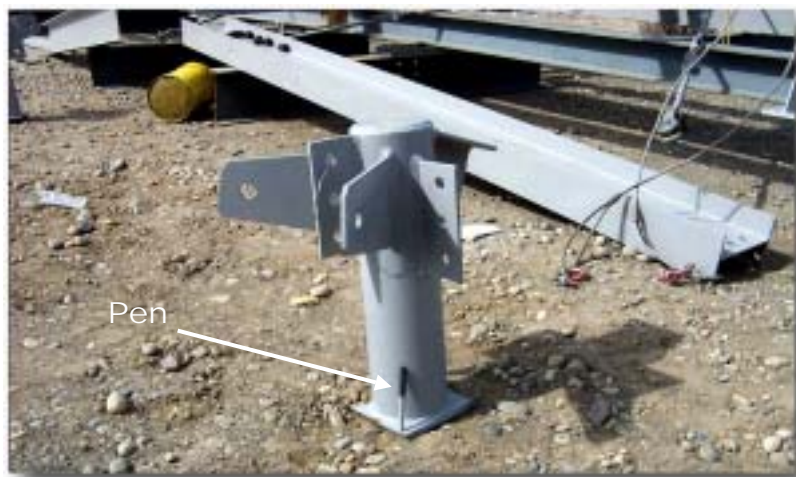
Figure 4-1 shows a spider column similar to the one that fell. A gouge where the column hit the concrete floor indicated that it missed the oxy-acetylene torch cart by only 18 inches. The skiff box, which contained five spider columns, was similar to that shown in Figure 4-2. Workers had hoisted it to the building roof earlier in the day of the incident, as directed by the ironworkers who would be installing the columns. Normally the spider columns are hoisted one at a

Figure 4-1. Example spider column (with ballpoint pen to show scale)

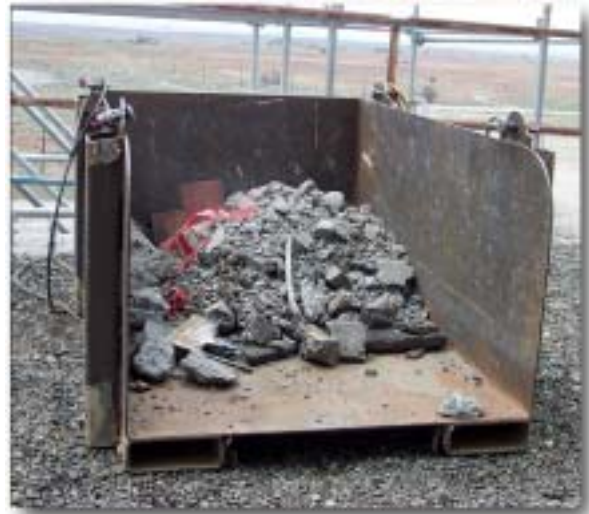
Figure 4-2. Example skiff box

- A crane hoist will be used to set the remaining spider columns in place, one at a time.
- Structural steel components will not be stored or staged on the roof.
- Tools, bolts, connection plates, and other incidental construction materials will be stored away from roof openings, preferably in containers.
- Workers must remain aware of the locations of their lanyards so that they do not snag on materials or equipment in the immediate work area.
- General work areas in the building beneath overhead work will be demarcated with caution tape and “overhead work” signs.

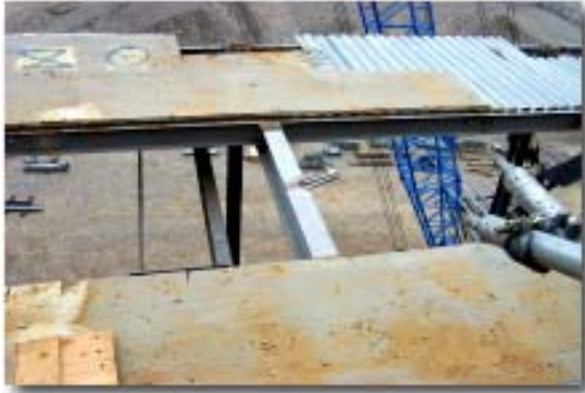
Workers placed the skiff box on the roof with the open end immediately adjacent to an 8-foot-wide opening in the roof. Figure 4-3 shows the roof opening that the spider column fell through. The lanyard strap that provided fall protection for the worker was attached to a column above and behind the skiff box. The worker stated that he did not feel the lanyard strap snag on the spider column before it fell. The ironworkers installing the spider columns thought that staging the columns on the roof and moving individual columns across a roof I-beam for installation was a safe work practice.

Figure 4-3. Roof opening near the skiff box

ciated with the innovation of staging spider columns on the roof were not sufficiently evaluated. The possibility of the fall protection lanyard snagging on a staged spider column and causing it to fall was not considered, and the skiff box should not have been placed with the open face immediately adjacent to an opening in the roof.

In addition to moving equipment out from under roof openings and installing barriers beneath overhead work, the following compensatory and corrective actions resulted from this incident.
