OPERATING EXPERIENCE SUMMARY

U.S. Department of Energy
Office of Environment, Safety and Health
OE Summary 2003-13
June 30, 2003

Operating Experience Summary 2003-13

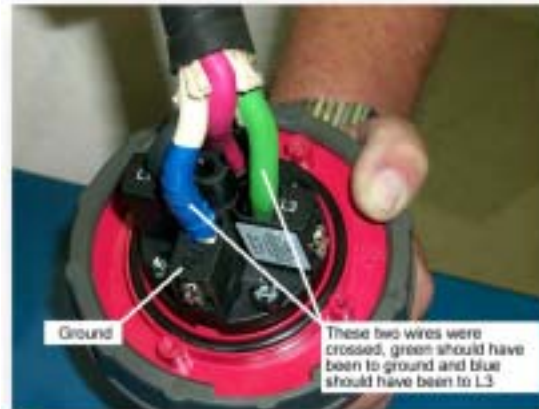
Figure 1-3 shows an incorrectly wired welding receptacle that resulted in a severe electrical shock in May 2003. (ORPS Report ALO-LA-LANL-NUCSAFGRDS-2003-0002)

Figure 1-3. Wiring error caused shock

Management should expect that work performed by a journeyman electrician will be error-free and not left in an unsafe condition. If an error is made (e.g., while wiring a piece of equipment, plug, or receptacle) it should be expected that the electrician will catch the error when checking his work to ensure correct voltages and grounding. This can be quite challenging at times, as Figure 1-4 demonstrates.

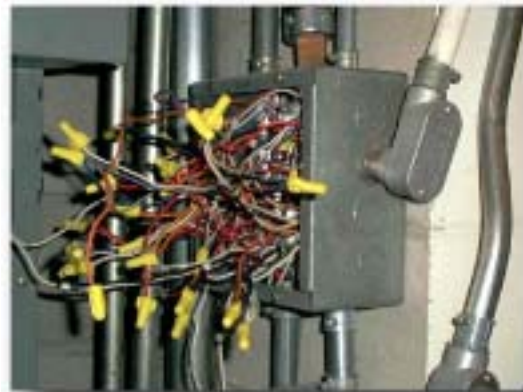
Figure 1-4. Electrical nightmare

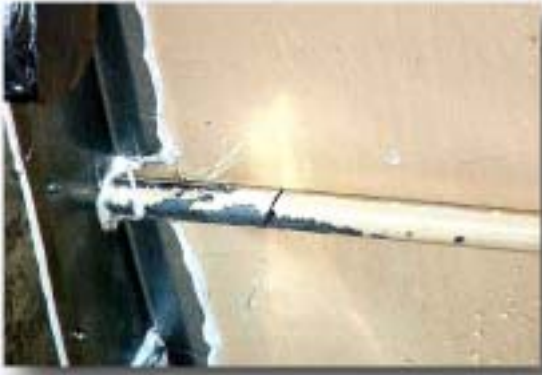
The number of electrical intrusion events in 2002 is down 27 percent from the previous year. However, during the first few months of 2003, electrical intrusions have occurred at the rate of 3.6 events per month. Figure 1-5 shows a conduit containing an energized 110-volt wire that

was cut during demolition in February 2003. (ORPS Report OH-MB-BWO-BWO04-2003-0002)

Figure 1-5. Cut electrical conduit during

Plan Jobs Thoroughly – Electrical planners need to use accurate drawings and consult subject matter experts regarding the as-built configuration of electrical systems and facility equipment.

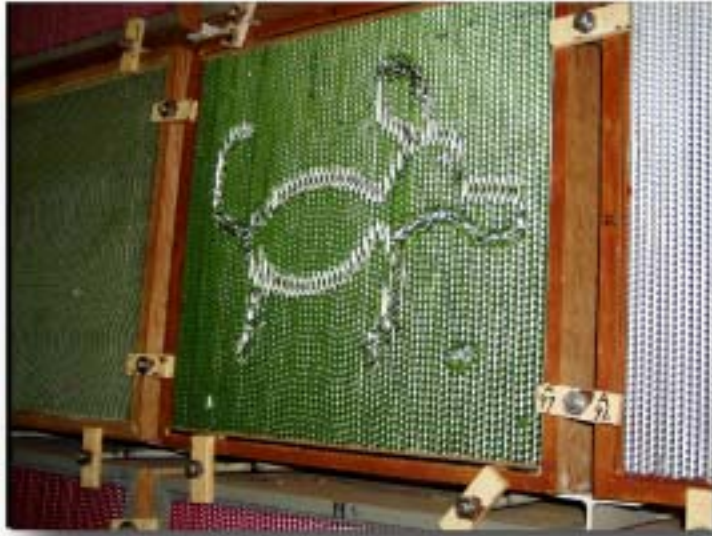
On May 27, 2003, at the Rocky Flats Environmental Technology Site, a facility representative inspecting a main exhaust filter plenum found that eight high-efficiency particulate air (HEPA) filters had been damaged. Further investigation revealed that decontamination and decommissioning (D&D) workers defaced the HEPA filters with graffiti about 10 days earlier (Figures 3-1 and 3-2). (ORPS Report RFO-KHLL-771OPS-2003-0010)

Figure 3-1. One of the defaced HEPA filters

Because there was no work in progress in the areas these filters serviced, the contractor entered a Limiting Condition for Operation action statement and suspended operations until Filter Services personnel could perform efficiency testing. They inspected the filters and reported that 34 of them needed to be replaced. Of these, 14 had been damaged by graffiti, and they sus-

Two D&D workers admitted to defacing the HEPA filters, and were disciplined. Project management also briefed the crew involved in the filter plenum D&D work on the purpose and importance of the filter plena as well as the authorization basis requirements. They also re-emphasized site policies, rules, and federal laws related to destruction of government property. A Site Safety Toolbox notice was published on the site Intranet and discussed with all work crews.

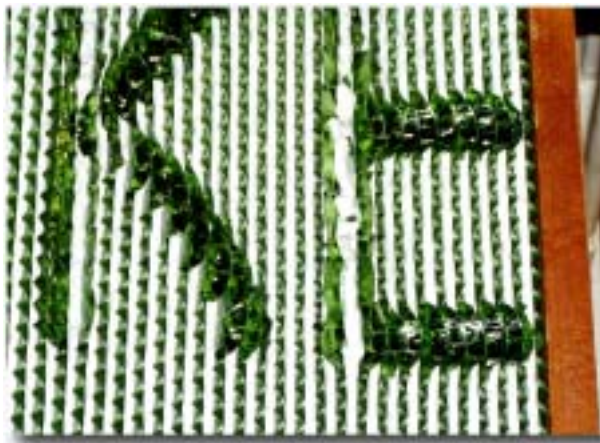
Figure 3-2. Another HEPA filter showing damage

pected an additional 40 filters were damaged as well. Tests on half of the 40 suspect filters indicated that they were operating at a sufficient efficiency level and did not need to be replaced. Filter Services reported that the credited filter stage removal efficiency of 90 percent was not compromised; only the margin of safety was impacted. At the same time that the damaged filters were replaced, the facility manager declared that the facility was operationally clean, and DOE concurred. This declaration closed out the Limiting Condition for Operation action statement. Management elected to test in-place aerosol efficiency as a best management practice during the remaining radiological D&D work at the facility.

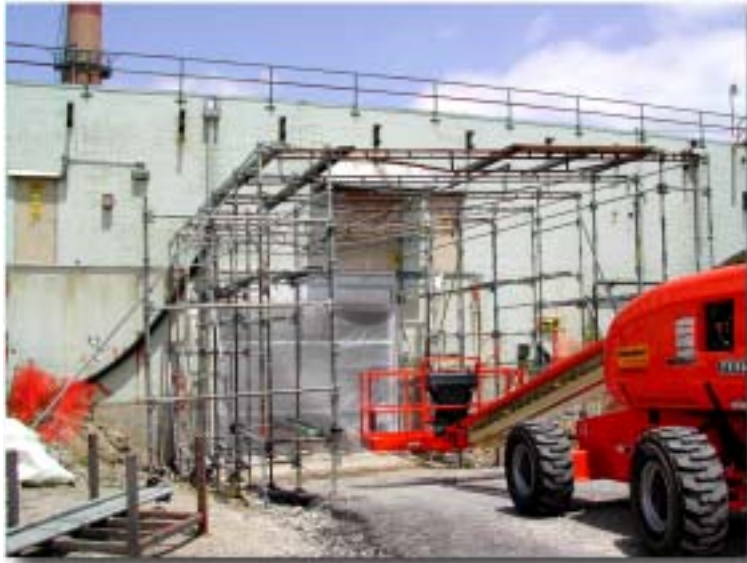
On June 5, 2003, at the Miamisburg Closure Project, a construction worker tripped on a protruding bolt while disassembling a 16-foot-high steel-frame scaffold and fell through an opening at the top of the scaffolding. The worker fell 9 feet before the lanyard inertia-braking mechanism arrested his fall. Before he tripped and fell, the worker had extended the retractable lanyard approximately 5 feet. Had the lanyard been extended any further, the worker could have fallen all the way to the ground. The worker was not seriously injured, but he struck the scaffold as he fell and sustained arm and back abrasions. (ORPS Report OH-MB-BWO-BWO04-2003-0008)

Figure 4-1. The worker fell from the top of this steel-frame scaffold

Investigators determined that the direct cause of this incident was that the worker tripped on a bolt protruding from a structural component of the scaffold. They determined that the contributing causes were process- and equipment-related. The work plan should have been changed when it was determined that there was no tie-off point for the fall protection lanyard above shoulder height, and an alternative, less hazardous method of performing the disassembly process should have been used. Using the man-lift instead of letting the worker perform the disassembly task from the top of the scaffolding would have been feasible and less hazardous.

- Replace the self-retractable lanyard with a fixed-length 6-foot lanyard while performing this task.
- Use retractable lanyards only in the proper circumstances, (i.e., where they cannot be extended such that they are longer than the distance to the ground).
- Always use tie-off points for the fall protection lanyard that are at or above the shoulder height of the worker.
- Conduct briefings emphasizing the need to comply with fall protection requirements and perform inspections of safety equipment (e.g., check the length of the lanyard vs. the distance to the ground).
- Ensure that the method used to perform potentially hazardous work is the safest one available.
- Ensure that all work tasks are properly planned, with the hazards ana-

lyzed and hazard control methods identified and properly implemented.
