OPERATING EXPERIENCE SUMMARY

U.S. Department of Energy
Office of Environment, Safety and Health
OE Summary 2003-14
July 14, 2003

Operating Experience Summary 2003-14

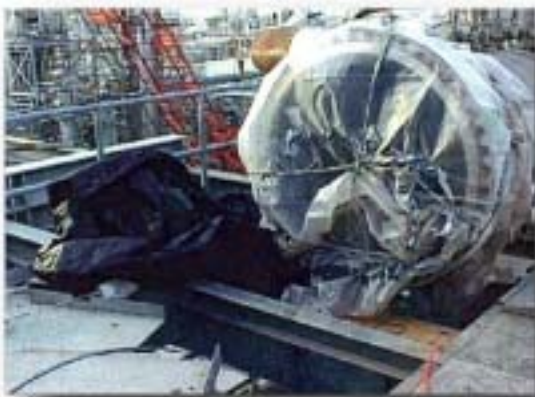
In March 1998, two workers at a Union Carbide plant were overcome by nitrogen while inspecting the inside of a 48-inch-diameter pipe (Figure 4-1). One of the workers died from asphyxiation and the other was severely injured from oxygen deficiency.

Figure 4-1. Pipe where workers were overcome by nitrogen-enriched atmosphere

Nitrogen injected into process equipment for moisture control had accumulated in the pipe, and the workers had covered the open end of the pipe with black plastic to block sun light while conducting a black-light test. No warning sign

was posted on the pipe opening identifying it as a confined space and potential nitrogen hazard.

Following this incident, CSB investigators recommended that the National Institute for Occupational Safety and Health study the feasibility of odorizing nitrogen.

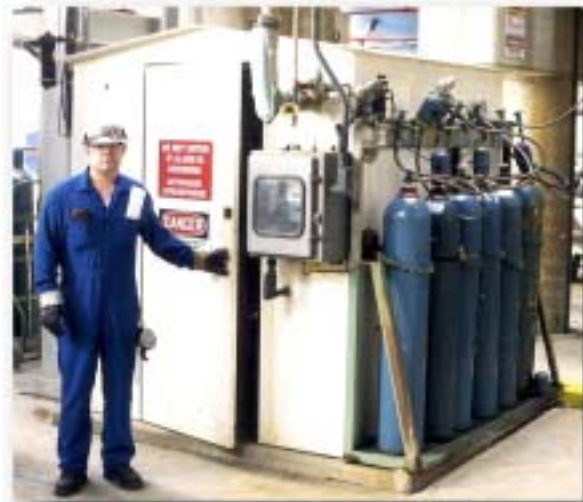
Figure 4-2. Confined area

Nitrogen is used commercially as an inerting agent or to keep material free of contaminants, such as oxygen, which can corrode equipment or present a fire or explosion hazard when in contact with flammable liquids or combustible solids. Because of its wide use in the workplace, it is important that confined areas (Figure 4-2) where gases can accumulate are properly posted to alert workers.
