OPERATING EXPERIENCE SUMMARY

U.S. Department of Energy
Office of Environment, Safety and Health

OE Summary 2003-15

July 28, 2003

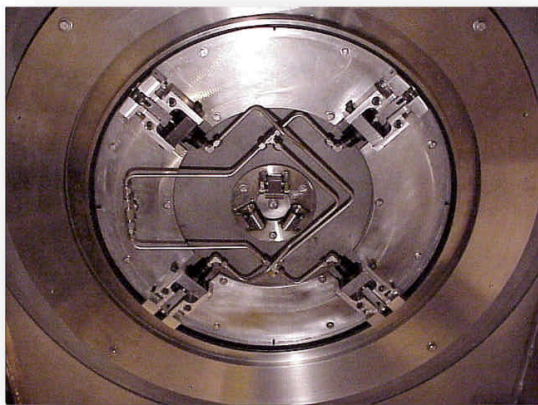
Figure 1-1. Glovebox line exit port

Facility personnel were performing modifications to the low-level glovebox line that included replacing a glovebox exit port like the one shown in Figure 1-1. Facility managers wanted to isolate power to the low-level glovebox line while other facility equipment remained operational. When designing the LOTO for the modifications, a system engineer reviewed engineering drawings showing all the potentially involved circuits. He highlighted those that were to be locked out but used two different colors to mark up the drawings and did not provide a color-code key.

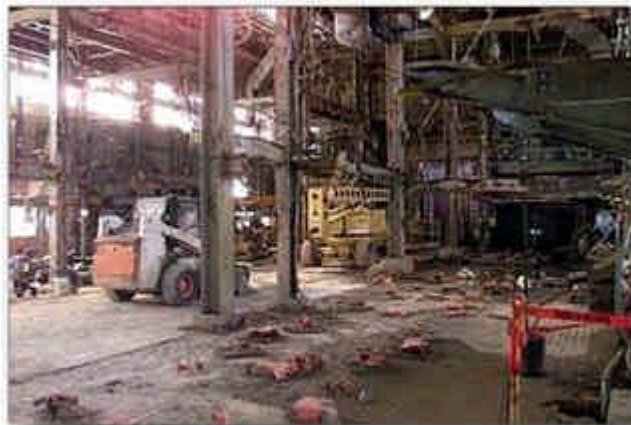
Figure 3-1. D&D work area

Because details leading to the event are unknown, investigators were unable to conclusively determine how and from where the pipe fell. However, based on the data collected, the investigators were able to infer how this incident most likely occurred. Figure 3-1 shows the area that was being demolished.

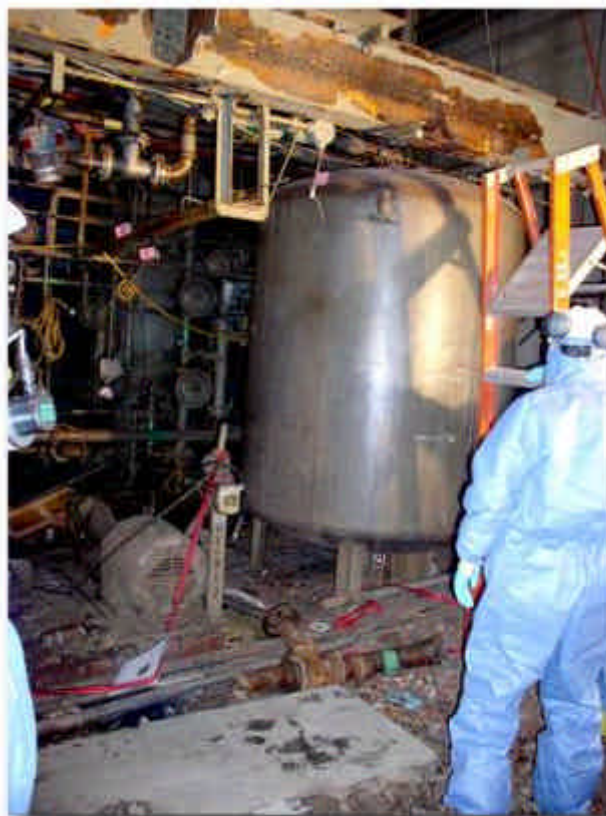
The 4-foot-long section of 4-inch-diameter pipe was probably cut from one of several that penetrated the south wall of the building at an approximate height of 17 feet. Workers had size-sheared the pipes into 10-foot lengths in mid-December 2002. When the pipe was sheared free, most likely in January 2003, it fell unnoticed on top of a tank in the demineralizer area (Figure 3-2).

The valve appears to have caught on a vacuum line running above the tank near a crossbeam and was on top of the tank and the crossbeam. Investigators believe the crossbeam hid the pipe from view. Figure 3-3 shows the piece of pipe that fell.

Figure 3-2. Tank beneath the crossbeam where pipe apparently fell

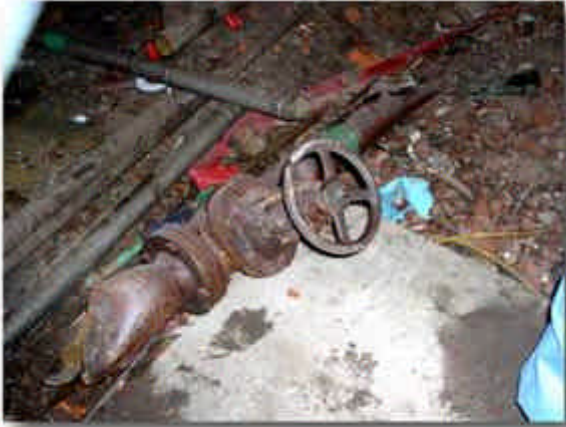
Figure 3-3. Pipe and gate valve that struck the worker

As the workers removed the pipe and flange from the tank, the valve apparently caught on one of these components and dislodged. The pipe then slid, fell, and struck the worker, causing him to stagger under the impact.

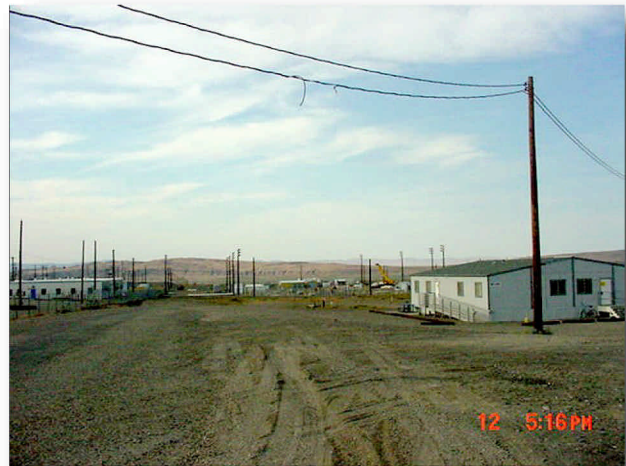
Figure 4-1 shows the incident scene immediately following the occurrence, with the damaged power line passing diagonally over the roadbed where the gravel was being spread. Although the potential for personnel injury existed, the truck driver was able to stop the truck before the energized wires were pulled down.

The overhead electrical line met the minimum height requirements of the relevant electrical code for its application. The minimum line height for this application is 15 feet, 5 inches above the ground per the Institute of Electrical and Electronic Engineers *Standards for Overhead Conductor Clearances*, Part 2, Table 232-1. Workers measured the height of the overhead line at various points, and determined the low-

Figure 4-1. Power line that was damaged by the raised bed of the gravel truck

est point to be 16 feet above the ground. At the location where the line was contacted by the bed of the truck, the line was 18 feet above the ground. The bed of the gravel truck, when fully extended, reaches approximately 19 feet, 7 inches above the ground.

- Install permanent caution signs on the side of the road near the power line to alert traffic concerning the overhead obstruction.
