OPERATING EXPERIENCE SUMMARY

U.S. Department of Energy
Office of Environment, Safety and Health
OE Summary 2003-16
August 11, 2003

Operating Experience Summary 2003-16

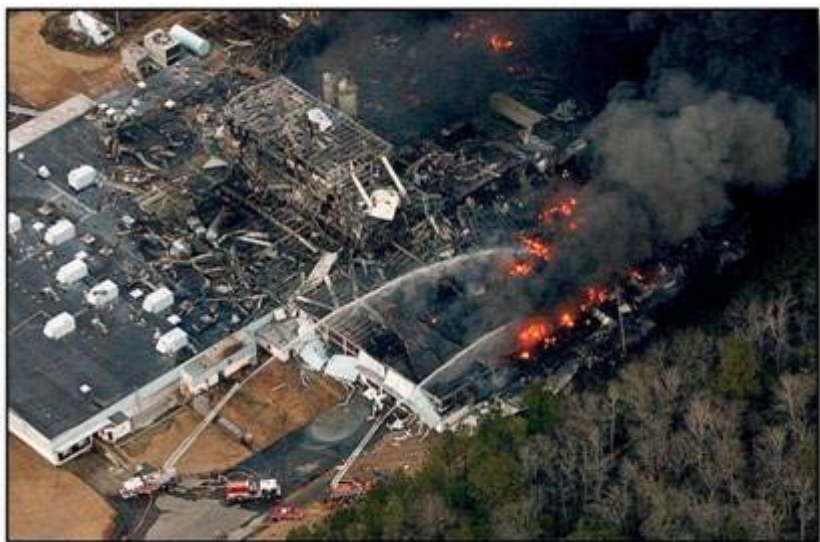
On January 29, 2003, the explosion ripped through the manufacturing plant (Figure 1-1), killing six workers and injuring dozens more. The dust explosion of fine plastic powder occurred above an area where rubber strips were coated with moistened polyethylene powder. The powder when dry is as fine as talcum and is capable of forming an explosive mixture in the air. Although investigators have not been able to determine the igni-

Investigators determined that the ventilation system drew fine dust particles into the space above an unsealed, suspended ceiling, where the particles settled and accumulated. They examined numerous ceiling tiles that were scorched on the upper surface, confirming that the explosion occurred within the overhead space. Eyewitnesses heard a sound like rolling thunder as the dust explosion propagated through the ceiling space, devastating the plant.

Figure 1-1. Aerial photo showing the magnitude of the explosion

- Ensure that ceilings in areas where explosive dusts may be present are sealed.
- Practice good housekeeping to ensure that flammable dust from ongoing processes does not accumulate to the extent that it can reach explosive conditions, particularly when fuel, oxygen, dispersion, confinement, and ignition are present.
- When entering a building that has not been occupied or cleaned for extended periods (as in decommissioning), carefully remove any potentially explosive dust that has accumulated.

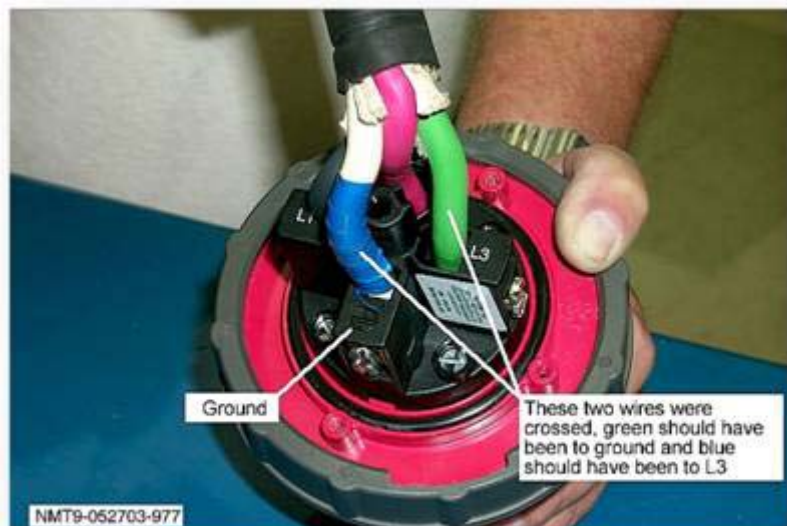
Immediately following the incident, an electrical technician de-energized the wall disconnect switch and locked and tagged it out. He also installed a lockout/tagout on the welder plug. When the technician performed diagnostics on the welding cart and its power source, he determined that the cart was still energized. Upon further investigation, the technician determined that the ground lead and one of the power leads within the welding cart plug had been reversed.

Investigators determined that an electrician had modified the power supply for the welder to increase the voltage from 240 to 480 volts. He also installed of a safety disconnect switch, a pin-and-sleeve welder plug (where the wiring error occurred), conduit and wire, and a 480-volt, 3-phase circuit breaker. Figure 2-1 shows the incorrectly wired welder plug, with the ground and one of the power leads reversed. A post-modification test of the completed installation, including the welder plug wiring, was not performed. Testing was not required by laboratory requirements or standards, and a verification check was not required by contractor procedures. After the electrician incorrectly completed the modification, the (now energized) welding cart sat undisturbed for nearly 2 weeks, presenting a potential electrical shock hazard.

Figure 2-1. Incorrectly wired welder plug

Investigators determined that the direct cause of this incident was personnel error (inattention to detail). The electrician who wired the welding cart plug said he was distracted and inadvertently reversed the positions of the two leads. The electrician did not verify that the wiring was correct, and neither an independent verification nor continuity checks were performed. Investigators identified a second personnel error (communications problem) as a contributing cause. The requirements for a disconnect switch were not identified in the original work package, and this change in the scope of work and the subsequent need to install a new pin-and-sleeve welding cart plug contributed to the cause of the incident.

- A new procedure for independent verification and testing for all completed electrical work packages.
- A new procedure on formality of operations, focusing on identifying an appropriate work scope, recognizing and responding to work scope changes, conducting pre-job briefings, and documenting a process for returning systems/equipment to service after maintenance or modification.
- A new refresher training course about this incident, focusing on the work control process, formality of operations, and maintaining a safe work environment.
- A new training course for work control personnel on management expectations for the proper development and execution of work requests.

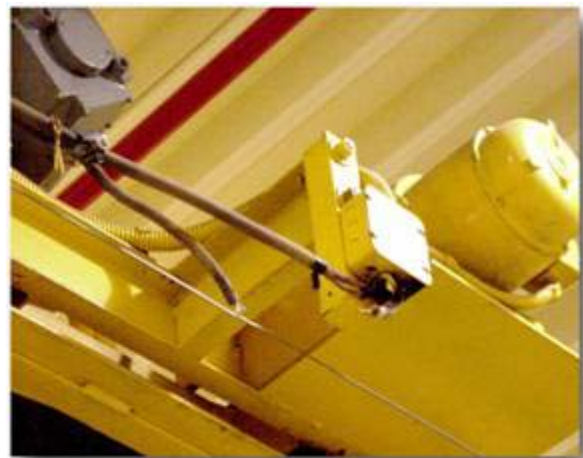
The workers notified their supervisors, who arrived at the scene to evaluate the situation. They determined that one of two crane power cords had pulled free of the bridge junction box, as shown in Figure 3-1. After tagging and locking open the crane's power supply disconnect switch, electricians restored electricity to the facility. Plant services covered the equipment hatch with planking and plywood.

Figure 3-1. Power cord pulled out of the bridge junction box

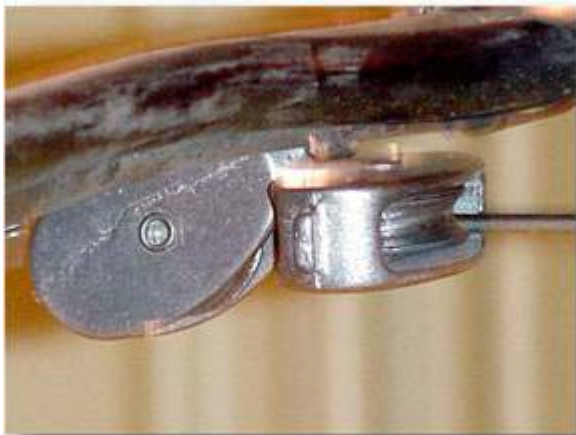
Personnel investigating the event discovered that the support cable was wedged between the leading pulley roller and the pulley housing.

This prevented the pulley from sliding along the support cable as the crane trolley was being moved by the crane operator. See Figures 3-2 and 3-3. As the crane continued to move, the power cable was stretched until it pulled out of the junction box. This caused the building power supply breakers to open.

Investigators determined that the wedged support cable was the direct cause of this event. This prevented the pulley from sliding along the support cable and caused the power cable to pull out of its junction box during crane movement. A contributing factor was the improper selection of the pulleys used to replace the cable support

Figure 3-2. Support cable wedged between the roller and housing of the pulley

rings. It appears that the pulleys were not adequately sized or designed to prevent the support cable from wedging between the pulley roller and the pulley housing. Investigators identified the root cause of this event as the failure of both workers and management to follow facility procedures when performing equipment modifications. Equipment is considered to be modified when replacement parts are used that are not identical or “like-for-like” to the parts being replaced. Procedures require facility personnel to initiate an ETA when performing equipment modifications.

- STOP WORK and consult with management when identical or “like-for-like” replacement parts are not obtainable.
- Perform an engineering evaluation before installing replacement parts that are not identical to the original equipment.
- Contact the original equipment manufacturer if there are questions regarding replacement parts.
- Recognize and follow the appropriate procedures.

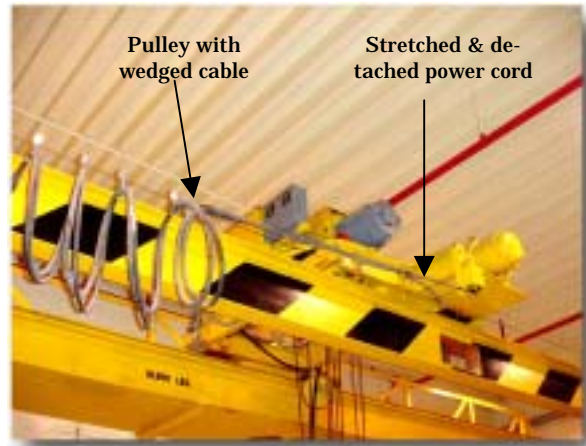
Figure 3.3. View of bridge crane showing pulleys, support cable, and power

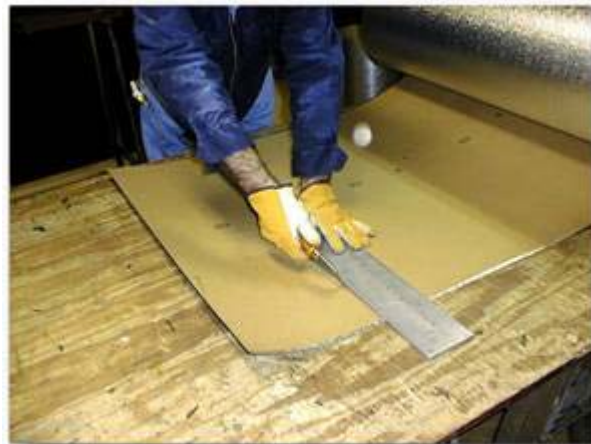
In November 2002, at the Oak Ridge East Tennessee Technology Park, a maintenance mechanic was using a linoleum knife to score lightweight aluminum insulation wrap. The mechanic placed an aluminum straightedge (see Figure 4-1) on the wrap to score a straight line. The straight edge started to move as he began moving the knife, so he knelt on the end of the straightedge and pulled the knife along it toward his body. The weight of his knee caused the straightedge to lift up on the opposite end. The straightedge knocked the knife handle as it

moved down the wrap, changing its path of motion. The sudden change of motion caused the mechanic to pull the knife across his left thumb and cut through his leather glove. The mechanic's thumb required nine stitches.

Figure 4-1. Scoring a straight line on aluminum wrap with a simple straightedge

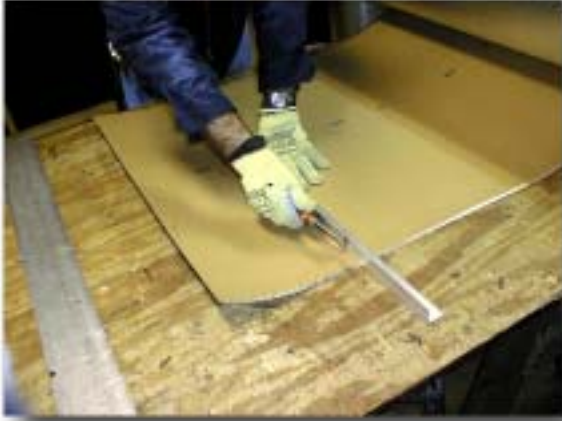
Figure 4-2. Scoring the aluminum wrap with a safer straightedge

Following an investigation, facility management revised the procedure for cutting aluminum wrap to specify the both the appropriate tools to be used and a safer cutting method. For example, an L-shaped aluminum straightedge, fabricated in-house, can be used to guide the knife while scoring the wrap (see Figure 4-2). Kevlar® gloves, shown below, help to prevent injuries as well. The use of scissors or snips should also be considered for cuts that do not create rough edges. (DOE Lessons Learned Identifier Y-2002-OR-BJCETTP-1201)
