OPERATING EXPERIENCE SUMMARY

U.S. Department of Energy
Office of Environment, Safety and Health
OE Summary 2003-17
August 25, 2003

Operating Experience Summary 2003-17

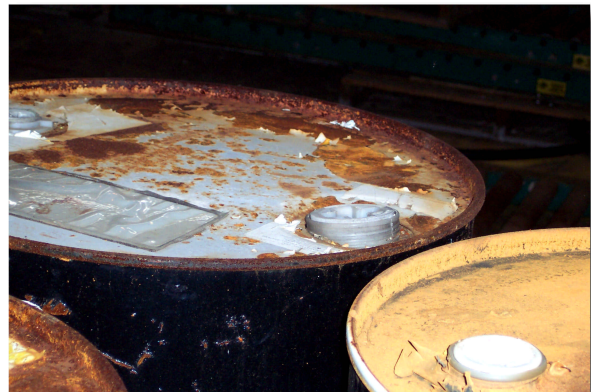
Old waste drums (Figure 3-1) at the Toxic Substances Control Act Incinerator were being staged for shipment to a disposal facility. While

Figure 3-1. Weathered waste drums for disposal

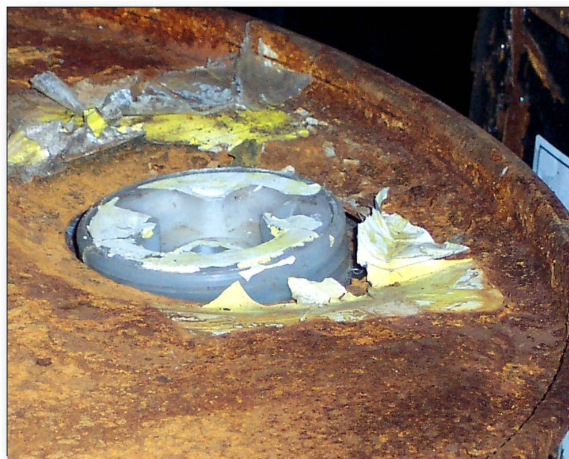
Investigators determined the direct cause of this event was the degradation of the plastic seal (Figure 3-2) on the TBP drums, which allowed rainwater accumulating on the top of the drum to flow into the space between the liner and the drum where it became contaminated. The root

Figure 3-2. Degraded bung on waste drum

cause was legacy contamination located between the liner and the drum that occurred years earlier during process operations while removing the contents from the TBP drums. The operator then spread the contaminated rainwater when he tipped the drums to remove the water from the top of the drums. A contributing cause was the storage of the waste drums outdoors where they were exposed to the weather. Corrective actions included the following.

- Empty drums with plastic bungs currently stored outdoors that previously contained radioactive material will be covered with suitable material to protect them from the

weather or moved into a covered storage area.

- Inspect waste drums equipped with plastic bungs for signs of degradation and leakage.
- Take appropriate actions to protect drums with degraded bungs from exposure to the weather (e.g., cover the drums or move them into covered storage areas).
- Consider the possibility that rainwater on top of drums or inside drums could be contaminated.
- If possible, try and minimize the length of time drums are stored or staged outdoors.

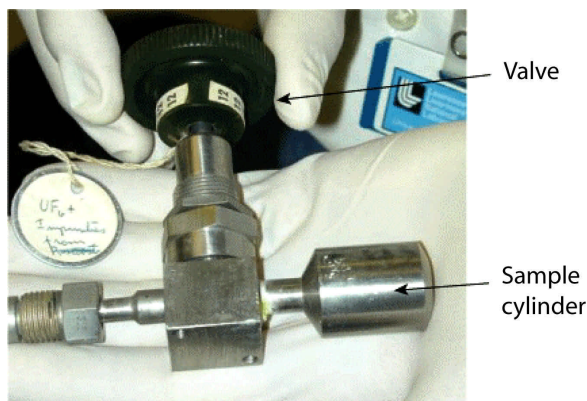
The technician went to the LLNL salvage yard in search of cylinders for a project. He found two stainless steel sample cylinders that were equipped with integral valves (Figure 4-1). The technician opened and closed the valves and concluded the cylinders were empty when nothing came out. He took the cylinders back to his laboratory to work on them.

Figure 4-1. Sample cylinder and valve with attached UF₆ tag

The cylinder had been used to take a small sample (less than 10 cc) of UF₆, and may have remained in a lab for years after the sample was taken. The valve may either have been opened or leaked, exposing the UF₆ to air. Water vapor in the air reacted with the UF₆ to produce uranyl fluoride (UO₂F₂) and hydrofluoric acid (HF). The yellowish-green UO₂F₂ clogged the valve orifice, effectively sealing in the remaining UF₆. Thus when the technician opened the valve, no UF₆ escaped. When he breached the tubing, the remaining UF₆ reacted with air to produce the wisp of HF "smoke."

- Ensure that every item placed in a recycle hopper is not hazardous. Individuals sending items to salvage are responsible to ensure items are non-hazardous.
- Do not put trash or non-recyclable items into recycle hoppers.
- Do not assume that items found at salvage are non-hazardous. Examine them for evidence of previous applications. Contact safety personnel or supervision before breaching unknown systems.
- Perform a careful, comprehensive cleanup of all hazardous materials and equipment when shutting down an experimental facility or laboratory. The potential exists for leaving unrecognized hazards during project closeouts.
- Be vigilant when cleaning up unfamiliar areas. Proper planning and oversight by knowledgeable program, facility, and safety personnel is essential.
- Properly mark all items containing hazardous materials to minimize the risk of improper handling in the future.
