OPERATING EXPERIENCE SUMMARY

U.S. Department of Energy
Office of Environment, Safety and Health
OE Summary 2003-18
September 8, 2003

Operating Experience Summary 2003-18

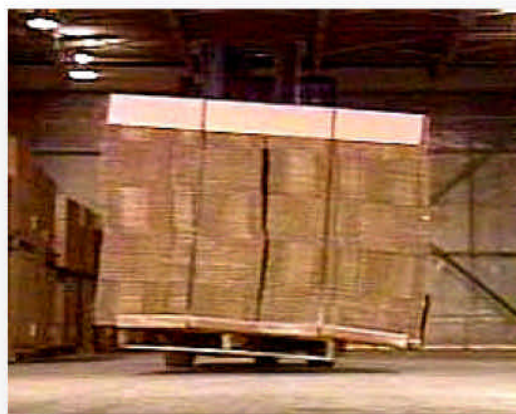
Figure 2-2. Large unbalanced load

Forklift operators need to ensure that the load is balanced, their view is unobstructed, and the weight of the load is within the stated load capacity of the truck (Figure 2-2).

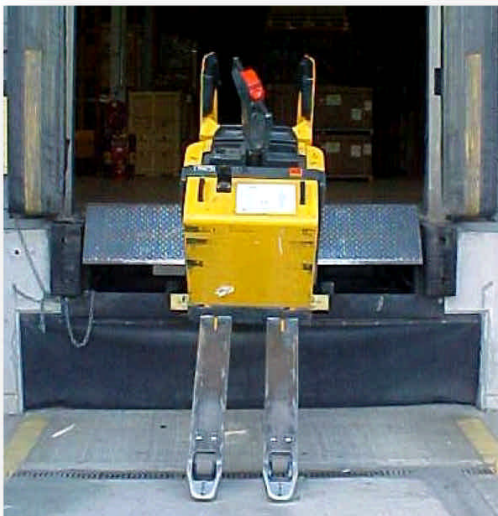
Figure 2-3. Loading dock mishap

Operating forklifts on loading docks can be dangerous, as shown in Figure 2-3. The impact of moving in and out of a trailer can cause the trailer to move. Operators need to know floor capacities (Figure 2-4) to prevent accidents resulting from collapsed floors. They also should be aware of overhead clearances to avoid hitting obstructions.

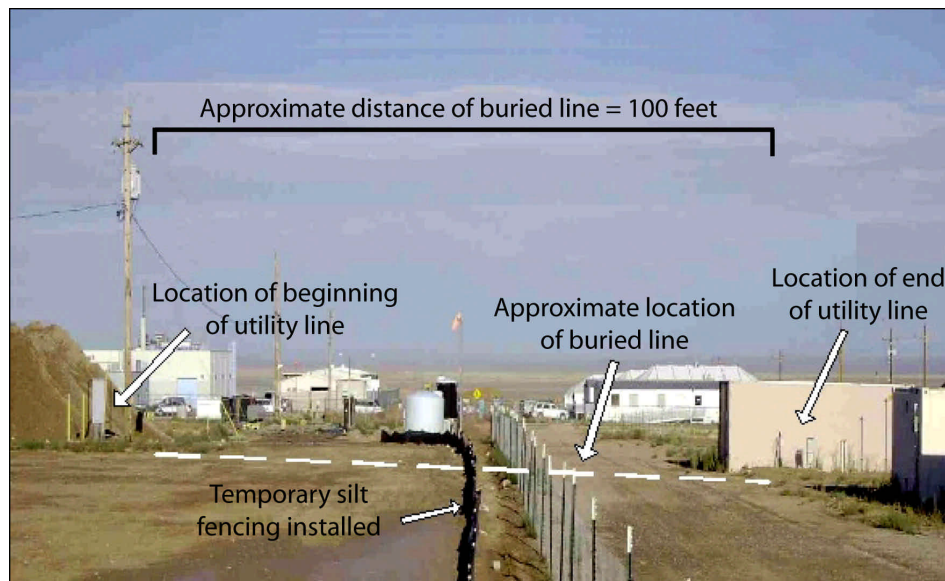
Figure 3-1. Location of cut cable

Figure 3-1 shows the site and the approximate location of the cable run, which was about 100 feet long. When the ripper blade snagged the cable, an equipment operator checked the breaker for the conductor and determined it had tripped. Workers used a multimeter to check the line for energy and concluded it was not energized, so they cut the line and continued with the installation. At the end of the shift, they told contractor management that they had encountered an electrical cable, determined it was de-energized, and cut and re-buried it. When Sandia managers learned that power had been lost to a nearby facility, they concluded that the line was probably energized when it was snagged.

Investigators determined that the direct cause of the occurrence was a lack of procedure because there was no relevant procedural requirement in the excavation section of the site Environment, Safety, and Health (ES&H) Manual that provided guidance to help the workers determine how to proceed when they snagged the line. The workers should have stopped work and notified a supervisor instead of cutting the electrical cable and continuing with the fence installation.

Investigators identified a communications problem as a contributing cause for the occurrence. Although the generic Site Excavation Permit was not considered applicable to the fence installation task, work planners assumed that an activity-specific excavation permit might be needed. They requested this permit from the facilities organization, but did not clearly define the area for which the permit was requested. Facilities personnel thought that the work area

Investigators identified the root cause of the occurrence as a defective or inadequate procedure.

- Conduct refresher training for all environmental restoration field workers to reinforce proper excavation procedures and to stress the need to stop work if unexpected underground utilities are encountered.
- Prepare and implement a new process for task planners to follow before conducting any soil disturbance activities and revise affected field checklists and Health and Safety Plans to reflect the new process.
- Prepare and implement a training program for all environmental restoration personnel on the new process for excavation planning.
- Prepare and implement procedural changes that make it clear that the former “1-foot rule” is no longer valid for environmental restoration work at this site.
- Review the sections of the site ES&H Manual that address excavations, trenches, and

floor/wall penetrations and make recommendations for additional or improved guidance in these areas.

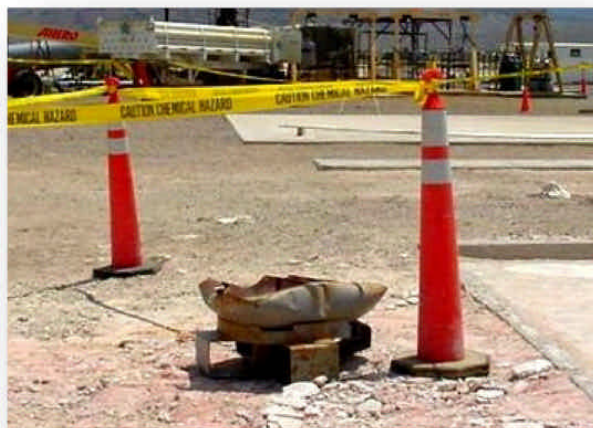
On July 28, 2003, at the Nevada Test Site, technicians found the bottom head (Figure 4-1) from a 110-gallon testing cylinder that apparently burst the previous weekend. The cylinder contained 55 gallons of hydrochloric acid, which was sprayed over a 50-foot radius when the vessel ruptured. The acid spray damaged some equipment, and personnel would very likely have been injured had the cylinder burst during work hours. (ORPS Report NVOO--BN-NTS-2003-0011)

Figure 1. *Facility personnel found the cylinder head lying on the ground some 50 feet away*

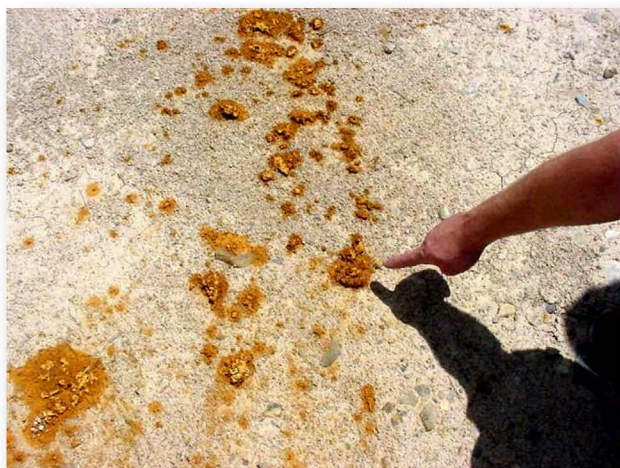
Figure 4-2. Sprayed contents of the cylinder

The following Monday, July 28, 2003, at 7:45 a.m., the technicians were preparing the area for the test when they noticed the cylinder head lying on the ground and a 50-foot zone of discolored debris (Figure 4-2) and discolored equipment (Figure 4-3). The remains of the cylinder hung from the gantry stand above the concrete pad. Personnel closed and barricaded the main entrance to the facility. They collected the cylinder contents, put it in waste drums, and tested the ground, verifying it was neutralized.

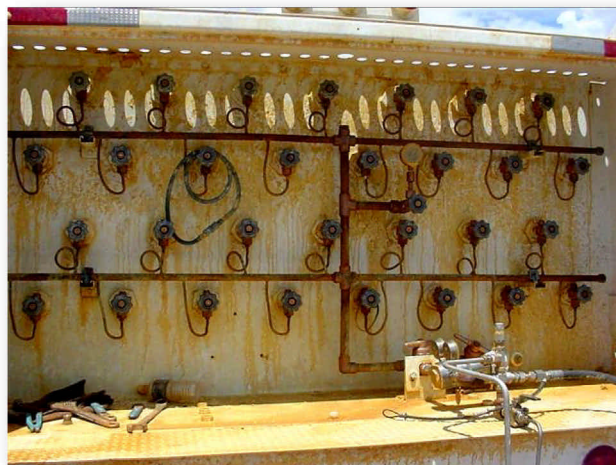
Figure 4-3. Acid spray on nearby equipment

- The stainless steel pressure relief valve was corroded from the hydrochloric acid fumes and could not relieve the excess pressure that ultimately ruptured the cylinder.

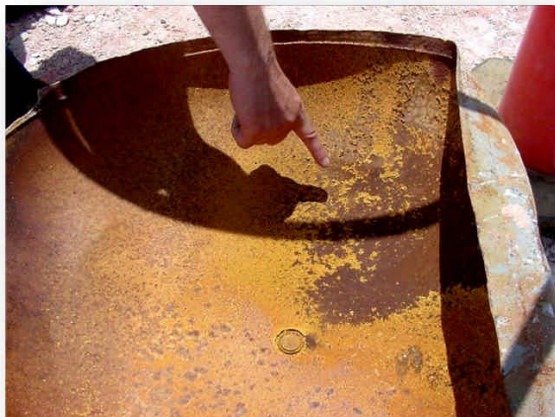
Figure 4-4. Acid corrosion inside the cylinder

- The cylinder was improperly used to hold the hydrochloric acid while waiting for the wind direction to shift. As it sat in direct sunlight, heat and chemical reactions within the cylinder caused excess pressure to build up. The Material Safety Data Sheet for hydrochloric acid clearly states that it is corrosive, reactive with most metals, and must be kept away from heat, as it can decompose to form explosive hydrogen gas.

- Facility procedures for testing corrosives failed to address the appropriate holding time. The work package for using and storing chemicals states that strong acids, with the exception of hydrofluoric acid, shall be stored in glass containers. Work planning documents, however, did not mention at what point, following a delay in the work process, the acid was to be returned to storage. Figure 4-4 shows the degree of corrosion within the cylinder.

Corrective actions, which are still under development, will include improving change control

procedure. Because the experiments will not be conducted until next June, the equipment will be disassembled and inspected.
