# OPERATING EXPERIENCE SUMMARY

**U.S. Department of Energy**  
**Office of Environment, Safety and Health**  
OE Summary 2003-19  
September 22, 2003

# Operating Experience Summary 2003-19

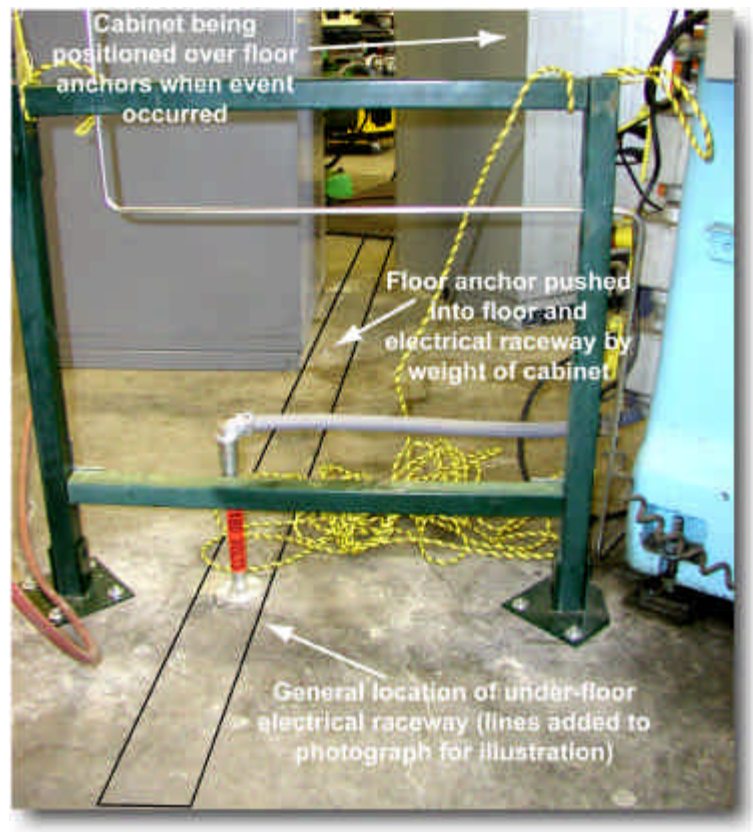
**Figure 1-1. Details of the incident scene**

Workers were to place the cabinet back-to-back with another cabinet that was already installed. They were lowering it onto anchor bolts that had held it in place for at least 13 years. The three workers in the immediate area at the time of the incident—two spotters and a crane operator—were wearing safety glasses and leather gloves, but no electrical-rated personal protective equipment. Figure 1-1 shows the area immediately after the incident. The cabinet is on the right; also shown are the floor anchors and the approximate location of the under-floor electrical raceway (lines superimposed after the incident). Figure 1-2 shows the burn mark on the back of the cabinet and the floor anchor that was displaced.

The mounting holes for the anchor bolts were approximately 2 inches from the end of the 28-inch-long, 2-inch by 4-inch rectangular steel tubes that form the mounting base for the cabinet (Figure 1-3). The spotters were helping position the cabinet onto the anchor bolts. They lined up the mounting holes as best they could by looking down the mounting base tubes (approximately 26 inches) and “eyeballing” the relative locations of the anchor bolts and mounting holes from the sides of the cabinet. However, they were unable to see the back of the cabinet because their view was blocked by cabinet that was already installed.

The root cause of the incident was a deficiency in work organization and a planning deficiency. Some time before 1989, the anchor bolt was installed too deeply in the concrete floor, directly over the electrical raceway. The anchor would not have been installed in this manner if a survey for subsurface obstructions had been performed to determine the location of the raceway.

- Revise the Machine Shop Facility Hazards List to include electrical raceways and 480-volt-ac conductors embedded in the concrete floor.
- Require subsurface surveys before making floor penetrations or attaching to any installed anchor bolts.
- Conduct a training session on this event for all appropriate personnel addressing the need to perform a comprehensive evaluation of the hazards associated with a task, to pay strict attention to the task being performed, and to stop work and seek assistance from others if unexpected conditions arise.

- Conduct a training session for supervisors on this event and on the importance of addressing “what-if” questions and accident precursor experience in pre-job briefings.
- Review the facility procedures on subsurface investigations and revise them if necessary to ensure that they provide adequate guidance to prevent the placement of anchoring hardware over shallow-placed subsurface utilities.

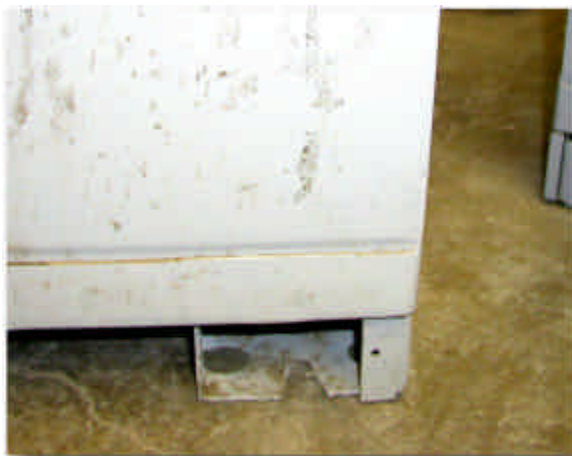
*Figure 1-3. Mounting hole in cabinet base*

Investigators determined that inattention to detail by the work crew was the direct cause of this occurrence. The workers had no reason to expect an electrical intrusion event if they misaligned the cabinet and the anchor bolts. How-

ever, had they taken greater care in aligning the cabinet mounting holes with the bolts, they could have prevented the incident.

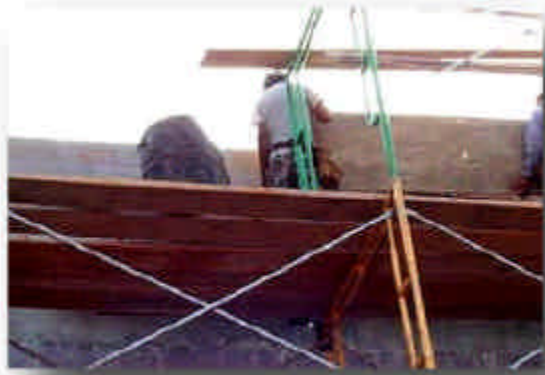
The OA inspectors discovered numerous instances where scaffolding was not erected in accordance with INTEC scaffolding program requirements. Deficiencies included inadequate guard railing, lack of toe boards, unsecured planks, and gaps between planks and vertical side members. Examples of unsafe scaffolding (not at INTEC) are shown in Figures 2-1 and 2-2.

**Figure 2-1. Example of scaffolding without handrails or toe boards**

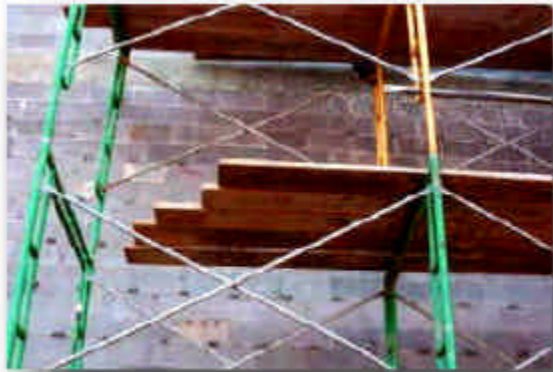
**Figure 2-2. Example of scaffolding with deficient spacing**

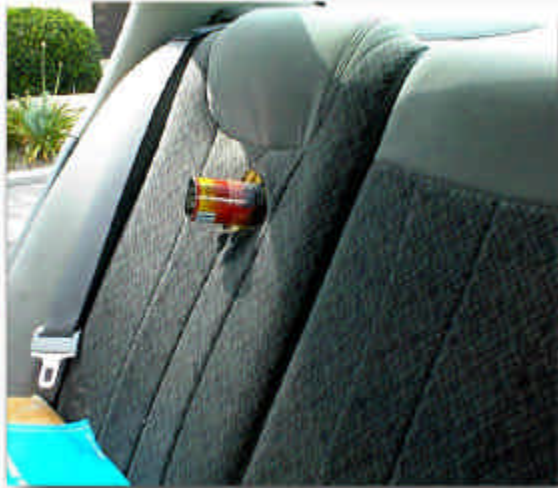
Aerosol cans carry a warning that they should not be exposed to prolonged sunlight or stored at temperatures higher than 130°F, but there is no specific warning against storing them in vehicles during hot weather. The ALCOA Safetygram cautioned against keeping items such as cans of WD-40®, Fix-A-Flat®, hair spray, or deodorant in a vehicle in hot weather and included photographs showing the damage that occurred when aerosol containers exploded. Figure 3-1 shows an aerosol can embedded in the rear seat of a closed-up car after it exploded on a day temperatures reached 100°F.

*Figure 3-1. Exploded aerosol can embedded in rear seat*

- Do not leave aerosol containers in a vehicle where they can be exposed to sunlight.
- If an aerosol container must be stored inside a vehicle, place it in an industrial cooler and slightly open one or more windows.
- Read caution statements on all aerosol products and take the recommended actions.

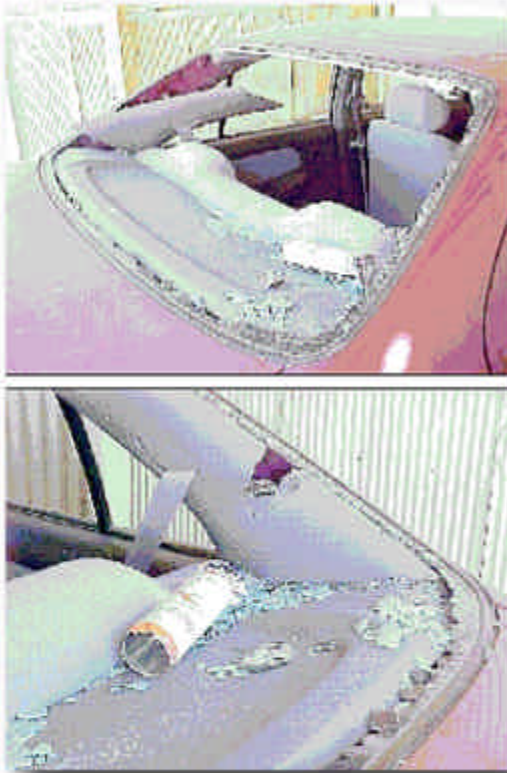
In the second incident, a can of deodorant stored in the back of a car parked in the hot sun exploded and shattered the rear window (Figure 3-2). A similar incident occurred several years ago at the Nevada Test Site, where two aerosol cans of dust remover burst inside a parked vehicle and blew out the window. The manufacturer's data indicated that a temperature of

greater than 130°F inside the vehicle would produce pressures of more than 266 psig within the cans.

*Figure 3-2. Shattered rear windshield following aerosol can explosion*
