OPERATING EXPERIENCE SUMMARY

U.S. Department of Energy
Office of Environment, Safety and Health

OE Summary 2003-20

October 6, 2003

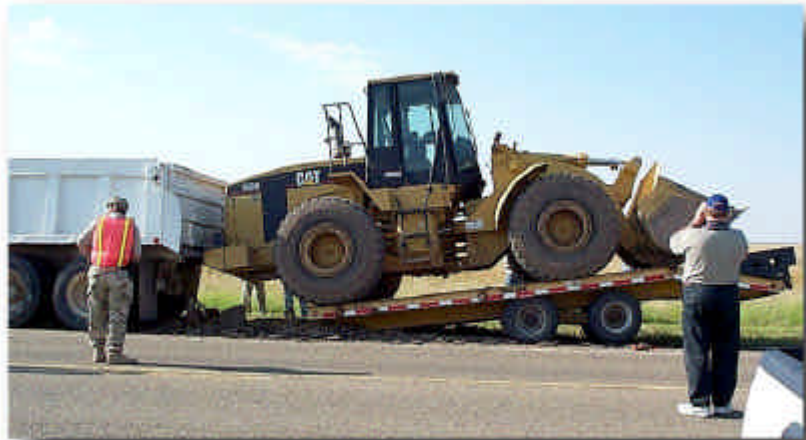
Figure 1-1. Vehicles immediately following accident

An equipment supplier had delivered the front-end loader to the Pantex Plant, but the subcontractor decided to return the loader using an available truck and trailer, rather than have the supplier retrieve the equipment. The subcontractor supervisor questioned the load capacity of the truck and trailer in relation to the size of the load, but did not stop the loading activity. He thought that the personnel who arranged for the truck and trailer knew the weight of the loader and the capacity of the trailer and correctly assigned the equipment. The truck driver secured the loader to the trailer and attached safety chains from the trailer to the truck. He had driven about 1.5 miles before the trailer tongue dropped to the road surface, making a 260-foot-long skid mark in the asphalt.

Figure 1-1 is a photograph of the truck, trailer, and front-end loader where they came to a stop on the shoulder of the road after the accident. As can be seen in the figure, workers loaded the equipment onto the trailer with its heavy end (engine, rear frame, fuel tank, and hydraulic reservoir) between the axles and the tongue of the trailer. This configuration produced higher forces on the trailer hitch than if the loader orientation had been reversed. Figure 1-2 shows the trailer hitch on the ground after the accident, with two of the four empty bolt holes.

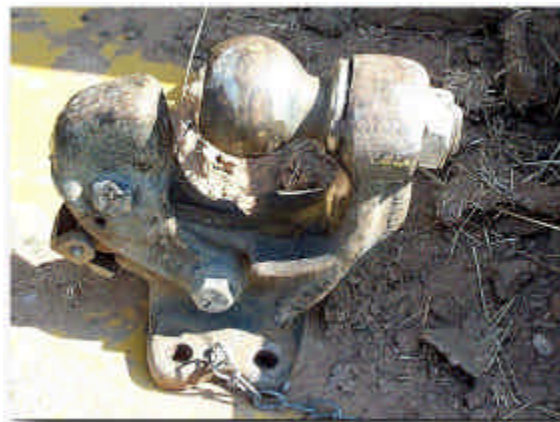
Figure 1-2. Trailer hitch after detachment from truck

The 28-foot-long utility trailer involved in this incident had a maximum hauling capacity of 30,000 pounds. Subtracting the weight of the trailer from the maximum hauling capacity, the load on the trailer should not have exceeded 22,300 pounds. The front-end loader weighed 48,500 pounds. The weight, which was clearly

stenciled on the loader, was more than double the trailer's capacity.

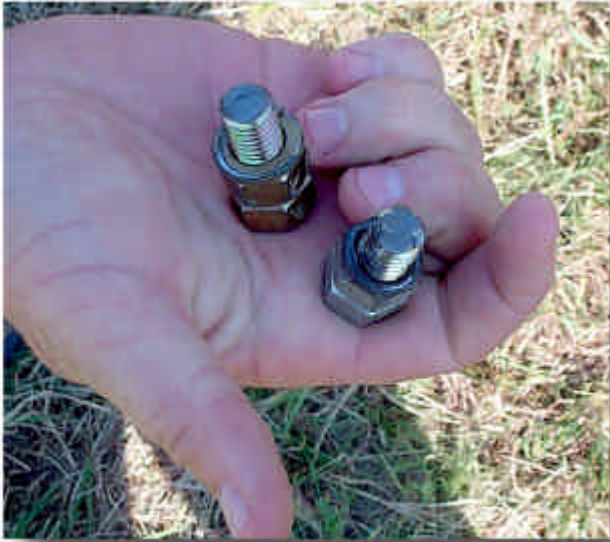
Figure 1-3. Two of the four sheared trailer hitch bolts

Figure 1-3 is a photograph of two of the four trailer hitch bolts after they were sheared off. Investigators determined that the shear-rating for the four bolts securing the trailer hitch was 4,900 pounds. They also inspected the bolts to determine if they were suspect or counterfeit items and determined that the stamped markings on the bolt heads were not on the suspect/counterfeit parts list.

Investigators determined that the direct cause of this incident was that the equipment selected to transport the front-end loader was inadequate. They also determined that the root cause of the occurrence was a work planning deficiency because the weight of the loader was not considered when selecting the truck and trailer used to haul it.

- Construction management personnel conducted a safety meeting with all subcontractors at the Pantex Site and discussed this event in detail. The content of the meeting focused on following safety rules, the competency of operators, and equipment selection. Construction management personnel provided all subcontractors with a summary of

- The Pantex Plant prime contractor will issue a lessons learned to all site subcontractors informing them of this event and describing the actions they must take when transporting equipment to and from the site, including evaluating the weight of the proposed load against the capacity of the transport equipment.

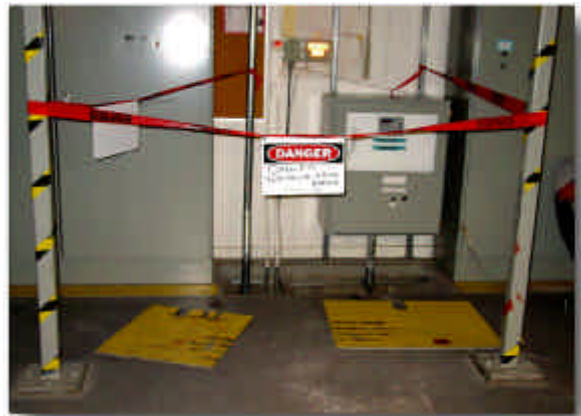
Figure 2-1. Cable trench and cover plates

A recessed lip in the concrete floor supports the 1/2-inch-thick steel trench cover plate on three sides. The cover has two threaded holes to install eye bolts for ease of handling, but they were never installed. Had the cover plate been fitted with eye bolts and a rope, the electrician could have attached the rope to a nearby structural column, which would have prevented the cover from falling into the trench when he lost control.

Figure 2-1 shows the location of the trench and cover plates, and Figure 2-2 shows the cover plate in the trench following the incident. Figure 2-3 shows the damage to the power cable insulation and the ground wire.

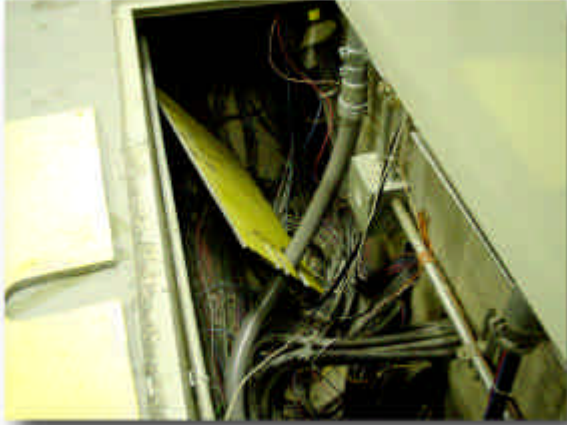
Figure 2-2. Smaller plate in trench following incident

The causal analysis for this occurrence focused on (1) the weight of the dropped cover plate and (2) the absence of eye bolts and associated rope that the electrician could have used to remove and install the cover. After the event, investigators asked the electrician how much he thought the dropped plate weighed, and he estimated 35 to 40 pounds—well below the 90-pound weight of the cover and the 50-pound limit for unassisted handling. This weight discrepancy and other factors, such as overlooking the stenciled lifting hazard caution sign on the plate, indicate that electrician was overconfident, lacked awareness about the risks involved, and lacked a questioning attitude.

Corrective actions being considered as a result of this incident include replacing the cover plates with new plates made of a different material. The cover plates serve as a deck plate and

provide an enclosure for the cables in the trench to prevent direct access to electrical equipment. Using plates made of steel is excessive and introduces unnecessary hazards in terms of lifting weight, pinch points that could injure fingers or toes, and electrical conductivity. Lighter, non-conductive cover plates could perform the required functions without the safety risks associated with the steel plates. An alternate corrective action under consideration is to provide a mechanical means, such as a mobile hoist in conjunction with eye bolts in the plates and rigging measures, to assist workers when they remove and replace the covers.

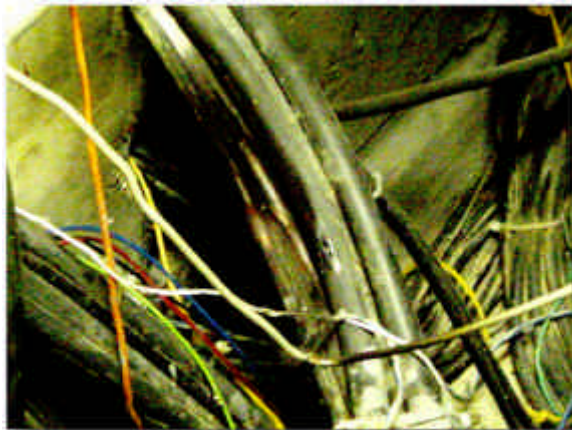
Figure 2-3. Damage to 480-volt cable and small white ground wire

On August 28, 2003, at the Hanford Tank Farms, as an electrician attempted to replace a trench cover plate, it slipped from his hands, fell into a cable trench, and damaged a 480-volt

power cable, creating an arc/flash to ground. The plate was stenciled with the words "Caution – Lifting Hazard Do Not Remove Trench Covers Without Permission From Facility Manager," but the lifting hazard was not identified in the Job Safety Analysis (JSA). No injuries resulted from this occurrence. (ORPS Report RP--CHG-TANKFARM-2003-0043)

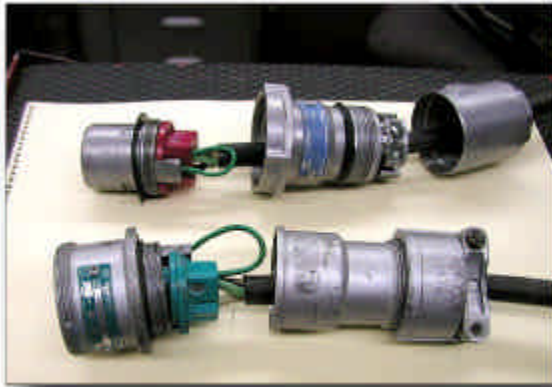
Figure 3-2. Disassembled extension cord plugs

On September 9, 2003, at the Idaho Test Reactor Area, electricians discovered a shop-fabricated extension cord that was miswired, posing a shock hazard. The extension cord was being used to power a filter blower (480-volt, 3-phase) from a disconnect switch. When the switch was closed, a fuse for one of the phases

Electricians performed a detailed inspection of the extension cord and discovered that one of the phase wires had been incorrectly connected to the case of the cord cap by a ground wire. Figure 3-2 shows the disassembled end caps and the installed green jumper wire connecting the green power wire to the cap. These cord caps are designed for four-wire (3 power/1 ground), three-phase applications. The electrician who fabricated the extension cord had not wired this particular type of three-prong cap previously and incorrectly wired it as a single-phase, three-wire plug.

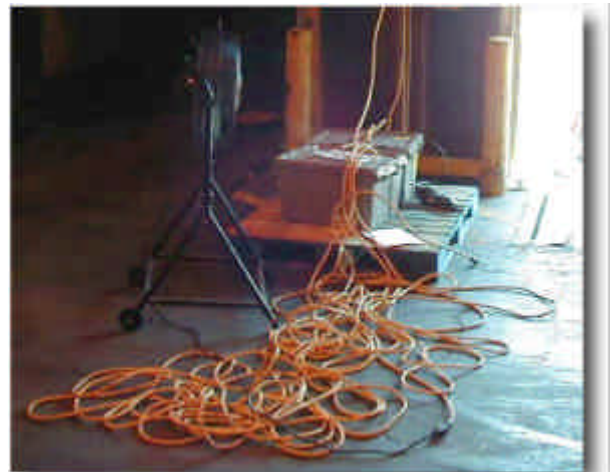
Figure 3-3. Practice good housekeeping

Extension cords can provide a convenient source of power in the workplace for maintenance and construction activities, but are often taken for granted and not properly maintained or used. Extension cords should not be left in areas where they could become tripping hazards or where they could be damaged, such as by being walked on or driven over (Figure 3-3).

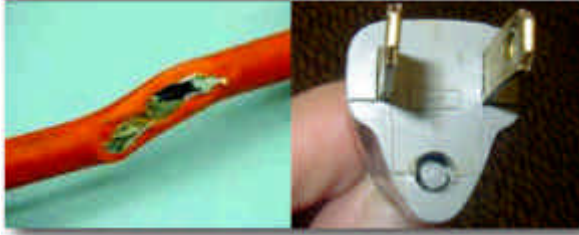
Figure 3-4. Damaged cord and missing ground

Check plugs on cords to ensure all prongs are properly attached and check the cord for insulation damage (Figure 3-4).

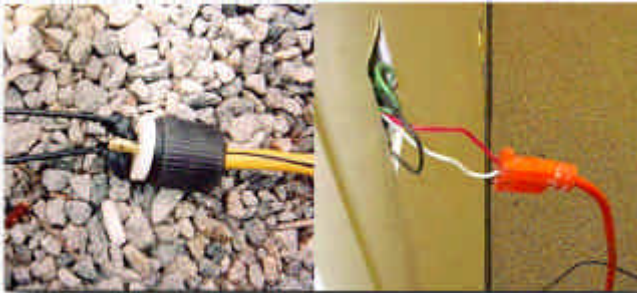
Figure 3-5. Unsafe use of extension cords

Do not use extension cords in an unsafe manner. Avoid plugging two cords together to make a longer one, thus reducing operating voltage at the end of the cord. Certainly, never wire up an extension cord, as shown in Figure 3-5.

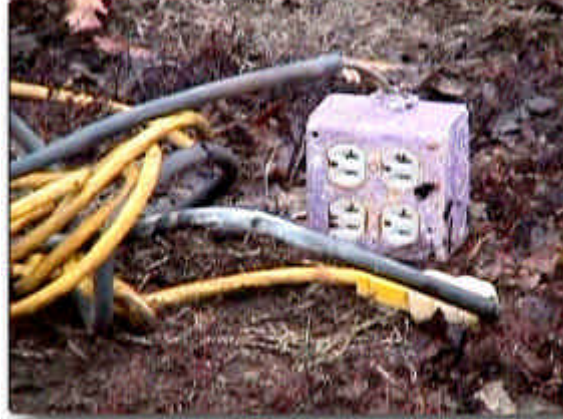
Figure 3-6. Remove this from service

Always remove defective or damaged extension cords and power strips from the workplace when they are discovered (Figure 3-6).

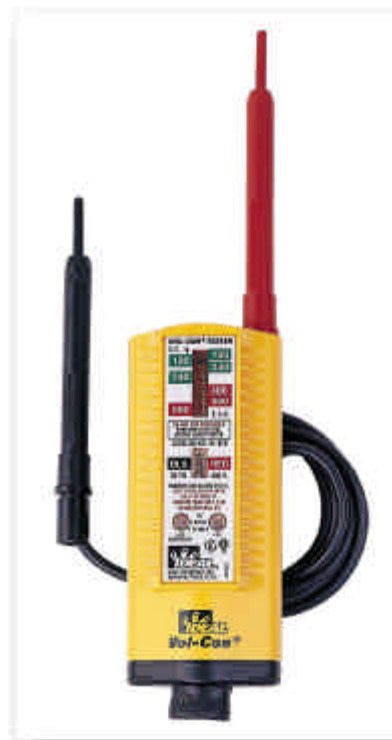
Figure 5-1. The recalled voltage tester

On July 31, 2003, the U.S. Consumer Product Safety Commission, in cooperation with IDEAL Industries, Inc., recalled about 121,000 potentially defective solenoid-type voltage testers and voltage/continuity testers. The testers may short out at high voltage, causing an arc flash that can injure users and blow out the faceplate. Model (Catalog) numbers for the hand-held testers being recalled are 61-065, 61-066, 61-067, 61-076, 61-079, and 61-080. Use of these testers should be discontinued immediately.

Figure 5-1 shows a typical recalled unit. The tester body is yellow, and the wire leads have one black and one red test probe. The model or catalog number is on the faceplate (see Figure 5-2). Electrical distributors, industrial distributors, and home centers across the country sold these hand-held testers between December 1999 and July 2003. Testers manufactured before November 1999 and after May 2002 are not included in the recall, nor are any other IDEAL testers or meters.

IDEAL will provide a free replacement for all recalled models manufactured between the applicable dates. Call customer service at 1-877-557-8598, toll-free, between 7 a.m. and 5 p.m. Central Time (Monday through Friday) to obtain more information on the recall and learn how to return defective testers. The email address for Customer Service is testersandmeters@idealindustries.com. Registration and return options can also be accessed through the IDEAL, Inc. website at www.idealindustries.com

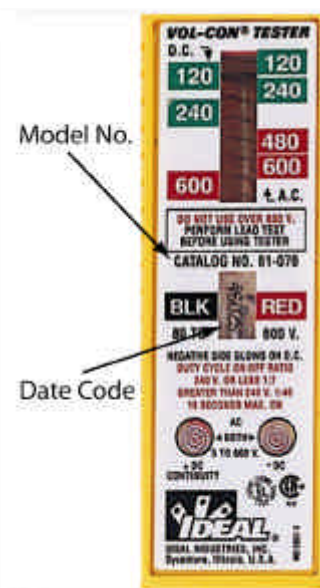
Figure 5-2. Model number and date code

IDEAL manufactures the testers at two locations (Sycamore, Illinois, and Ajax, Ontario, Canada). Date codes, located on the faceplate of the units (Figure 5-2) indicate where and when they were manufactured. This information can be used to determine whether a tester is in the group that has been recalled. The date code information should be interpreted as follows.

- For Sycamore-manufactured units — Recall date codes are 4799S through 1902S, in a week/2-digit-year format, with “S” indicating the tester was manufactured in Sycamore, Illinois. For example, 4799S means the tester was manufactured in the 47th week of 1999 in Sycamore.
- For Ajax-manufactured units — Recall date codes are 479I through 192I, in a week/1-digit-year format, with “I” indicating the tester was manufactured in Canada. For example, 479I means the tester was manufactured in the 47th week of 1999 at IDEAL Canada in Ajax. Some testers manufactured in Ajax have a day, month, and 1-digit-year date code. In this case, a date code of 01032 would mean the tester was manufactured on March 1, 2002.
