# OPERATING EXPERIENCE SUMMARY

OE Summary 2003-21

October 20, 2003

# Operating Experience Summary 2003-21

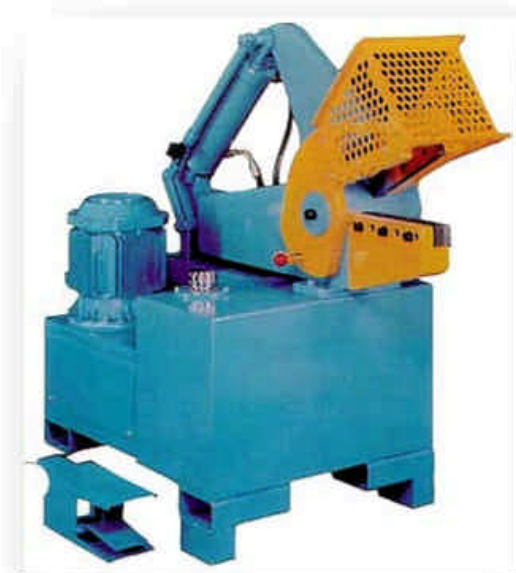
*Figure 1-1. A typical alligator shear*

Figure 1-1 shows a typical alligator shear (not the one used at Y-12). The shear that malfunctioned was used to cut metal stock up to ½-inch in thickness and was approximately 40 years old. The manual safety switch used to actuate the shear was spring loaded to return to the open (de-energized) position when released by the operator. A check of this switch following the incident revealed that it occasionally hangs up in the closed (energized) position, and if the

foot safety switch remained pressed, a second actuation of the shear could occur without additional operator action. No procedures were violated during this incident, and the worker involved was following the appropriate radiological work plan. Following the incident, alligator shear operations were suspended, and access to the area was controlled by postings on the glovebox containing the alligator shear and on the access door to the room containing the glovebox.

In addition to identifying the faulty manual actuation switch as a likely cause of the malfunction, investigators examined records associated with the shear to try to determine the condition of the machine. They reviewed maintenance records, vendor manuals, and engineering drawings, but none contained information that shed light on other possible causes of the malfunction. They also conducted interviews with machine operators and supervisors who had used the alligator shear. Several people reported that they had experienced a “double-clutching” problem with the machine, where it would actuate a second time without operator intervention after completing a shear action. Each individual indicated that they had reported the “double-clutching” malfunction to supervisory personnel when it occurred. Several of the operators remembered that maintenance personnel had inspected the machine after these malfunction events, but they did not know what repairs or adjustments had been performed, if any.

Based in part on the fact that machine operators reported that the shear had been known to “double-clutch” without activation by the operator, investigators determined that the direct cause of the incident was a malfunction of the machine. A communication problem related to malfunctions of the machine contributed to the incident. The “double-clutching” problem was known to a few operators and supervisors, but it was not common knowledge and was not identified in the job hazards analysis associated with the alligator shear.

Investigators identified a management problem as the root cause of the occurrence. Managers failed to act on the reported machine malfunctions to (1) eliminate the hazard by repairing

- Repair the manual shear activation switch to eliminate the “double-clutching” malfunction.
- Design, fabricate, and install a safety shield to prevent operators from getting their hands near the blade path of the shear.
- Purchase two manufacturer’s operation manuals for the alligator shear; one for operator use and one for the engineering files.
- Evaluate other equipment in the building to see if there are any similar problems that need to be addressed.
- Review the maintenance history of the alligator shear to determine why the reported malfunction of the machine was not corrected.
- Brief appropriate workers and supervisors on the importance of identifying safety concerns to management personnel.
- Generate a list of safety concerns associated with equipment and track the resolution of these safety concerns in a database.

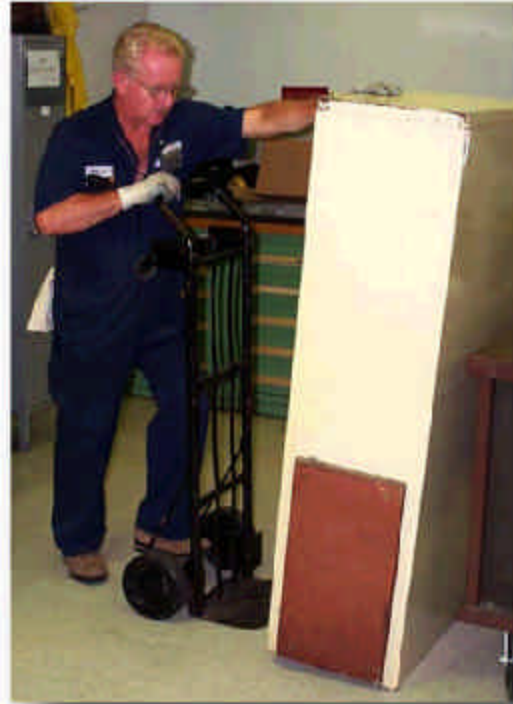
Figure 2-1. Loading cabinet on dolly (reenactment)

The worker tipped the file cabinet forward to slide the dolly underneath (Figure 2-1). A 72-pound metal anchor plate had been bolted to the rear of the cabinet to provide stability when it was standing alone or was not secured to an-

other cabinet. This additional weight was not identified as a hazard.

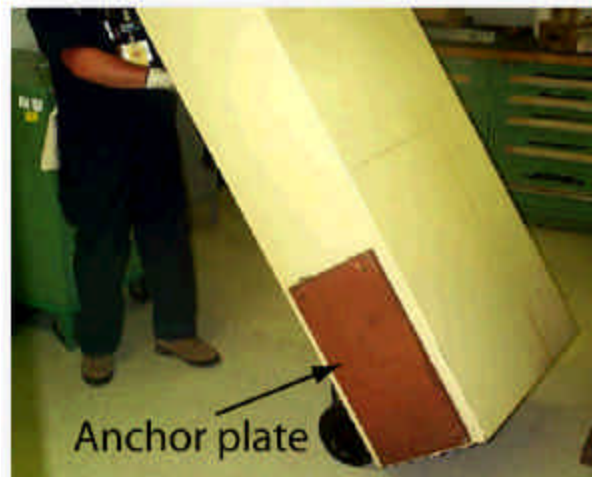
Figure 2-2. File cabinet lifted off the floor

The worker tilted the dolly back to take the load and lifted the cabinet off the floor (Figure 2-2). The dolly was placed too far to the left of the cabinet, such that the heavy anchor plate was off center. This caused the file cabinet to fall to the right and strike the co-worker as it fell to

the floor. The top corner edge of the file cabinet tore through the worker's blue jeans and caused a deep laceration that required more than 20 sutures to close.

Investigators determined that the balance point of the load was not correct. The file cabinet was lifted from the side instead of from the rear so that the heavy anchor weight would be centered low on the dolly and positioned over the axle. A more detailed report on this event can be obtained from the SELLS website at <http://tis.eh.doe.gov/ll/>.

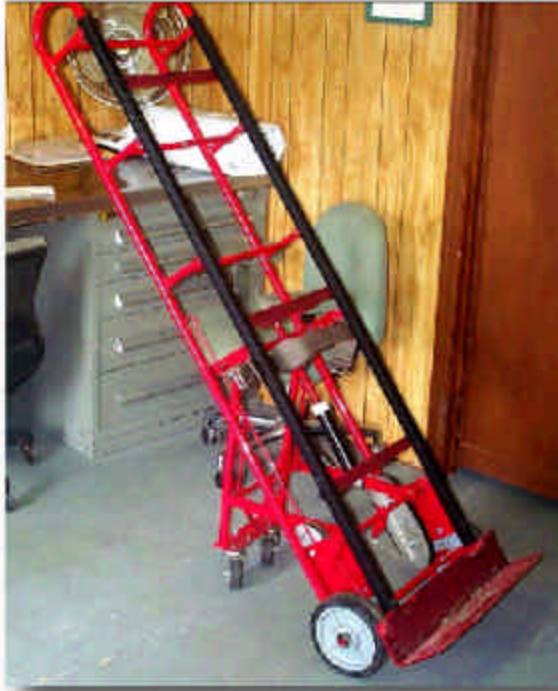
A more appropriate dolly with a strap for securing the load had been used by this work group the previous day but was not used in this case (Figure 2-3).

*Figure 2-3. Dolly with strapping mechanism and rear support*

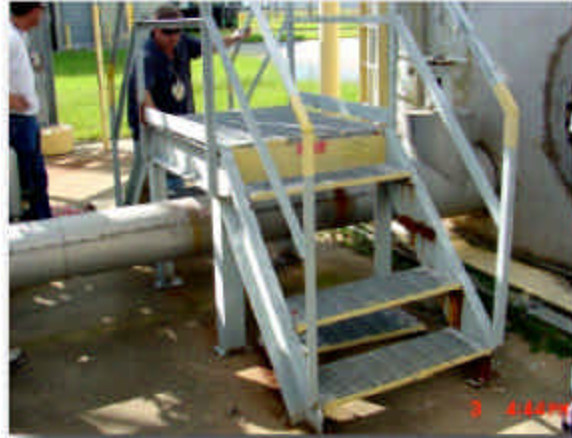
On September 3, 2003, at the Savannah River Site, a worker performing a routine equipment walkdown fell and cut a 6-inch-long gash in his left shin when a metal exterior stair broke under his weight. Defective welds, coupled with corrosion, caused the step to break. All steps and platforms in the area were roped off and secured following the incident. (ORPS Report SR-WSRC-FDP-2003-0005)

The worker walked across a permanently installed metal walkway to cross over some piping and began to descend the four-step metal stairs to the ground. As he placed his weight on the second step from the top, it broke loose, and the worker hit his left shin on the inside edge of the third step as he fell through the steps. Although the worker needed 25 stitches to close his wound, holding onto the handrail during his descent probably saved him from a more serious injury. Figure 31 shows the stairs, after the incident, with the broken step on the ground.

**Figure 3-1. Stairs after the incident, with the broken step on the ground**

Investigators determined that defective tread support welds, coupled with corrosion, caused the step to give way. Corrective actions taken following this event included inspecting all outside metal steps and platforms and evaluating them for safety issues. Site safety personnel also issued a Lessons Learned Special Information Notice about the incident. The Notice is an attachment to a lessons-learned report (2003-SR-WSRC-0015) published by the Society for Effective Lessons Learned Sharing (SELLS) and can be accessed at the SELLS website via the following link: <http://tis.eh.doe.gov/ll/listdb.html>.

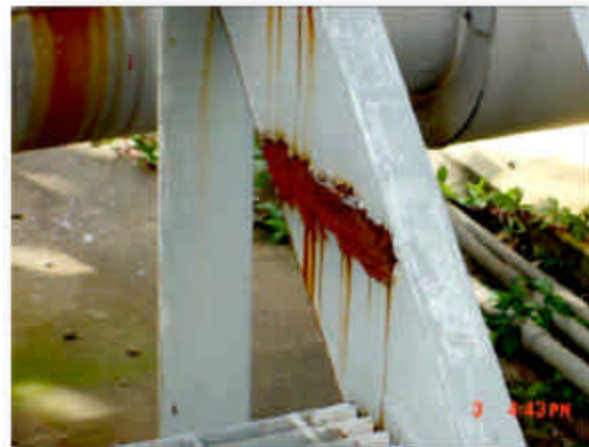
The steps, made of galvanized grating and structural supports, were welded, not bolted, to the stair framework. The stairway had not been repaired since it was constructed. Figure 3-2 shows the badly corroded area where the stair tread attached to the frame of the stairs.

When the stairs were inspected following the incident, inspectors determined that they had not been properly constructed, and the defective tread support weld caused the step to give way when the worker stepped on it. Construction drawings specified using a 3/16-inch fillet weld all around the tread to attach it to the support, but tack welds were used instead. Inspectors also found defective support welds on two simi-

**Figure 3-2. Corrosion where stair tread attached to the frame**

lar sets of stairs in the area. Welds on the failed tread support and some other supports were completely corroded away.

Defective stairs should be removed from service and modified to ensure they are safe for use. Recommendations in the SELLS lessons-learned report about this event include inspecting exterior stairs in corrosive environments for defective fabrication and corrosion of tread support welds and installing 3/8-inch-diameter galvanized bolts and nuts in tread supports with inadequate welds.

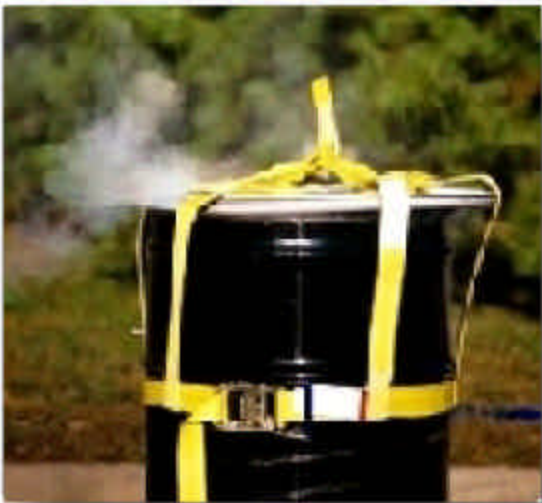
*Figure 4-1. A drum harness*

A drum harness (Figure 4-1) or lid restraining device (Figure 4-2) would have prevented the lid from flying off uncontrolled. In fact, other facilities at Hanford use drum harnesses routinely, having implemented a lesson from a 1995 event at the T Plant, where a drum lid, locking ring, and internal 90-mil drum liner lid were explo-
