OPERATING EXPERIENCE SUMMARY

U.S. Department of Energy
Office of Environment, Safety and Health

OE Summary 2003-22

November 3, 2003

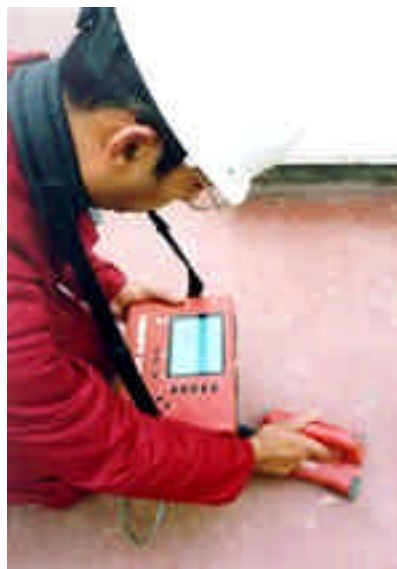
Figure 1-1. A Ferrosan FS10

Before work began, workers used a Hilti Ferrosan FS10 (Figure 1-1), "Quickscan," survey to identify any hidden obstructions in the wall, but the scan did not indicate the presence of wiring. The construction worker was drilling holes for guardrail supports when his drill bit penetrated the ½-inch metallic conduit and tripped the circuit breakers. Apparently, the workers who performed the pre-work survey did not understand the limitations of the "Quickscan," which only scans to a depth of 4 inches. The wiring was approximately 6 inches inside the wall. Other available methods such as survey instruments, drawings, construction records, and personnel knowledge were not used.

Investigators determined that the direct cause of the occurrence was that work planners did not identify the presence of the energized conductor. They also identified several contributing causes for the occurrence, including (1) using a Ferrosan "Quickscan" survey instrument under conditions where it could not produce a meaningful reading; (2) considering non-compliance with the blind penetration permit requirements a "standard practice"; and (3) failing to mark the location of hidden utilities on the structure to be penetrated.

- Procure scanning survey equipment that is compatible with the conditions encountered in the facility.
- Provide training for all personnel who use the survey scanning equipment on the specific operating characteristics and limitations of the equipment.
- Provide briefings on the requirements of the blind penetration permit to appropriate personnel.
- Develop a checklist of good practices and incorporate it into the blind penetration permit process.

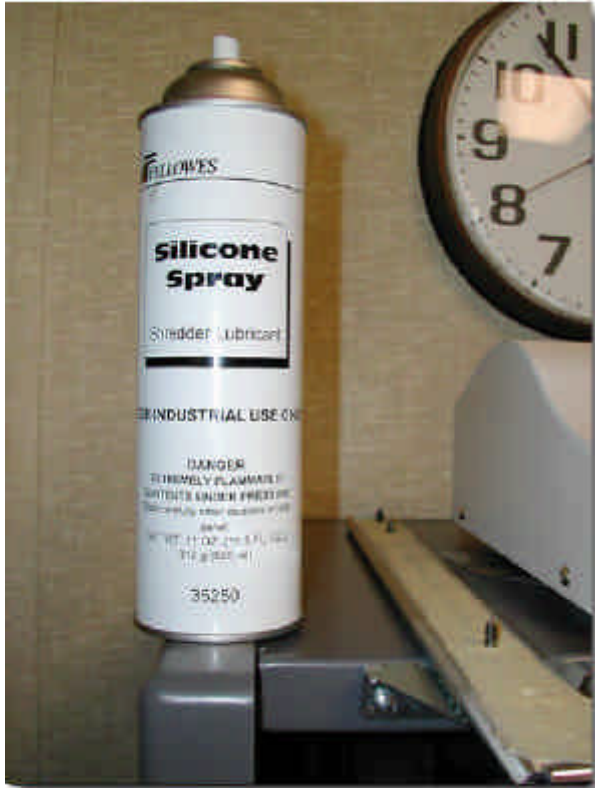
Figure 3-1. Fellowes Silicone Shredder Lubricant

The technician sprayed Fellowes® Silicone Spray Shredder Lubricant (Figure 3-1) on the paper to prevent the shredder from clogging. Liquified petroleum gas (LPG) is used as the propellant for the silicone spray, and the label on the can warns that it is extremely flammable. The instructions on the spray can direct users to insert a spray extension tube into the nozzle, place the

The technician held the can in a horizontal position and sprayed the lubricant onto the paper, without using the extension tube. The instructions on the spray can did not indicate that the equipment should be de-energized when using the lubricant, so the technician did not turn the shredder off before he sprayed the lubricant.

Following the event, facility personnel contacted Fellowes and learned that they discontinued making the lubricant in 1995, but not because of safety concerns. The Material Safety Data Sheet (MSDS) for the silicone lubricant states that it is considered non-flammable, but page 3 of the MSDS indicates a fire index value of 4 be-

cause of the LPG propellant, which has a 1.8 percent lower explosive limit. If the can is held vertically as it is being used, the propellant remains in the can; however, the flammable LPG can escape if the can is held at an angle (or horizontally, as the technician held it).

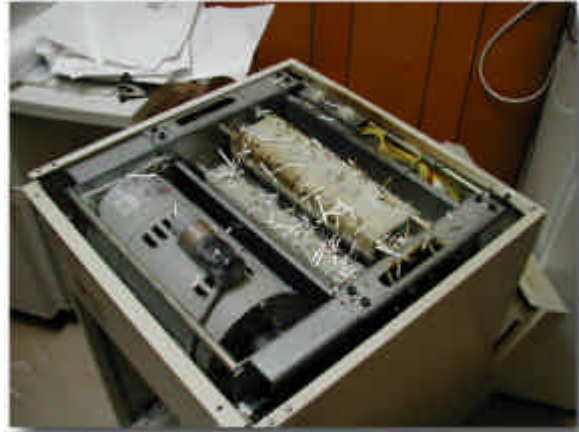
Figure 3-2. The shredder after the fire

The technician resumed shredding, and about 5 minutes later, the flash occurred. He immediately stepped back, saw a flame in the cabinet of the shredder, and used a halon fire extinguisher to extinguish the fire. Figure 3-2 illustrates the burned shredder.

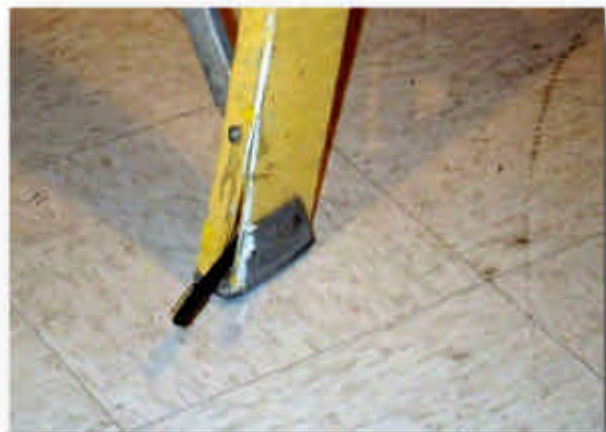
Figure 4-1. Cracked ladder foot

Following the incident, inspectors found cracks in the right front and rear legs (Figure 4-1) and along the right and left front legs where the spreader bar is attached to the ladder side rails (Figure 4-2).

Investigators believe that the right foot of the ladder began to split at the bottom, allowing the ladder to bow out to the left. This in turn placed

abnormal stress on the ladder spreader bar, causing the split in the left leg of the ladder. Part of the right front foot of the ladder appeared to have worn away as though it had been dragged while being moved, and the unsealed fiberglass edges were exposed. This is where investigators believe the ladder began to split.

Inspectors conducted mass inspections of ladders in adjoining facilities following this incident. Managers continue to emphasize that users must inspect ladders before they use them and must follow the requirements in the site procedure for ladder and scaffold safety.

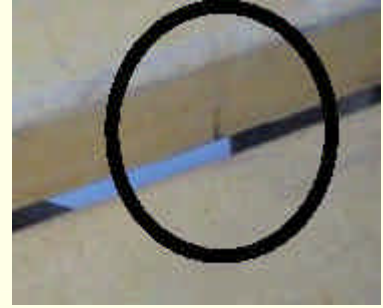
- Scrape a fingernail along the surface of ladder structures to discover cracks forming that may not be easy to see.

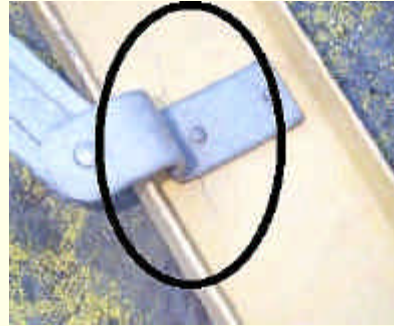
- Check areas that have been drilled (e.g., to attach metal fittings with rivets). Areas that have been drilled become vulnerable to cracking.

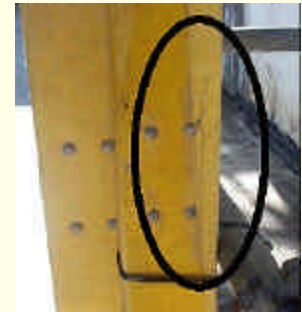
- Look for bent back supports where someone may have attempted to stand.

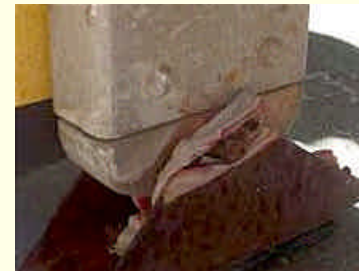
- Check the feet of the ladder to ensure that the rubber feet are intact and that metal hardware is undamaged. The feet absorb the shock of contact with hard surfaces and can crack and split.

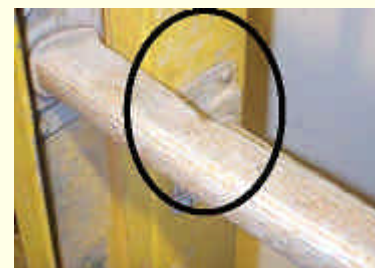
- Check for dents in the ladder rungs. When a round tube becomes bent, the bent area becomes the weakest point.
